TECHNICAL BULLETIN

PART NUMBER 22331

2004-2010 Dodge Ram
2500, 3500 5.9L, 6.7L Diesel

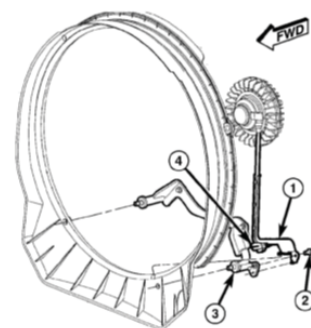
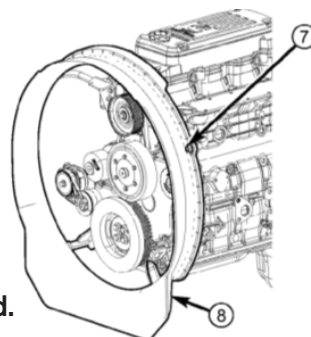
PROBLEM - Reports from the field, across all manufacturers replacement parts, including OEM, experience a high incident rate of cooling fan blades contacting the cooling fan clutch wires, resulting in damage to the fan clutch and cooling fan (fig 1-4). Usually found in higher mileage vehicles, the incidents are reported as occurring while traversing water, towing, and other high engine load conditions and at fan clutch replacement start-up or soon after. The OEM vehicle design places the fan clutch wire harness, that mounts to the fan shroud, very close to the fan blades. The fan shroud and brackets can become loose over time, causing the fan shroud to move and bring the fan clutch wires into the path of the fan blade.

SOLUTION - Inspect and secure the fan shroud and brackets before and after replacing the fan clutch (fig 7-8). Replace the fan shroud if damaged.

CAUTION - The cooling fan blades should also be inspected. Inspect for fatigue cracks, or chipped blades or any marks indicating contact with other engine compartment components. Replace fan blade assembly if any of these conditions are found.
