Subject: Brake Rotor Plate Thickness Variation

Vehicles: All Passenger Cars and Light Trucks

WINHERE

Technical Service Bulletin

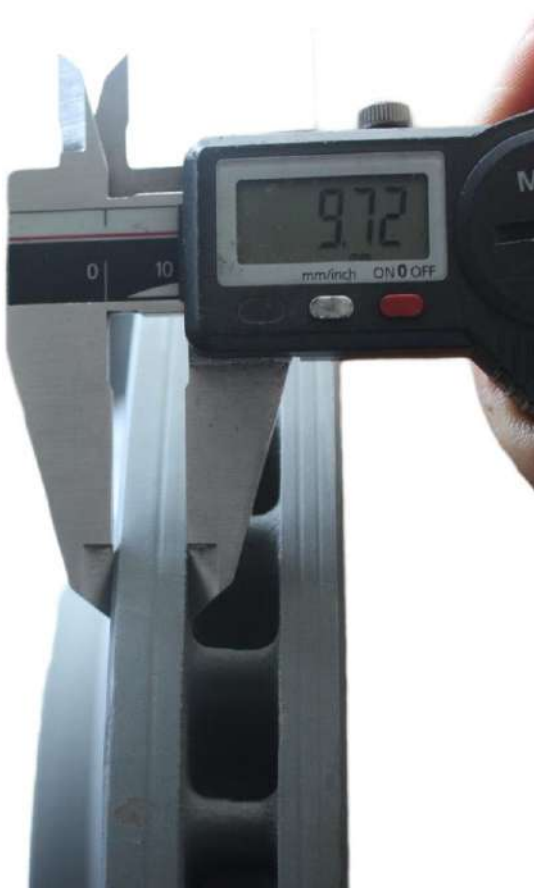
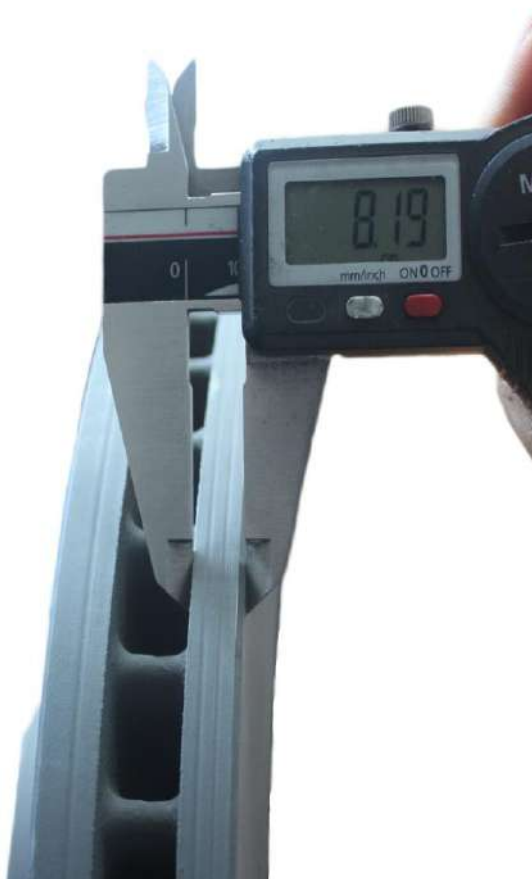
Concern: The image below is of an OEM rotor that is designed intentionally with different inboard and outboard braking plate thicknesses. This rotor fits 2006 and newer Chevrolet and Buick midsize sedans. There are several other OEM rotors that are intentionally designed this way. In addition, every rotor will have some thickness variation between the inboard and the outboard braking plates, but most of the time it is not visible with the eye. However, the machining tolerances are such, that there may be a visual difference between plates, but the plate thickness and the air gap are still within tolerances.

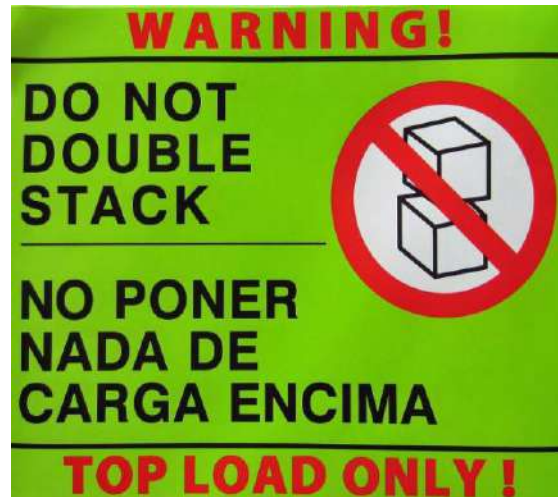
Concern: Excessive run out or an out of round condition due to improper drum and rotor handling. All drums and rotors are manufactured to very specific tolerances prior to being shipped from our factory. Excessive run out or an out of round condition usually occurs as a result of mishandling, improper storage or improper shipping techniques. The most common occurrences are double stacking of drum pallets; dropping a drum/rotor or storing drums on edge. We have added to every drum box "Stock flat, not on edge". Also please take note that all drum pallets contain a label warning against double stacking of pallets.

Always handle drums and rotors with care, as they are precision manufactured and machined components

- NEVER** drop a drum or rotor
- NEVER** double stack drum pallets
- NEVER** store drums on edge

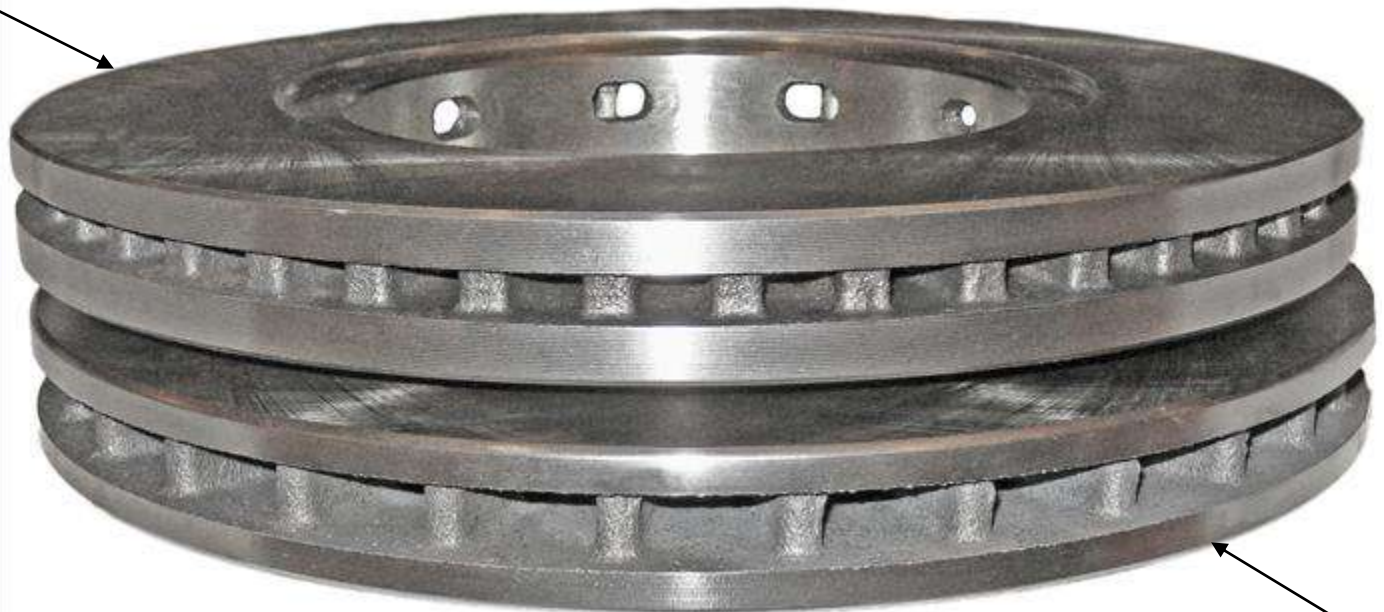
Concern: There are increasing numbers of lightweight/thin plate (bottom rotor) rotors showing up in the market lately. A rotor is considered “lightweight” when it contains 7-25% *less* mass than the Original Equipment rotor. One of the primary functions of the brake rotor is to dissipate heat away from the brake pads and calipers. Extensive testing has shown that a rotor with reduced mass will not absorb or dissipate as much heat. In addition, lightweight rotors cannot be machined, have fewer and thinner cooling vanes, an increased air gap, will crack prematurely, will develop premature excessive lateral run out, may cause overheating of brake fluid leading to brake pedal fade and may cause more brake noise.

***Plate Thickness DOES NOT Meet OE Manufacturer Specification
*25% Fewer Cooling Vanes**

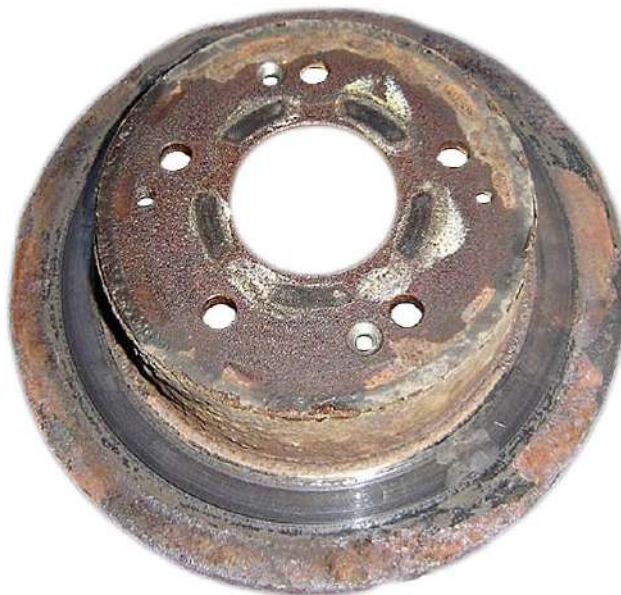
Concern: Rust on the braking surface of a rotor can be classified into 2 different categories: Rust Flaking (Left Image) and Rust Pitting (Right Image). It is important to understand the causes of the 2 different varieties of rust. Rust flaking is caused by a problem in the base brake system, not allowing the brake pads to fully contact the braking surface. Frozen or locked up caliper slides, a rusted caliper bracket or rusted anti-rattle clips will not allow the brake pads to slide freely. When the brake pads are not sliding freely, as much as 80% of the brake pad material may not make contact with the rotor. Rust then naturally appears in the metal, but is never cleared away by the brake pads. Rust pitting is caused by moisture in the brake pad material. The base brakes are working correctly, but due to moisture being held in contact with the rotor surface, small rust pits have formed. Under normal driving conditions the moisture and rust is cleared away. However, when a vehicle sits for extended periods or short trips are the norm, the moisture is never completely dissipated. The natural rusting process continues at an accelerated rate.
