Technical Bulletin

Servicing Meritor TN/TP Series Trailer Axles Equipped with 12.25" x 7.50" Brakes

ABS Block Location Change

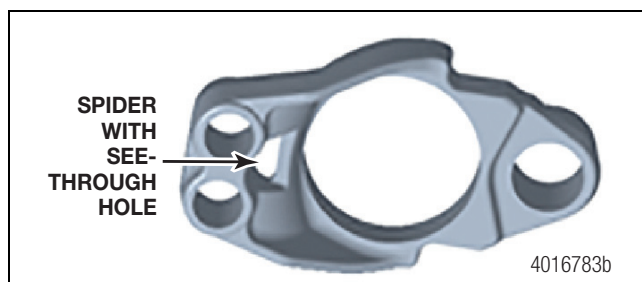
Figure 1

If the spider on the axle has a see-through hole (Figure 1) **AND** the ABS block is in line with it (Figure 2), use the post-August 1, 2019 return spring to service the axle. All others use the pre-August 1, 2019 return spring. Figure 3.

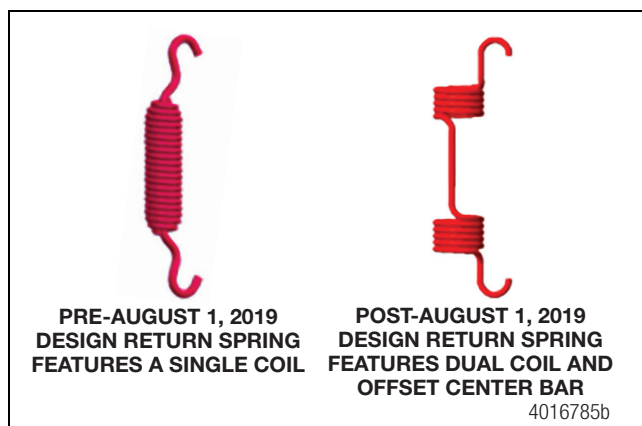
Figure 3

Meritor aftermarket kits now include the pre-August 1, 2019 design return spring that features a single coil, as well as a post-August 1, 2019 design return spring that features a dual coil with an offset center bar. To determine which spring to use, check the spider and ABS block for the following:

NOTE: The post-August 1, 2019 return spring must be installed with the offset center bar positioned outboard of the axle. This position is necessary to prevent the spring from contacting the ABS sensor.
