Troubleshooting

1 Weep Hole Coolant Leak

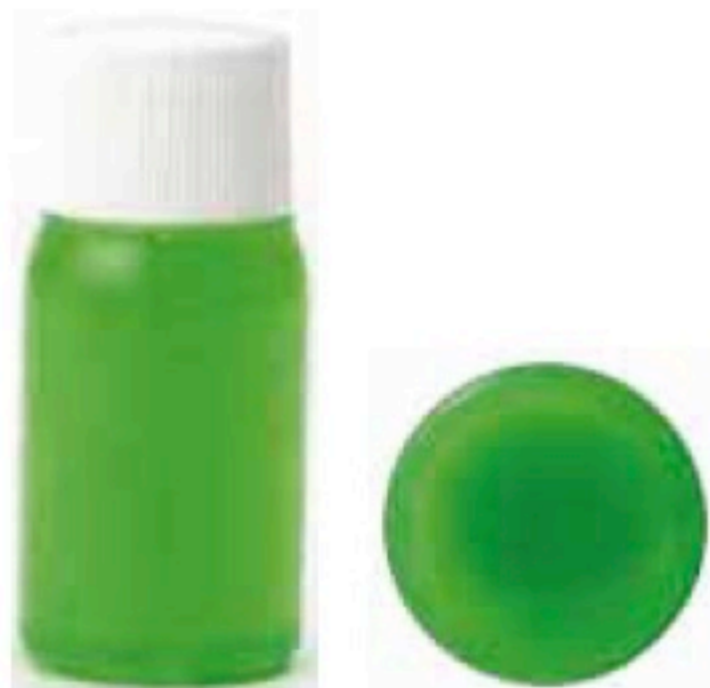
New

→ Coolant degradation

Older coolants have higher risks of leakage.

- Always flush the radiator and replace with new coolant.
- Replace coolant regularly.

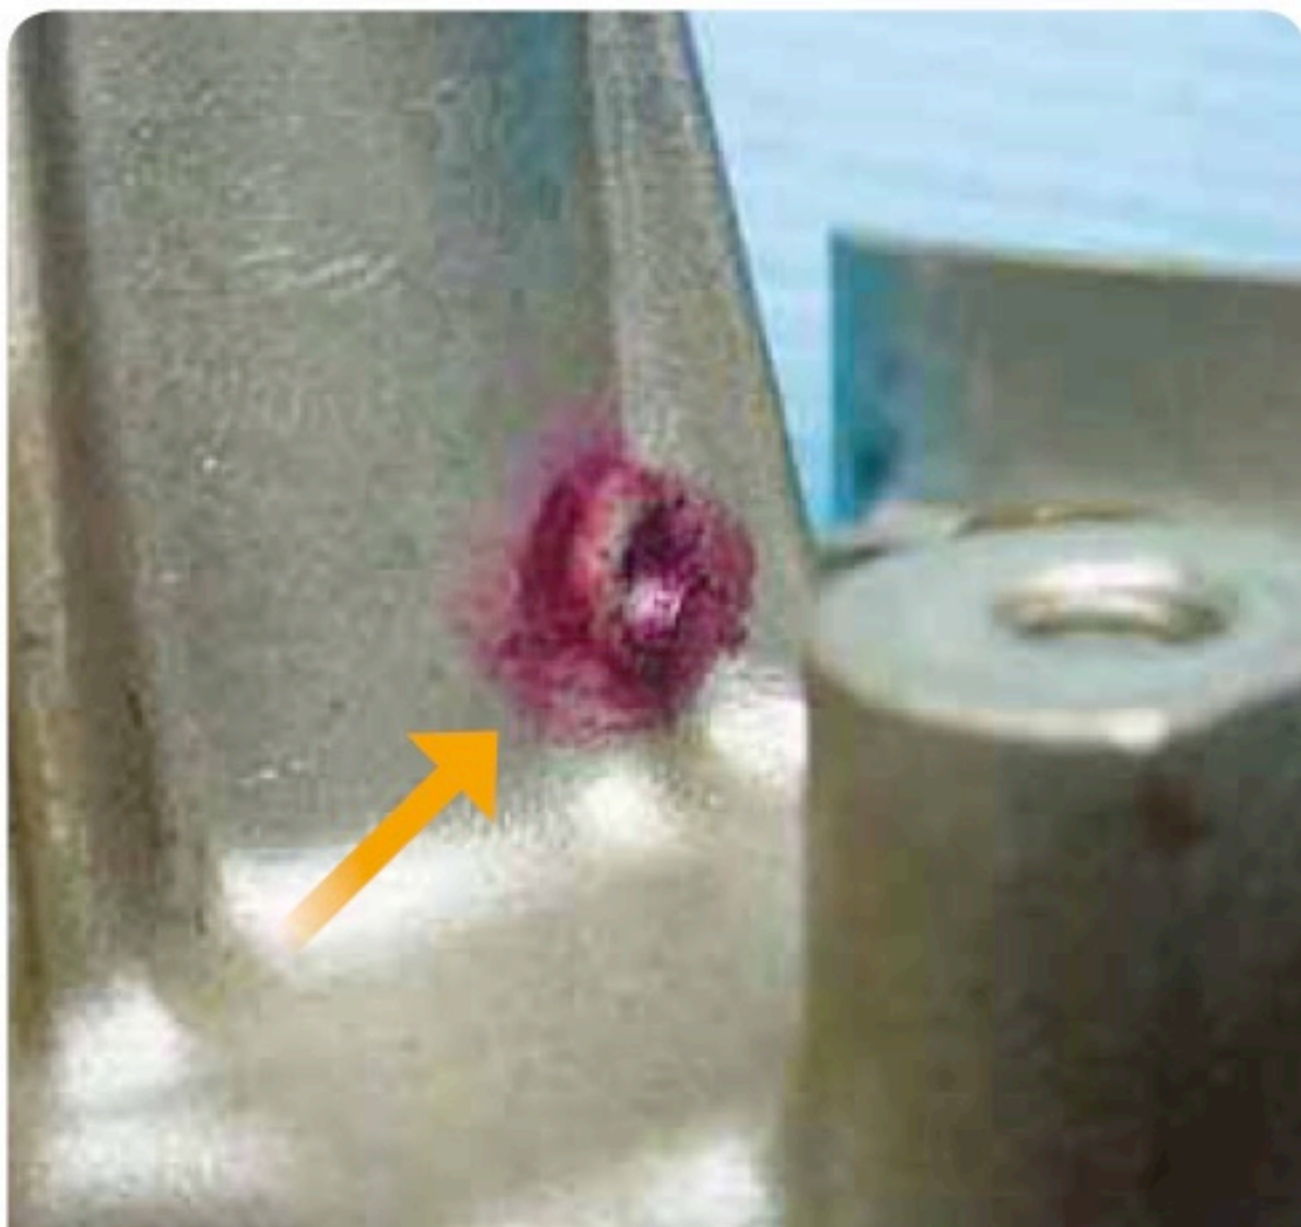
NORMAL

→ Fair and Poor, leak from the weep hole

Dried coolant residue.

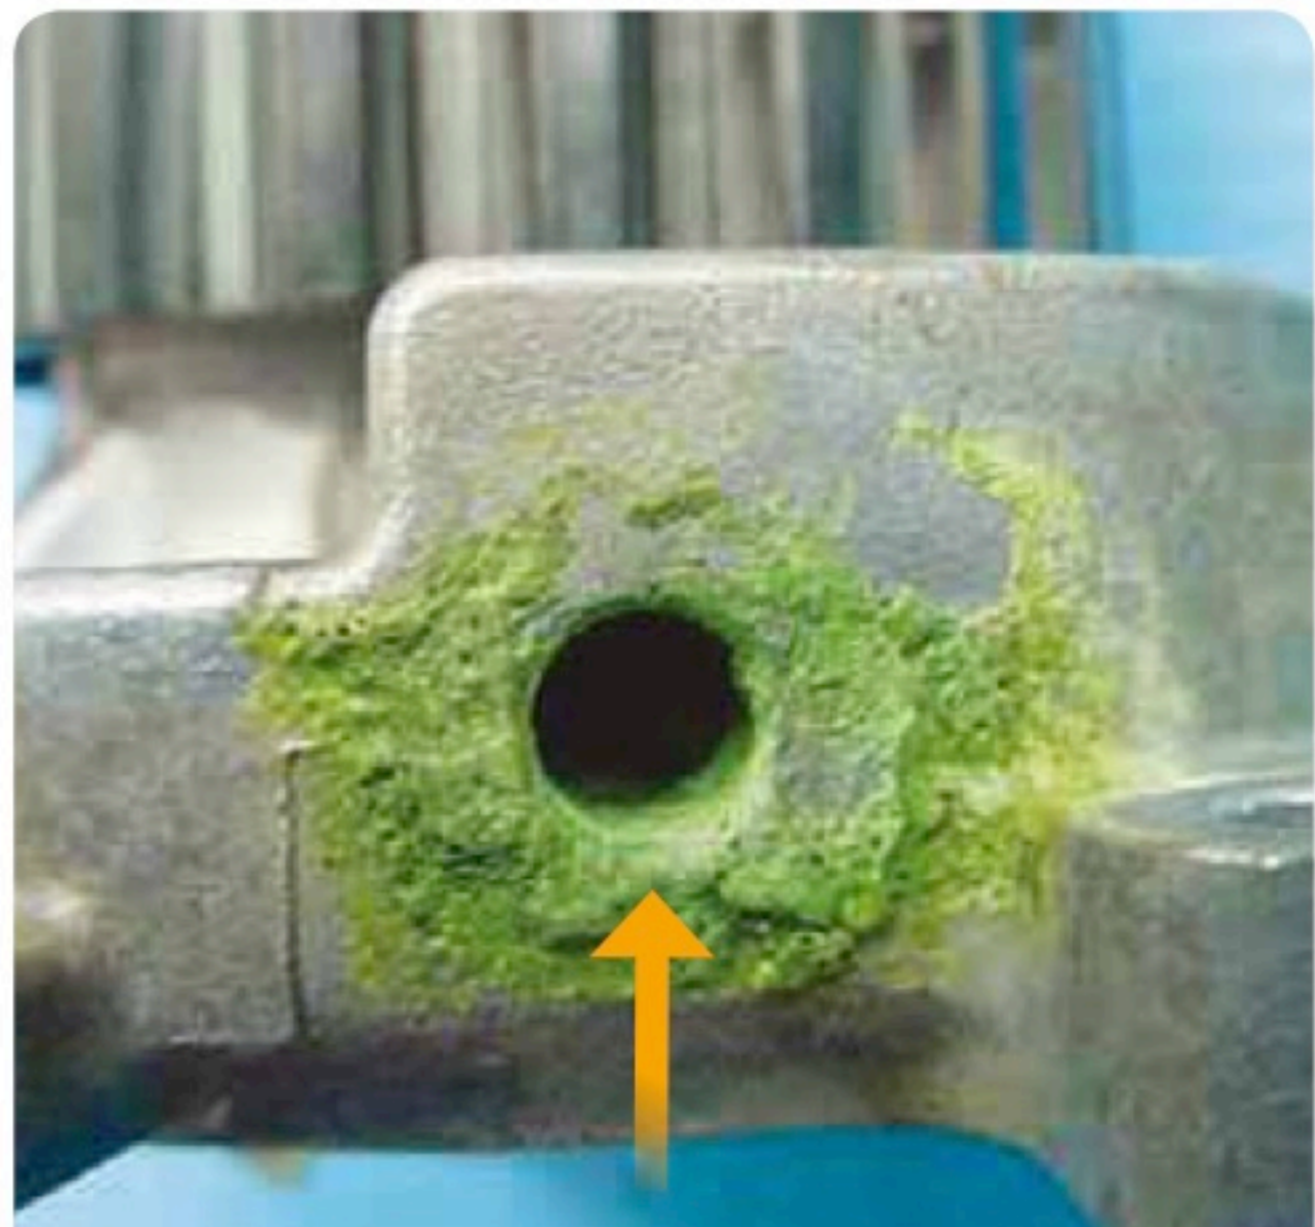
DAMAGED

Large coolant bleed mark, dampness or dripping.

Condition	<ul style="list-style-type: none">• The weep hole protects bearings from corrosion damage by preventing seepage of coolant into the pump body.• In normal operation, traces of dried coolant may be visible around the hole. Coolant leak may be occurring if there is fluid around the weep hole or if the reservoir tank reaches low coolant levels within about a month.
Cause	<ul style="list-style-type: none">• Contamination and sludge has damaged the mechanical seal, reducing sealing performance.
Cure	<ul style="list-style-type: none">• Before installing the new water pump, flush the cooling system 2 - 3 times and let engine idle for about 3 minutes with the old pump to remove any sludge deposit.• Replace the anti-freeze regularly at the specified mixture and fluid level.• Do not use sealants (RTV) when gaskets are supplied.• When sealants are necessary, apply evenly and do not allow excess to enter the water channel.

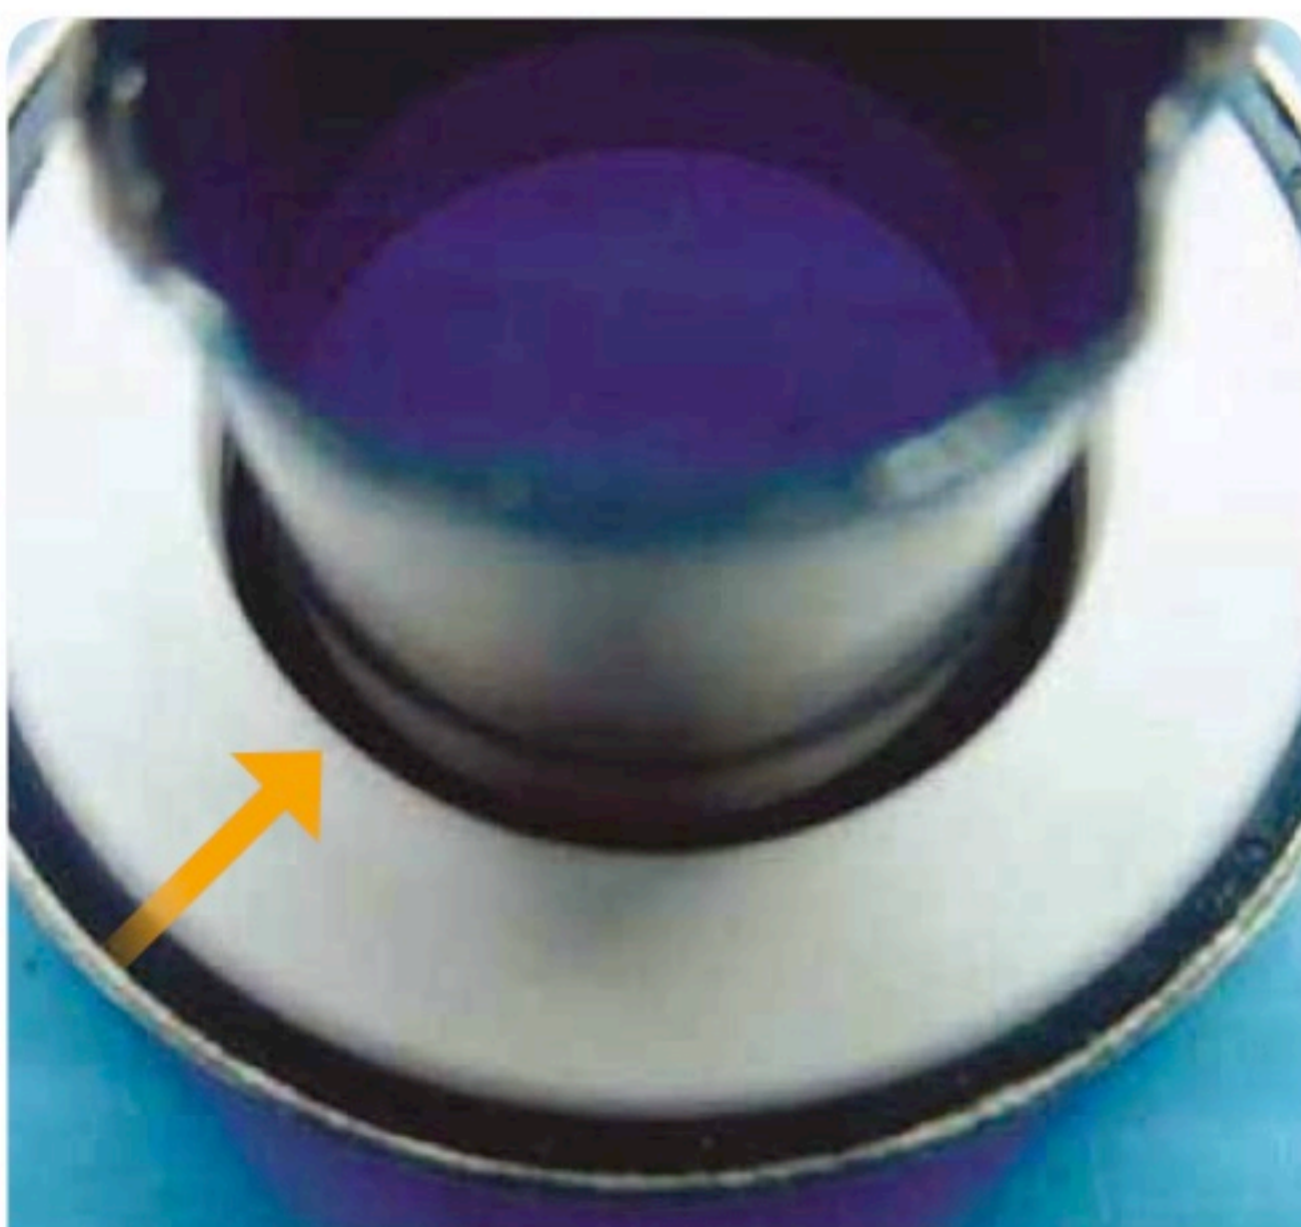
NORMAL

→ Fair and Poor, mechanical seal ceramic

Clean ceramic.

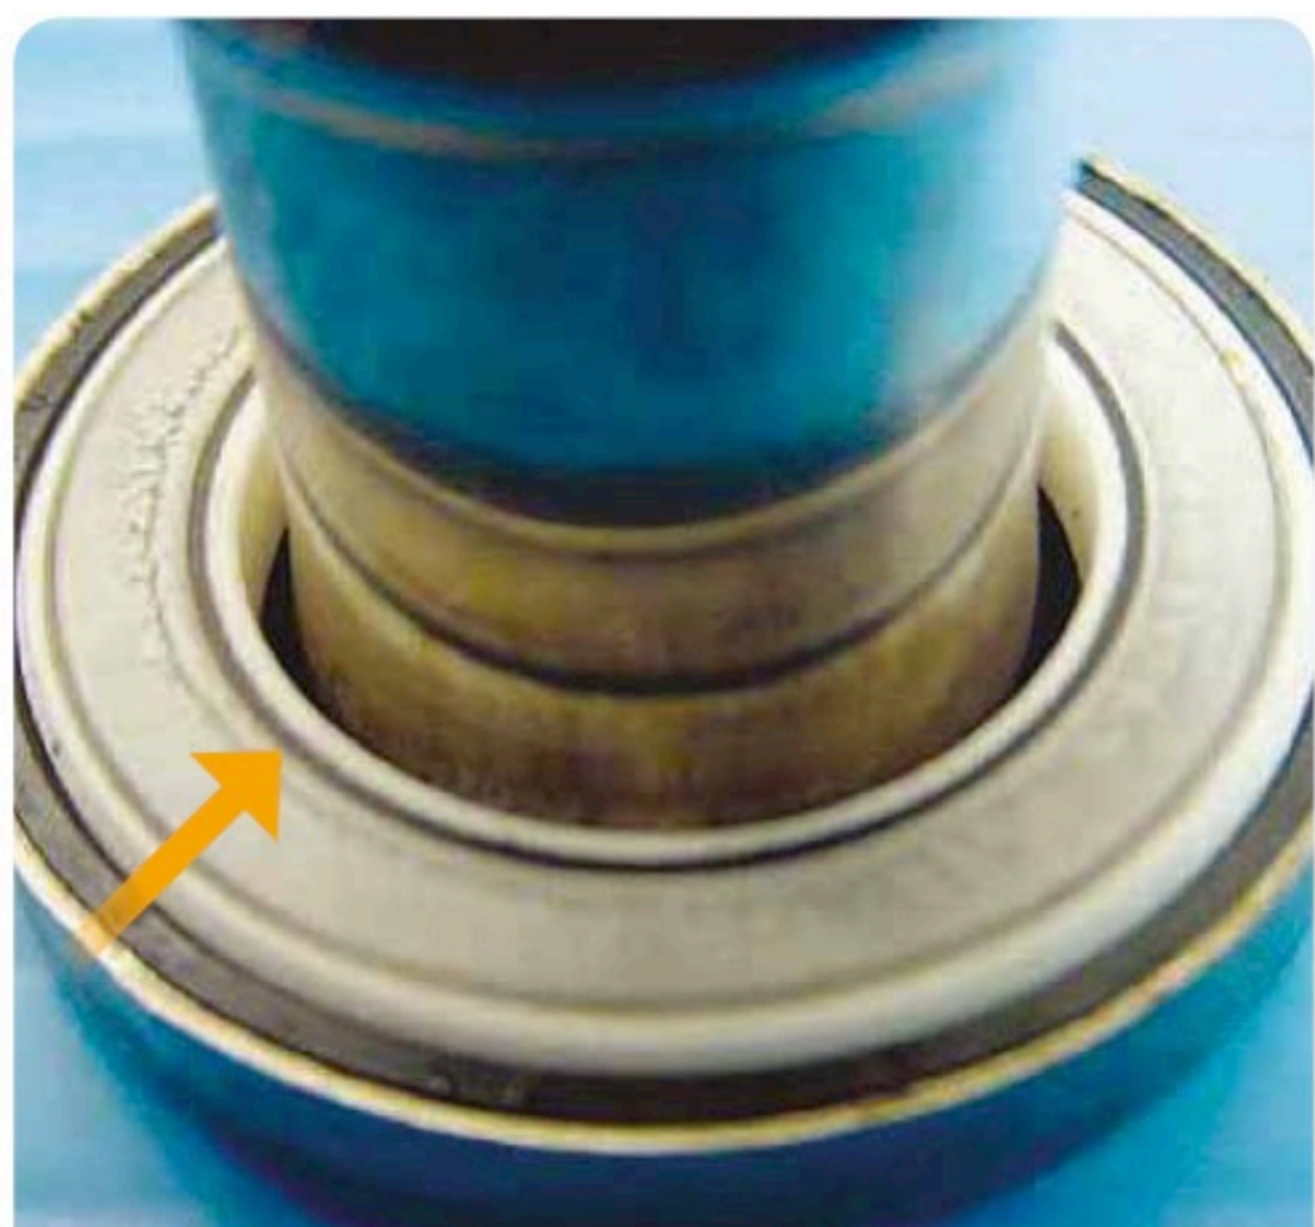
DAMAGED

Accumulated sludge (Contaminated coolant).

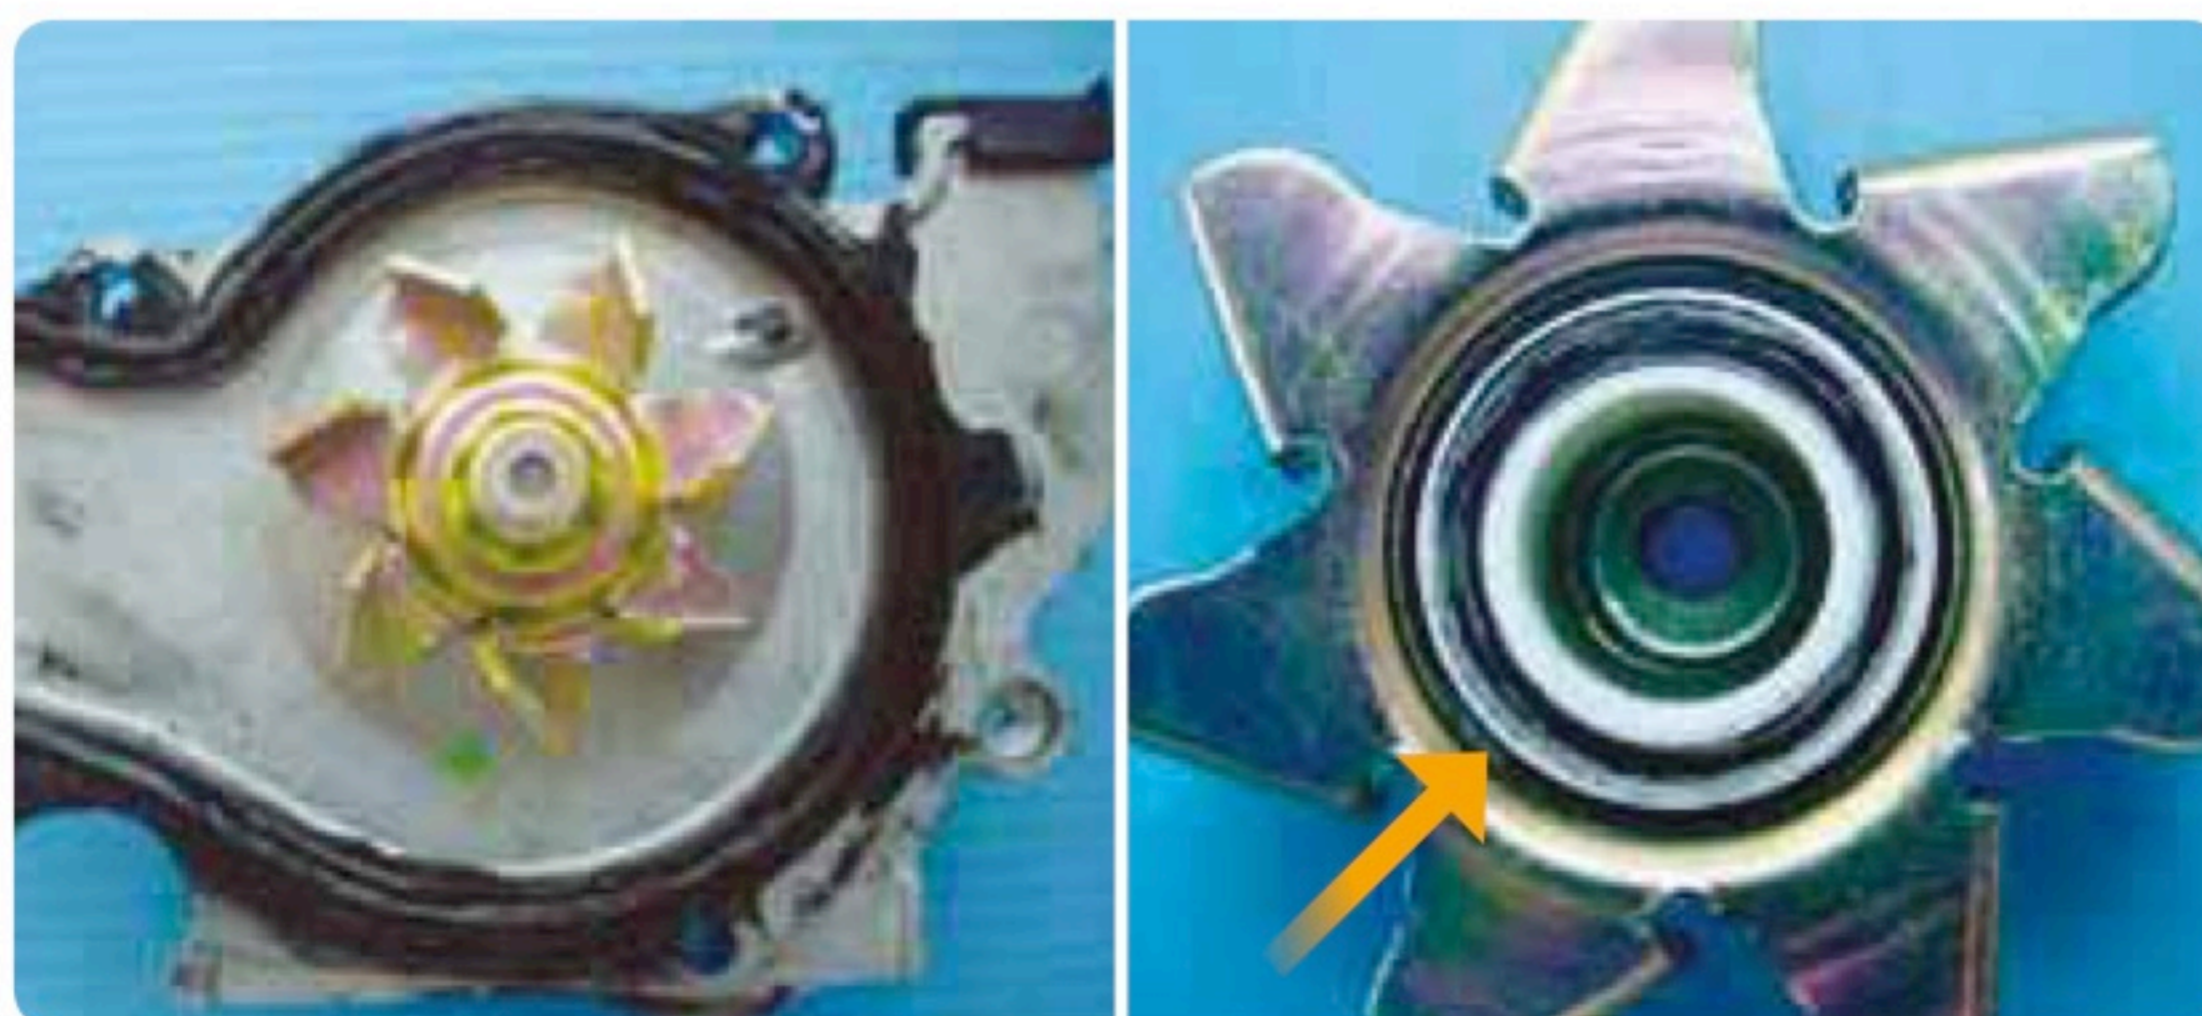
→ Poor application of sealant

Sealant has interfered with the mechanical seal causing leaks.

Condition	<ul style="list-style-type: none">• Seepage from the mounting surface• Fractured/deformed gasket• Unevenly tightened bolts (one side)
Cause	<ul style="list-style-type: none">• Deterioration of the sealing performance caused by unevenly applied sealant (RTV)• Deterioration of the sealing performance caused by the use of adhesives• Sealants used on the O-ring deteriorated the elasticity of the rubber• Bolts tightened unevenly• Contamination (dirt/grime) on mounting surface• Mounting surface dented caused by mishandling
Cure	<ul style="list-style-type: none">• Use manufacturer specified sealant• Do not use sealants when gaskets are supplied• Do not use adhesives in place of sealants or gaskets• Install the new water pump in a diagonal (star) pattern and apply torque specified by the vehicle manufacturer• Clean mounting surface free of contaminants• Do not re-use old gaskets and previously applied sealant

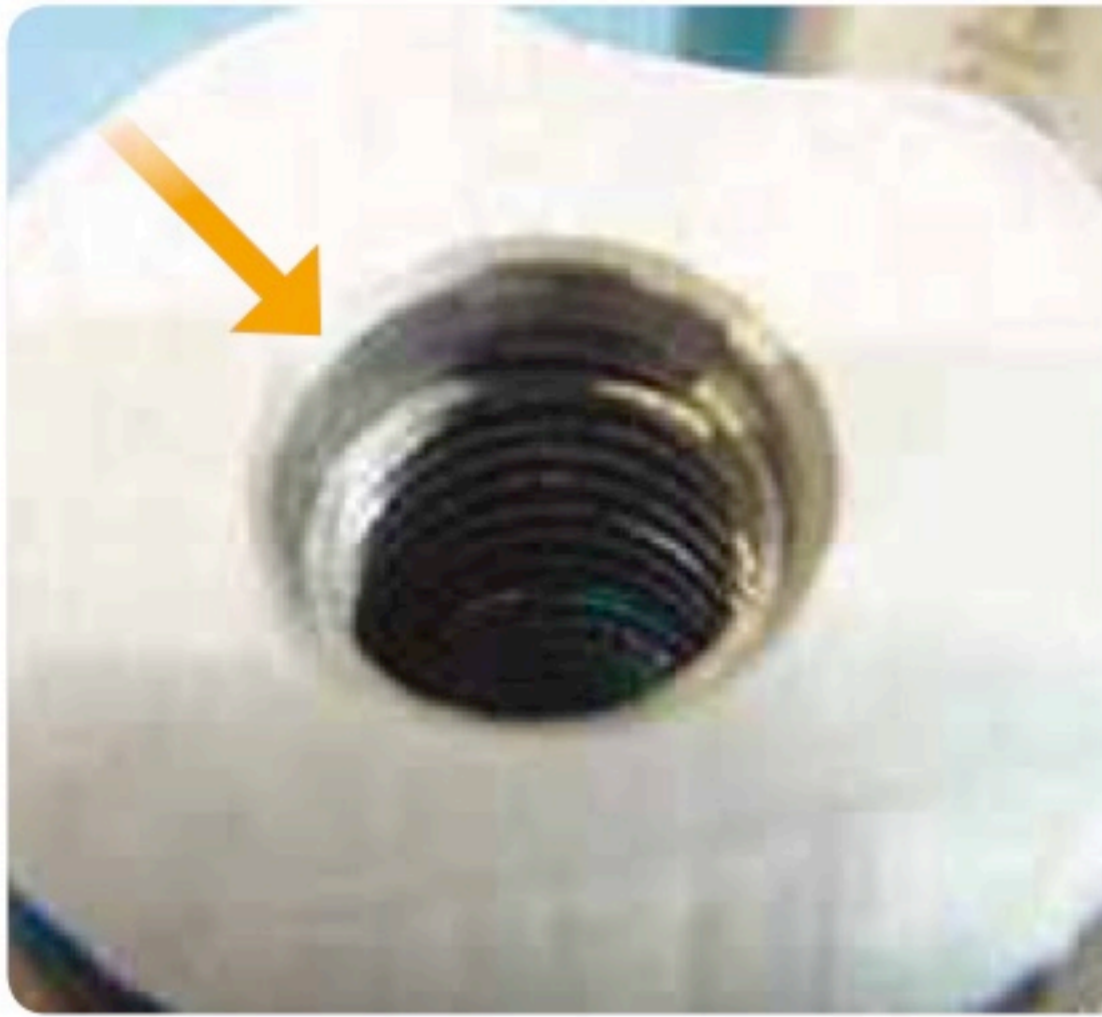
→ Excess torque of the mounting bolt

Threads have been stripped.

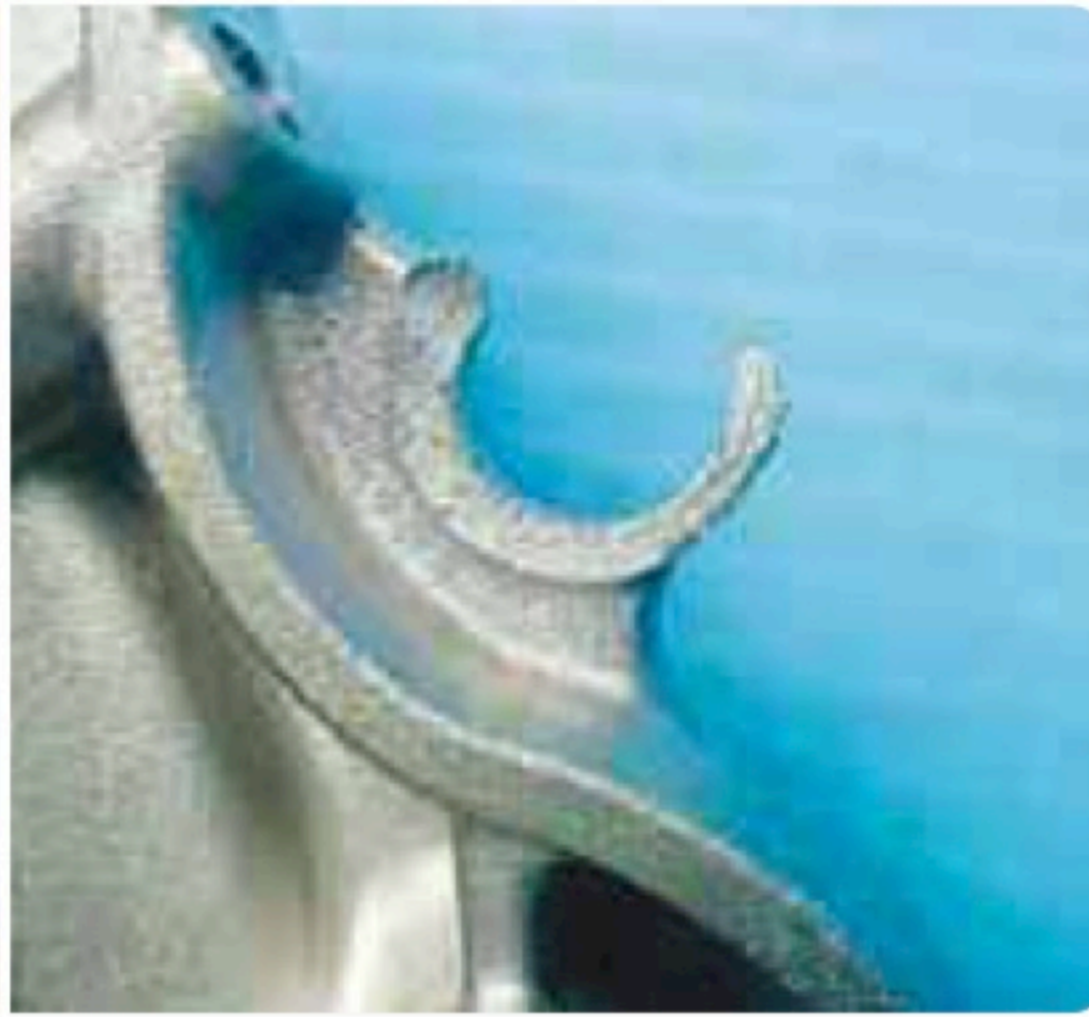
Unevenly tightened or over torqued.

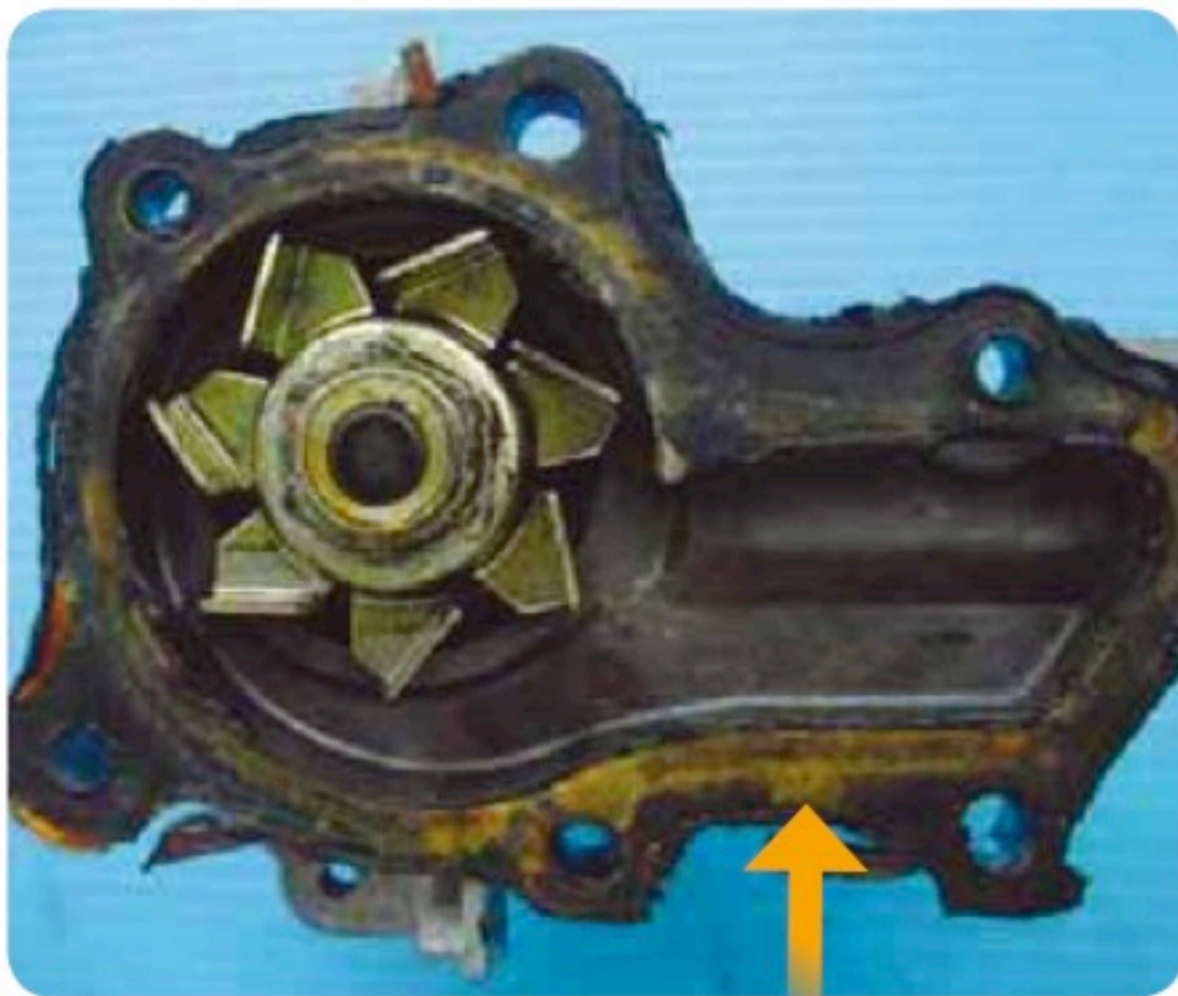
→ Poor cleaning of the mounting surface

Insufficient accuracy on the mounting surface.

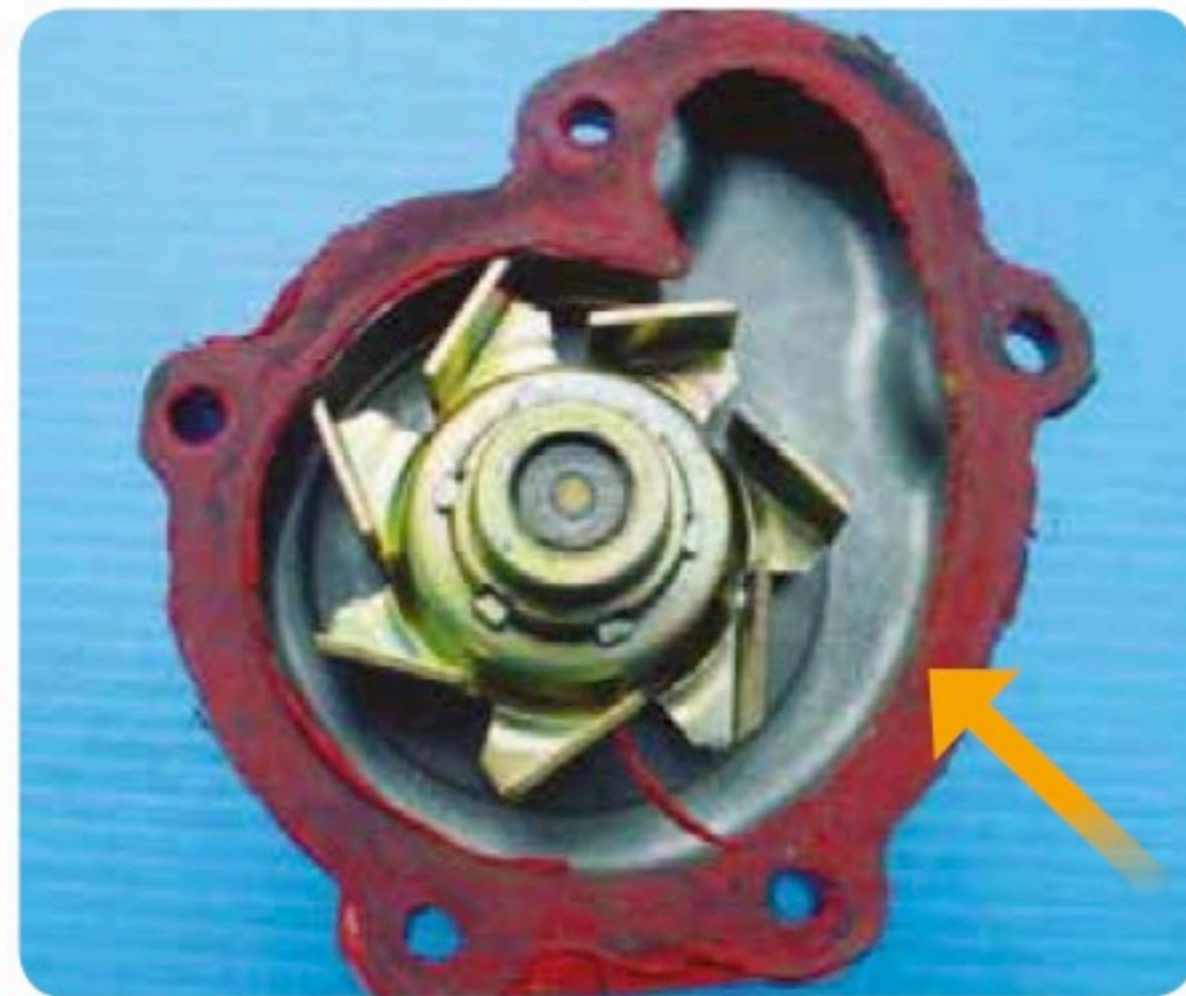
→ Sealant used on supplied gasket

Gasket performance has degraded.

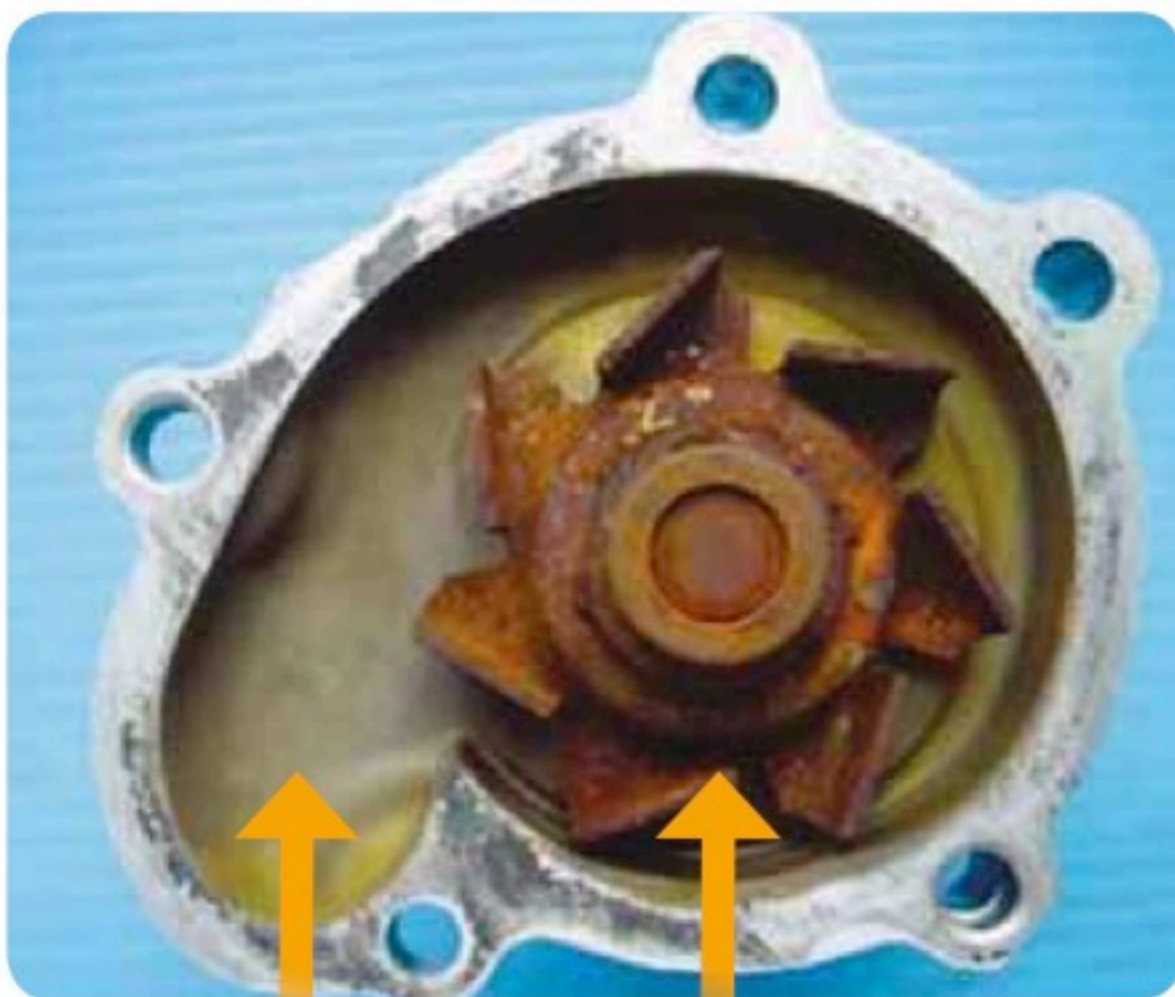
→ Coolant degradation

Contamination
of water pump body

Impeller
corrosion

Condition	<ul style="list-style-type: none">• Corrosion of the impeller• Fracture of the bearing• Internal corrosion of the water pump body
Cause	<ul style="list-style-type: none">• Old/used coolant• Coolant deterioration• Insufficient flushing of the radiator
Cure	<ul style="list-style-type: none">• Discontinue use of old coolant• Fully flush the radiator• Replace coolant with manufacturer's specified mixture and fluid level

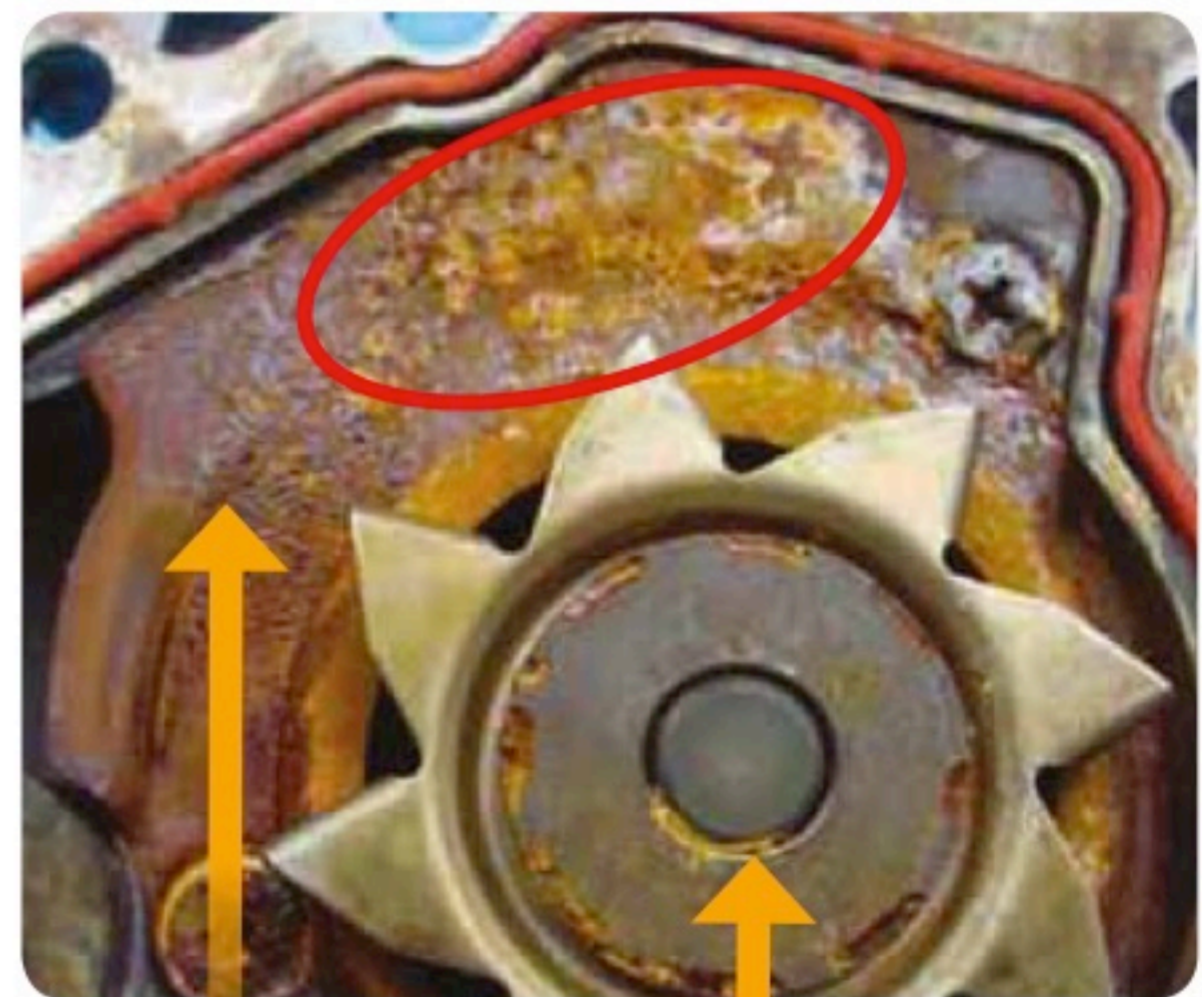
→ Cavitation

Cavitation

Corrosion around
crimp

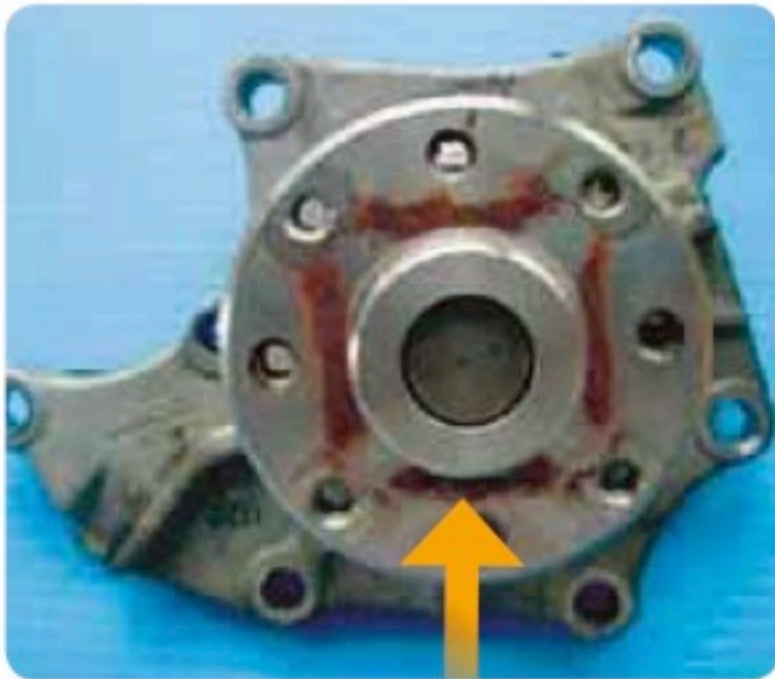
→ Flecking at the pulley seat

Flecking at the pulley seat

Condition	<ul style="list-style-type: none">• Rumbling sound heard when manually turning the pulley• Abnormal wear at the base of the stud bolts• Scratches and flecks found around the bearing during disassembly• Contamination of the pulley seat
Cause	<ul style="list-style-type: none">• Bearing fracture caused by excess belt tension• Bearing was fractured due to excess vibrations caused by misalignment of parts such as the fan coupling pulley• Uneven torque of bolts resulted in bearing failure• Contamination of the pulley seat
Cure	<ul style="list-style-type: none">• Tighten belt tension to vehicle manufacturer specifications• If the fan coupling pulley is reused, confirm the run-out with a dial indicator• Replace fan coupling pulley with new on older vehicles or high mileage engines• Confirm that the bearing is lubed and free of rust, and replace if necessary

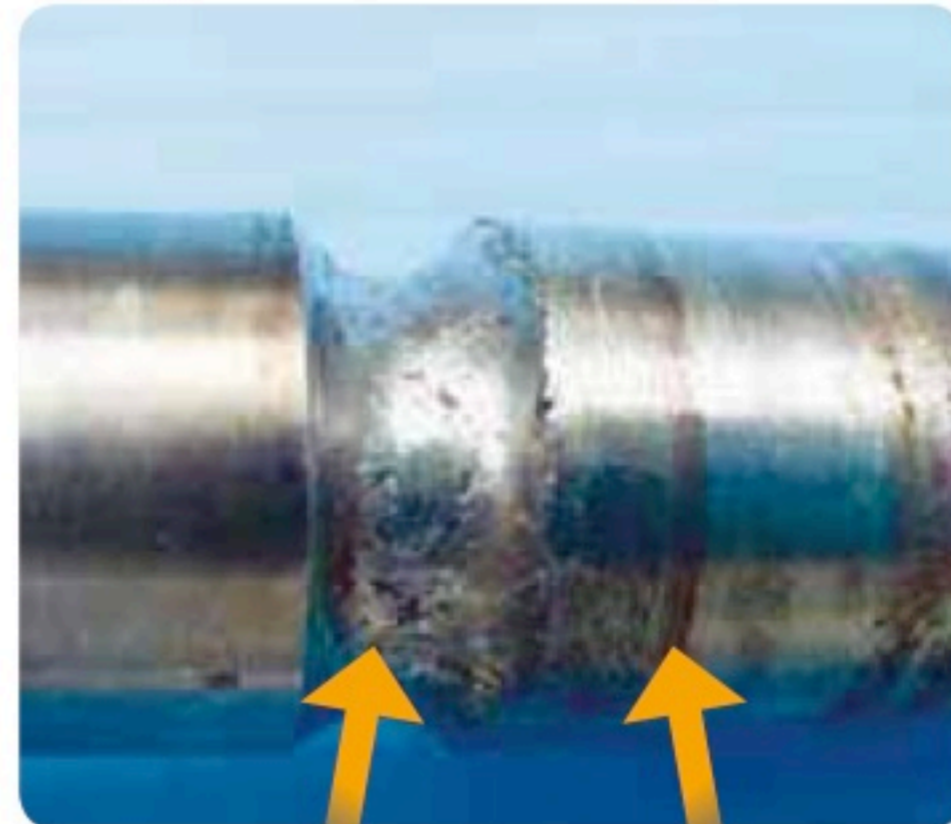
→ Flecking at the bearing

Damage due to overload and seepage

Damage due to excess backlash

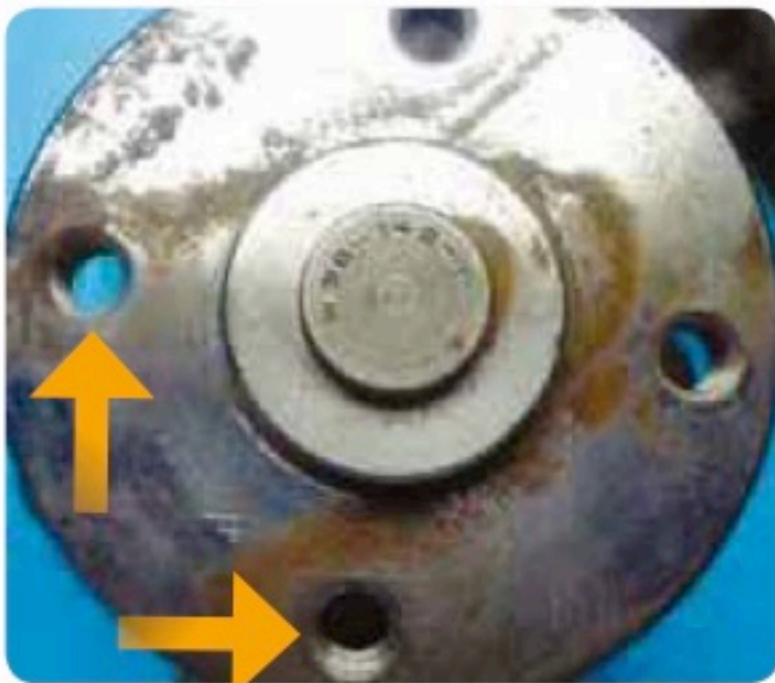
Damage at the stud bolt ends
