## What Causes Broken Starter Nose Cones?

## STARTER WILL NOT CRANK WHEN HOT (HEAT SOAK)

# IMPORTANT NOTICE

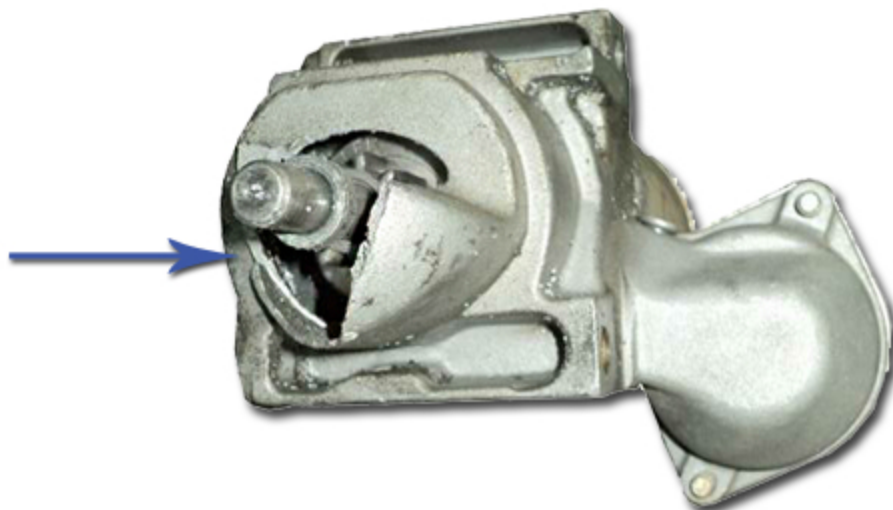
Cracked or broken starter drive end housings result from a variety of vehicle or installation related issues. Causes include:

1) Improper flywheel clearance (tight mesh). Improper mounting alignment may occur on certain “pad mount” starters due to lack of installing a spacer shim, or on “flange mount” starters due to not seating the starter completely flush to the bellhousing. Even .015” variance (typical shim thickness) can affect proper mesh.

2) Engine kickback or backfire. Besides generic timing problems, causes include a faulty Crankshaft Position Sensor (1996-2000 General Motors C/K, G, P, and S/T Series) and electrical system noise interference prompting the ignition module to fire the spark plugs prematurely (Hyster forklifts with 3.0L GM engine).

3) Starter activation with engine already running. Instances of operator error on older vehicles is one reason why turning the ignition key on most late model vehicles simply sends a “crank request” to the Powertrain Control Module. In milliseconds, the PCM then decides if it’s safe to activate the starter.

4) Excessive engine resistance. Dirty or improper weight motor oil may cause excessive mechanical resistance to cranking, as can brand new “crate” motors with (initially) tight piston rings.

Missing starter support brackets, loose starter mounting bolts, and harmonic engine vibrations cause most other damaged starter housings. The likelihood of pre-existing flaws in starter nose castings remains very rare.

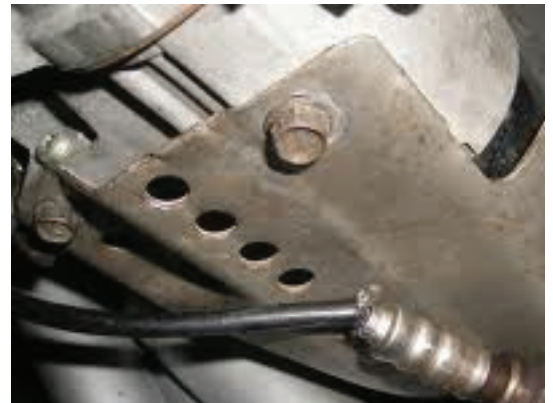
If your starter easily cranks a cold engine, but “drags” or cranks very slowly when hot, there may be a “heat soak” problem. Before you condemn the starter as bad, you should perform a system diagnosis of the battery, cables and starter.

Assuming that the diagnosis results are within acceptable ranges and the starter cranks fine when cold, it is quite possibly a “heat soak” condition. What exactly is starter “Heat Soak”? Without getting into the physics of thermal conduction or Newton’s law of convective cooling, it is simply a matter of the starter absorbing and retaining heat from under-hood sources such as the exhaust manifold. This absorbed heat adds resistance to the electrical conductors inside the starter. The additional resistance results in the starter requiring more amperage than it normally does when cool. Once under-hood heat warms the battery, cables, and starter, a “tipping point” is reached concerning the overall amount of resistance a starter can accept (and still function properly).

The TOTAL effect of all this unwanted resistance is a dramatically reduced current flow, which in turn means the starter is limited in current, and therefore either turns very slowly or not at all. The starter solenoid is equally vulnerable to this condition, and thus may not activate the starter at all. Another overlooked contributor to “heat soak” is corroded battery cables. At some point, cleaning the battery terminals and connectors may no longer help if the corrosion has already spread throughout the length of the cables. The cable’s outer insulation “hides” the corrosion.

Heat soak can usually be solved by installing a heat shield on the starter; this will reflect the heat away from starter. In fact, many vehicles are originally equipped from the factory with a heat shield. Unfortunately, they are often discarded when the starter is replaced. You can likely find a used heat shield at a salvage yard, or source a new one from your local parts store. Other fixes can involve upgrading the battery cables with a heavier gauge cable or installing a higher capacity battery. Anything that will keep the starter cooler or allow more amperage to the starter should help considerably.

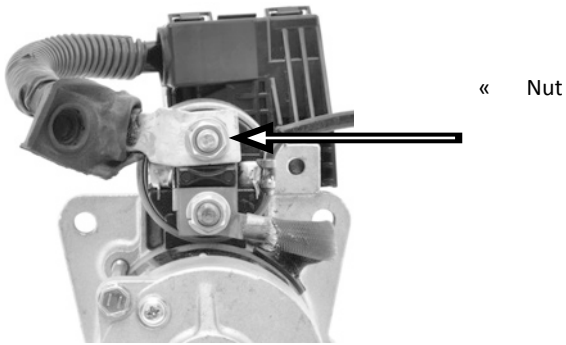
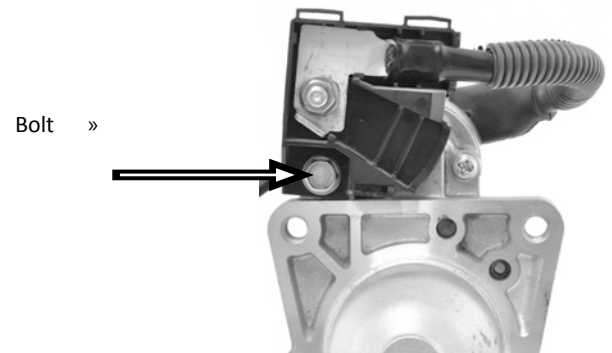
This application was originally supplied with a transferable harness attached to the starter. This harness must be transferred to the replacement starter.

1. Remove solenoid battery post nut and wire from post.
2. Remove harness bolt located on the front of the starter.

1. Installation is the reverse order of removal.
