# ProTech

## CV DO's and DON'Ts

## Don't Reuse Torque-type CV Axle Nuts

## Tips To Prevent CV Axle From Getting Stuck in Transmission

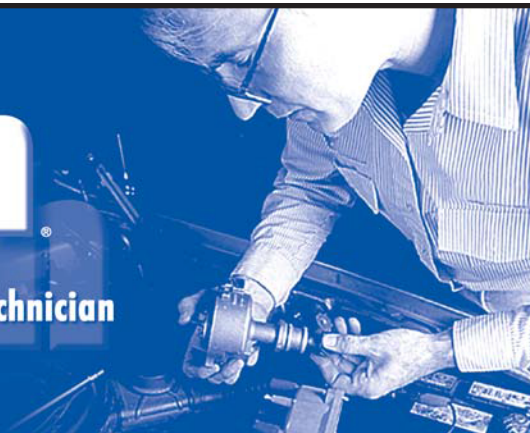
**Problem:** Outer Constant Velocity stub shaft has movement in and out with resulting clunking and damage to the outer joint.

**Cause:** Reuse of retaining nut of a prevailing torque type.

Prevailing torque-type nut

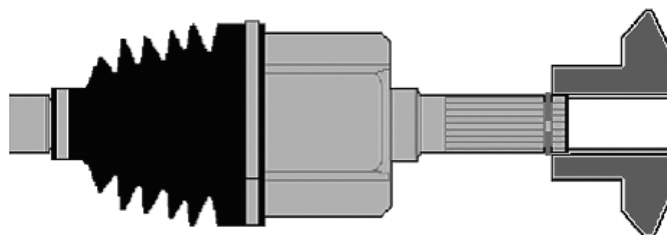
Top View

C-clip mis-shaped or rolled over upon installation.

- Use a small amount of light grease to help slide the splines and clip in.
- Orient the clip opening at 12:00 to prevent the ends from rolling over.
- Use a special compress tool where applicable.
- Do not use a hammer or force the axle into the transmission.

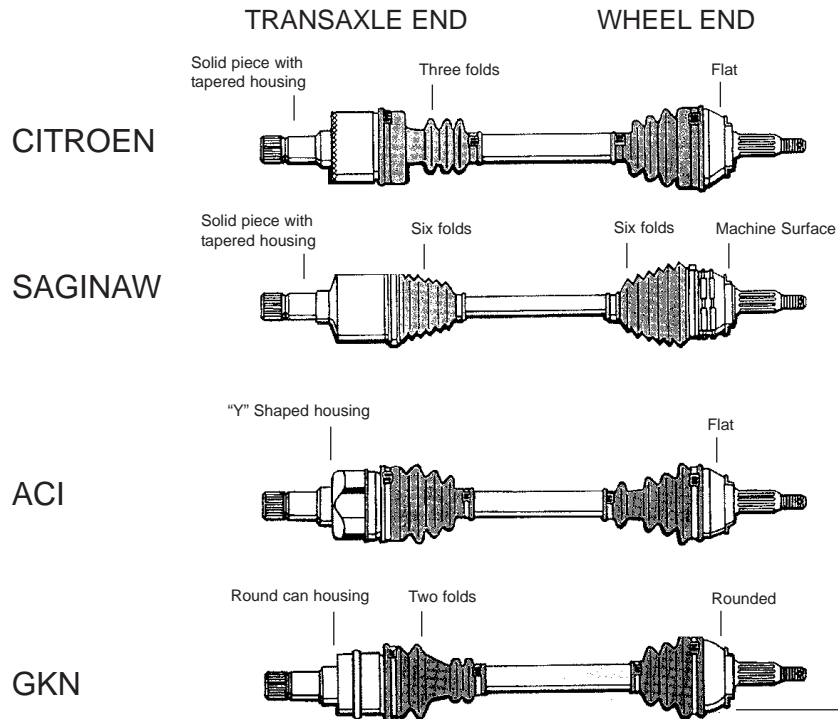
Chrysler uses four different design joints.

All four designs are interchangeable as long as the complete axle is installed.

Chrysler CV axles **MUST** be handled with extreme caution! The inboard joint is spring loaded and may pop loose, causing a total malfunction and **VOID THE WARRANTY.**

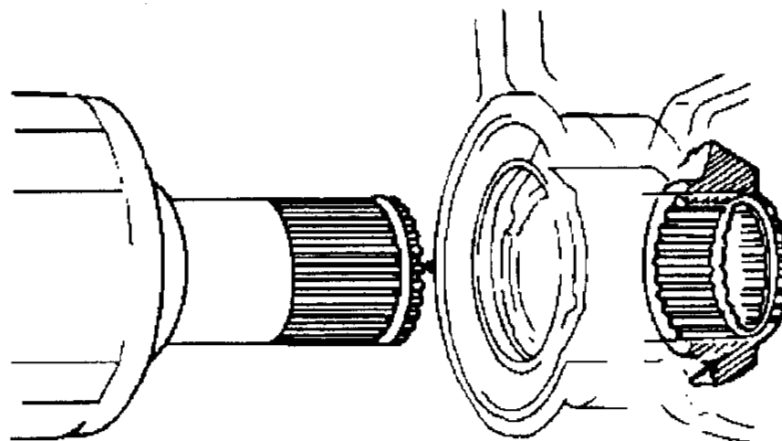
Output bushing for driveaxle in transmission case is defective/worn.

Install an axle saver kit on the transmission case.

If the original axle has a collar pressed on the bearing surface, you must install an axle saver kit on the replacement axle.

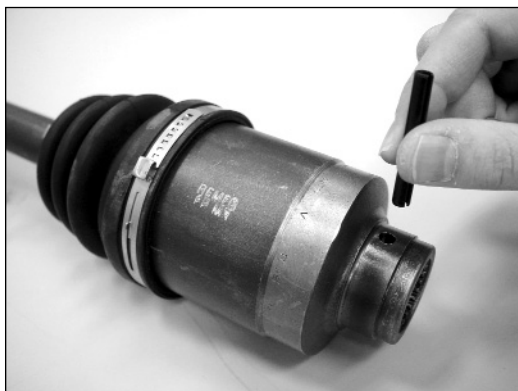
Subaru Design

The inboard stub shaft is removable. For axles of this type, the original stub shaft is either stuck in the original unit or is secured with a roll pin.

Transfer the stub shaft to the replacement unit. Some typical units are shown below. CARDONE supplies a new roll pin for units of that design.
