CARDONE™ ProTech®

81-158PB Replacement Pulse Board Park Problem

Application CARDONE™ Wiper Motor Pulse Board part number 81-158PB. See catalog for proper vehicle applications.

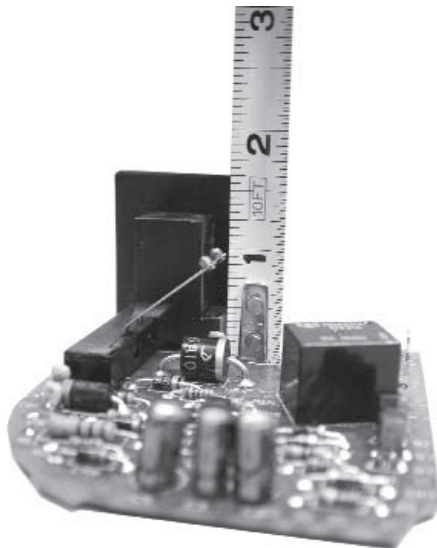
Problem Wipers will not park after replacing Pulse Board.

Cause Contact arms on Pulse Board may not be contacting Wiper Motor. Packing material or movement during shipping may have bent contacts.

Solution Check position of contact arms before installation. Contacts should be approximately 1 inch (25 mm) above circuit board (see picture). Correct contact position ensures proper Wiper Motor parking function.
