New Aftermarket Repair Solution

90449

Various GM Vortec
6 & 8 Cylinder Engines
2006-92

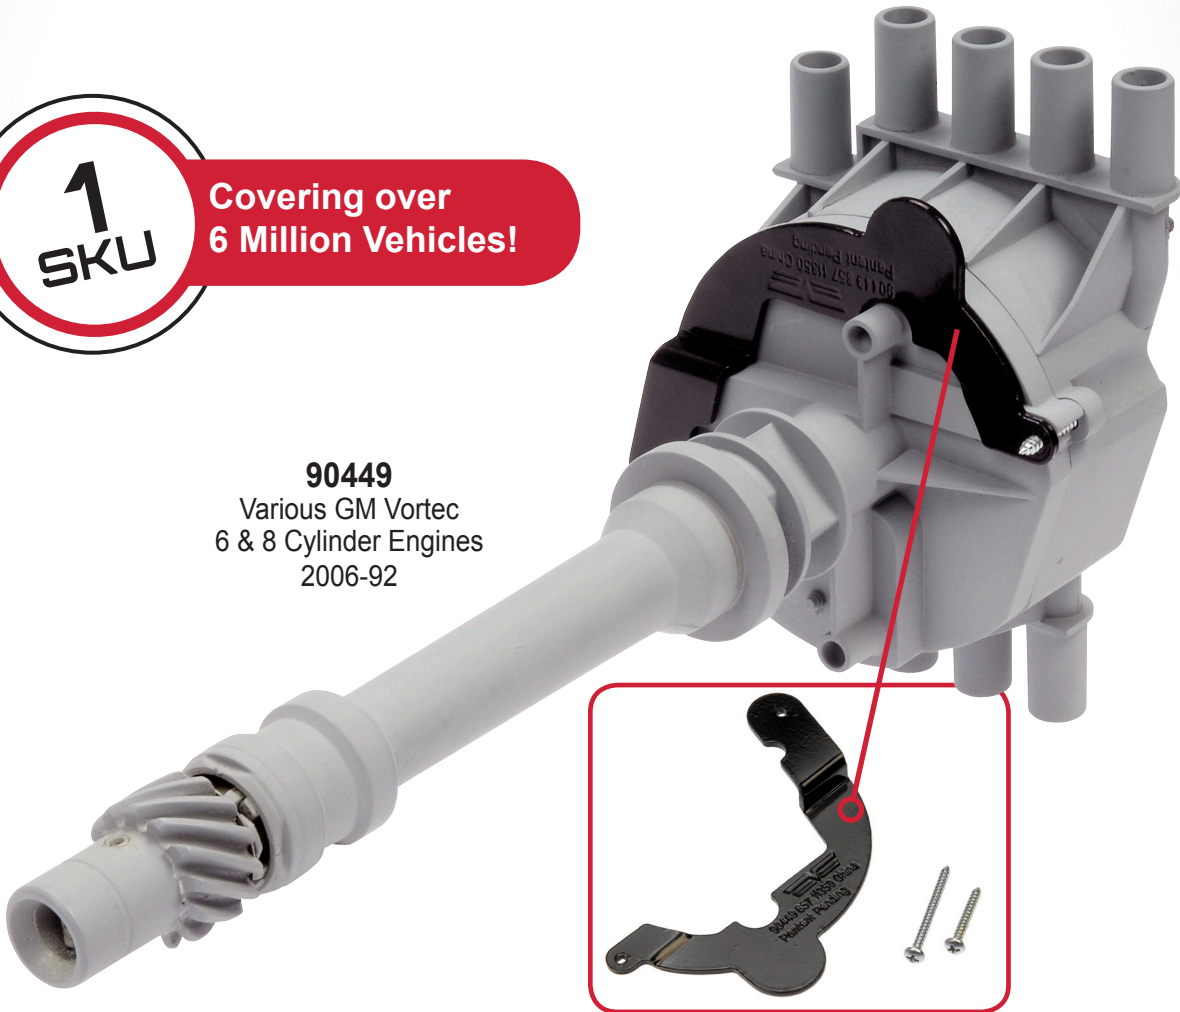
PROBLEM: Tabs crack and break off distributor base resulting in engine misfire

Repair plate designed to repair the broken tabs on the distributor housing and properly align the cap during replacement/installation.

This repair solution provides up to a 90% savings opportunity by eliminating the need to replace the entire distributor assembly
