Installation instructions

For set # 8.3128

07-08 Toyota FJ Cruiser

ENERGY
SUSPENSION

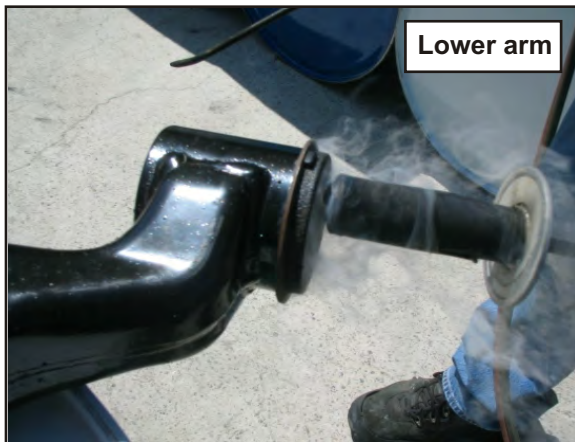
Do not remove the factory metal shells from the lower control arms, they must be reused. The inner metal sleeves and washers on the lower control arm must be reused. To remove the old rubber from the factory shells and inner sleeves, apply light heat evenly around the outside of the control arm outer metal shell, just enough to brake the bond with the rubber. Do the same on the inside of the sleeves on the lower control arms. When you see light smoke coming from the sides of the bushing the bond should be broken. At no time should there be any flames coming from the rubber, if there are any flames, you need to back off with the heat. Just push the old rubber and inner metal sleeve out. Let the outer metal shells and sleeves cool off before cleaning. Use a wire brush to remove any remaining old rubber. File off any sharp edges that will contact the new polyurethane bushings.

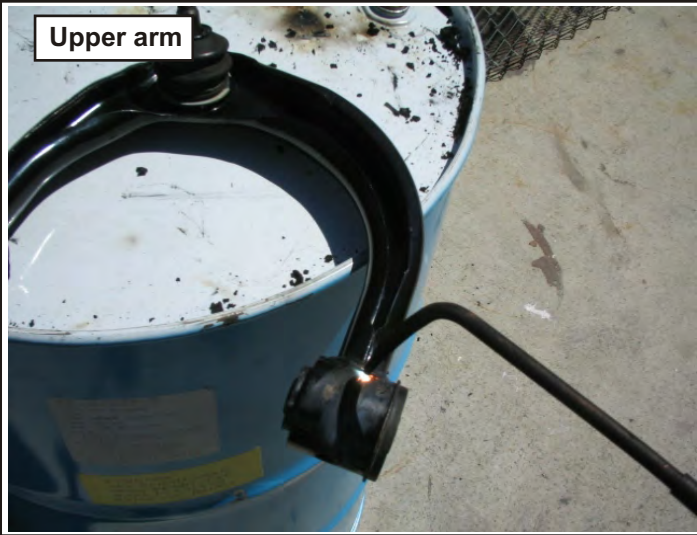
Do not remove the factory metal shells from the upper control arms, they must be reused. New inner metal sleeves are supplied for the upper control arms. To remove the old rubber from the factory shells and inner sleeves, apply light heat evenly around the outside of the control arm, just enough to brake the bond with the rubber. When you see light smoke coming from the sides of the bushing the bond should be broken. At no time should there be any flames coming from the rubber, if there are any flames, you need to back off with the heat. Just push the old rubber and inner metal sleeve out. Let the outer metal shells and sleeves cool off before cleaning.

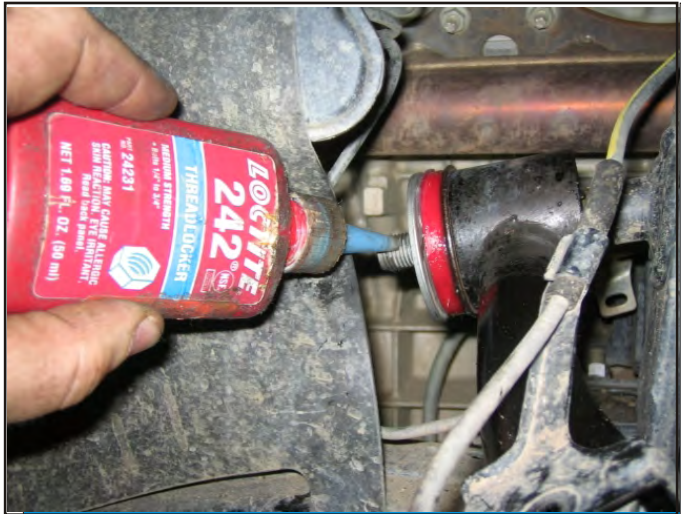
Use a wire brush to remove any remaining old rubber. File off any sharp edges that will contact the new polyurethane bushings. Apply grease to all metal parts that contact the polyurethane bushings. Apply thread locking compound to upper control arm through bolt then torque to 85 lb.
