////// *Tech Tip* ////

## Checking Those Switches

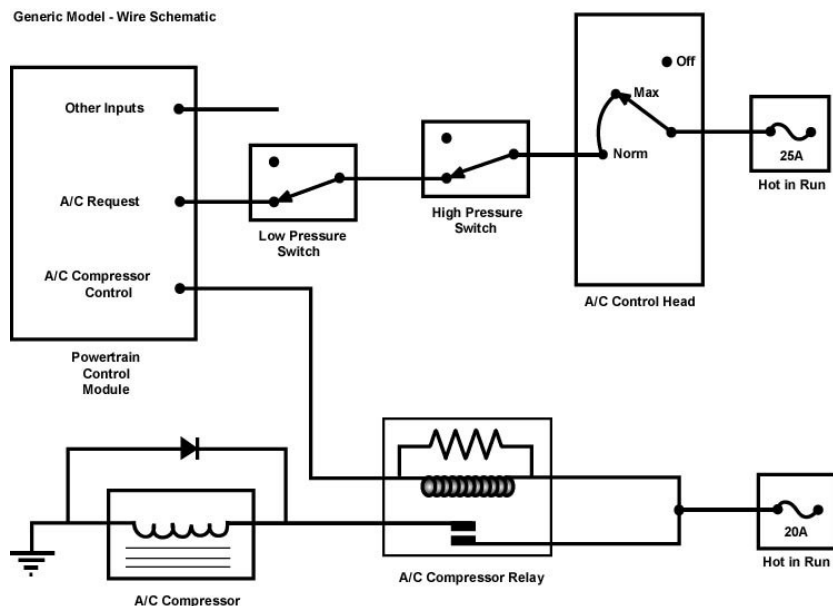
In the wiring diagram shown below a positive voltage signal is sent from the *A/C control head* to the high-pressure switch. The high-pressure switch should be closed below 400-psi, which will allow the signal to pass on to the low-pressure switch. If there is sufficient refrigerant pressure (minimum of 40-psi) at the low-pressure switch, the signal will pass through the low-pressure switch where it will be received by the PCM. After the PCM receives this signal, it processes this information and checks to see if all other input sensors are within specifications before proceeding. If everything passes, the PCM will supply a ground signal to the *compressor clutch control relay* which will then engage the compressor clutch.

With the customer's vehicle the scanner revealed no A/C request to the PCM. So the no clutch operation could be due to a faulty low-pressure switch or a faulty high-pressure switch. Use a fused (10amp) jumper wire to bypass each switch individually. When the scan tool shows an A/C request then the problem has been isolated to the switch and/or harness connector. Further testing of these two components will be required to pinpoint the exact problem.
