## TECH TIP COOLING SYSTEM

### BULLETIN TT006-16

### Automotive Sealant Use During Water Pump Replacement

### Water Pump Failure Signs

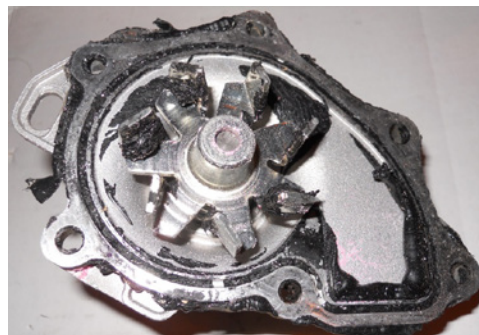
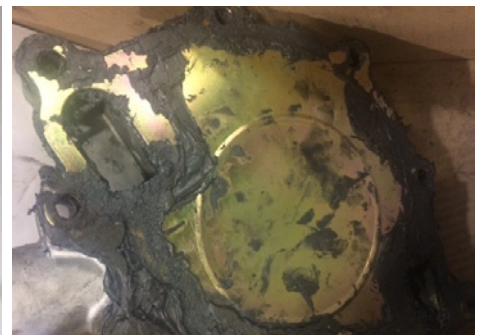
Both pumps were supplied with a cellulose / rubber binder gasket. These gaskets do not require the use of any sealants. However if the mating surface is damaged a small skim coat of sealant is allowable with these types of gaskets.

The improper use of sealants can contribute to premature failures of the water pump. Below are examples of improper use of sealant.

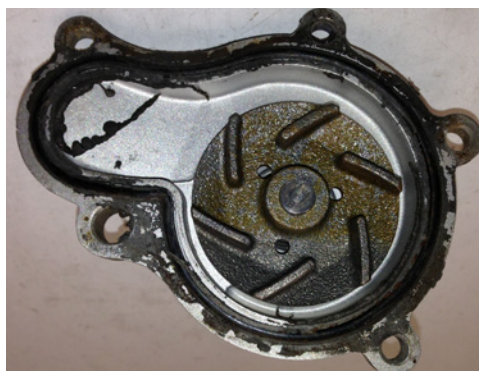
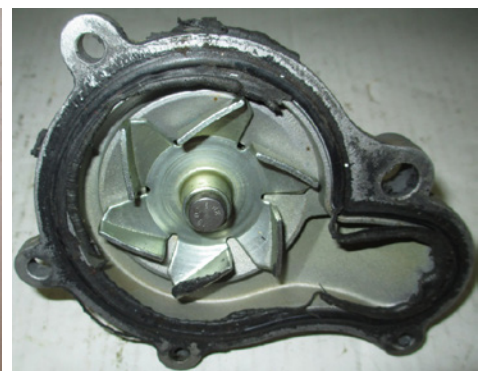
Both pumps were supplied with a rubber / O-ring style gasket. These types of gaskets do not require the use of any sealants.

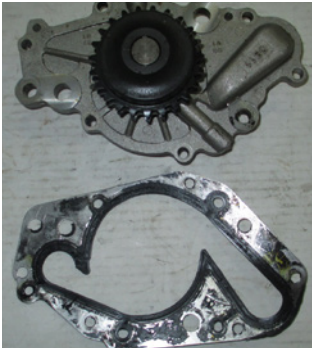
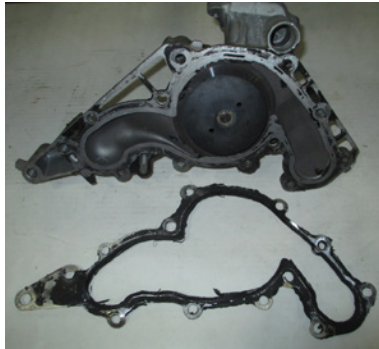
Both pumps to the left were supplied with a metal gasket with a rubber lining the interior perimeter. This type of gasket does not require any sealer. It is clear that over use and misuse of sealants occurred. Installation practices of this nature will lead to premature water pump failures. Premature failures lead to product reliability / quality concerns from customers when in actuality the failure arose from miss-installation / improper use of sealants.

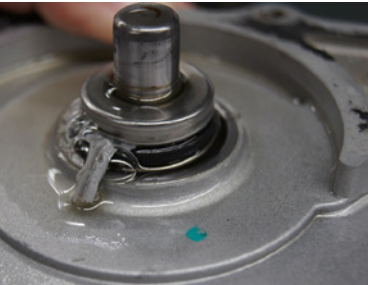
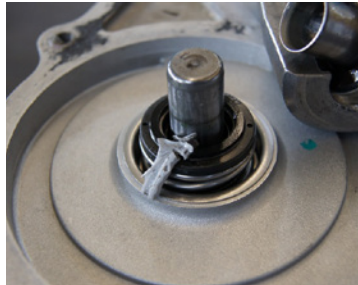
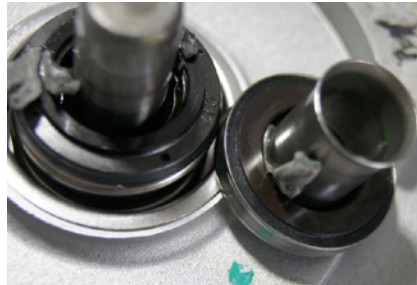
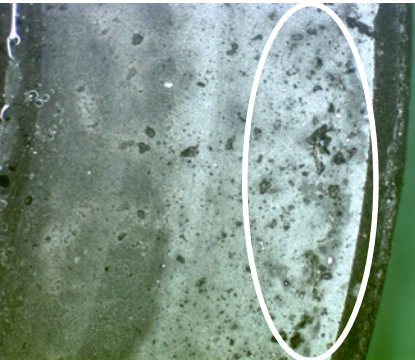
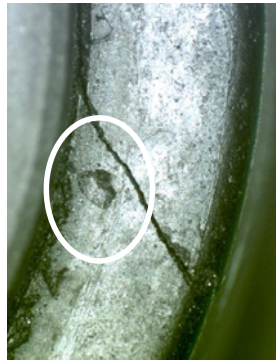
In the examples below one can see where sealer material has been found within the cartridge seal and has led to premature leakage of the water pump and the customer returned the pumps as an alleged manufacturer defect.

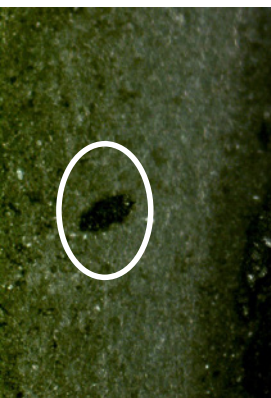
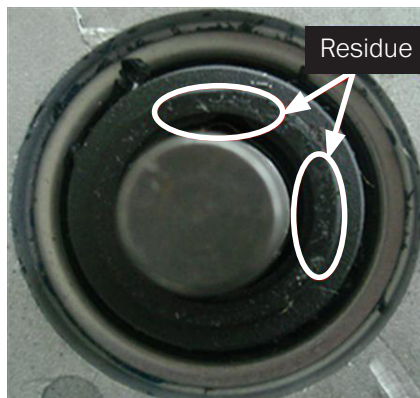
To the left are examples of Dynamic and Static seal contamination / filming caused by over use of sealants. When sealant particulates / residue get trapped between the Dynamic and Static seal faces it causes a separation of the two surfaces which leads to a seal leak.

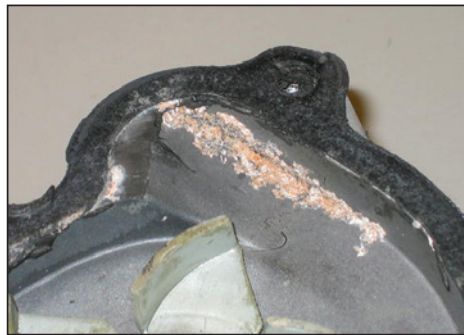
DEPOSITS/CALCIUM BUILDUP

If during the course of an inspection the water pump is found to look like any of the below, Gates recommends properly flushing the system, filling the system with a new mixture of the correct coolant, and possibly replacing the water pump depending on the issues found.

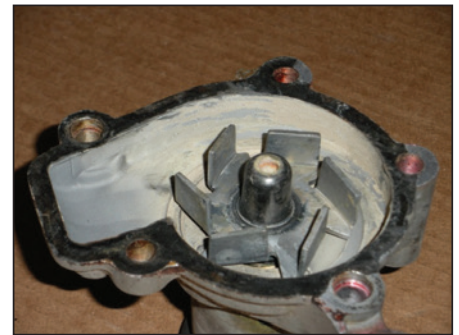
DEPOSITS/CALCIUM BUILDUP

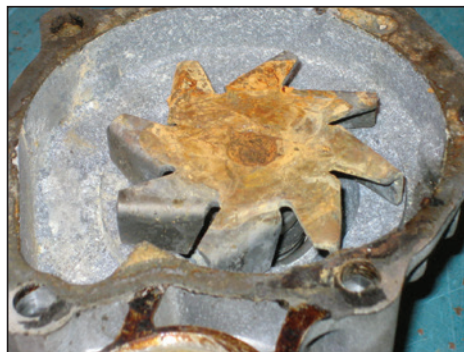
RUST/CORROSION

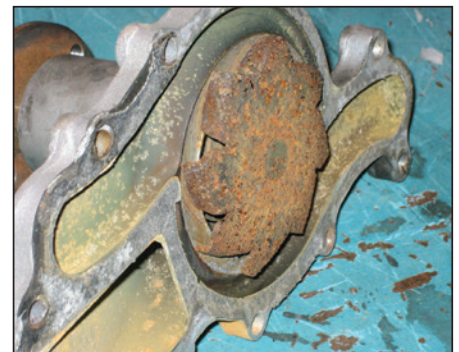
RUST/CORROSION

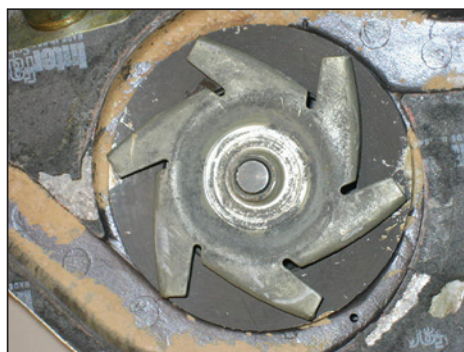
DEPOSIT BUILDUP

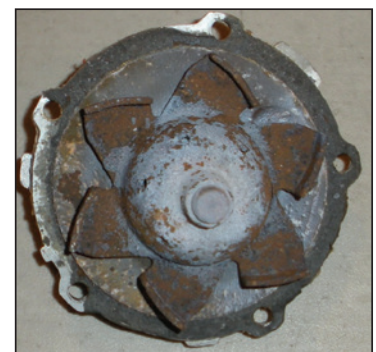
RUST/CORROSION

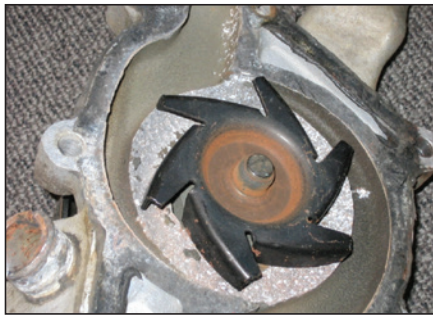
CAVITATION / CORROSION

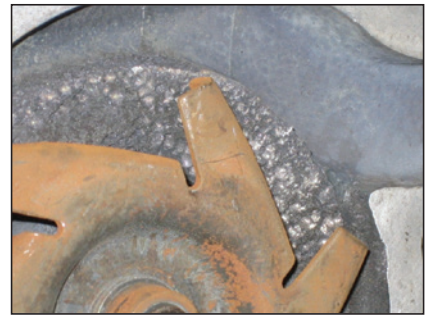
CAVITATION / CORROSION

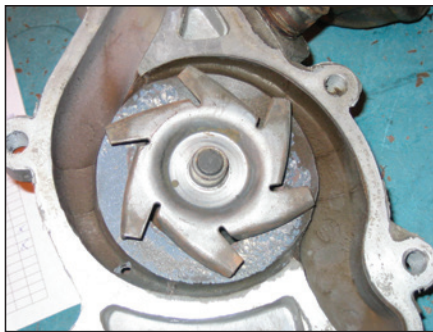
CAVITATION / CORROSION

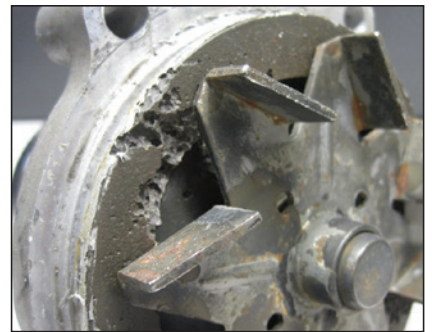
CAVITATION / CORROSION

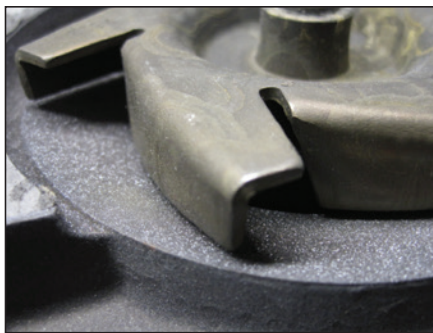
CHEMICAL ETCHING

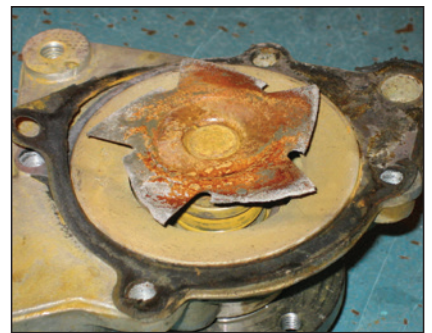
CORROSION
