| PART # | DESCRIPTION |
|---|---|
| 58620 | 00-06 TUNDRA 2.5 VS IR <a href="#">COILOVER KIT</a> |

## INSTALLATION

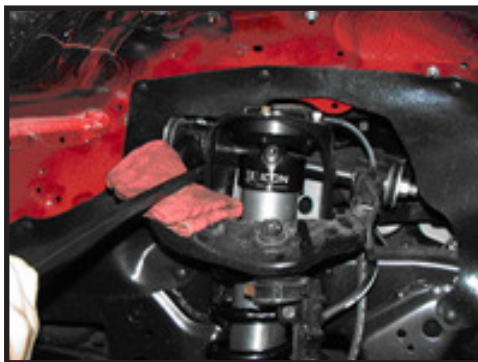
FIG.1

**6.** Install ICON coilover assembly: there are six holes in the upper coilover mount. All Tundra and Sequoia models will use the holes with the dot next to them. Install upper mount with the charge port pointing outward using the supplied (605101) bolts and (605131) lock washers. [Torque to 30ft-lbs] (FIGURE 1)
