## Installation procedures

### Filler neck

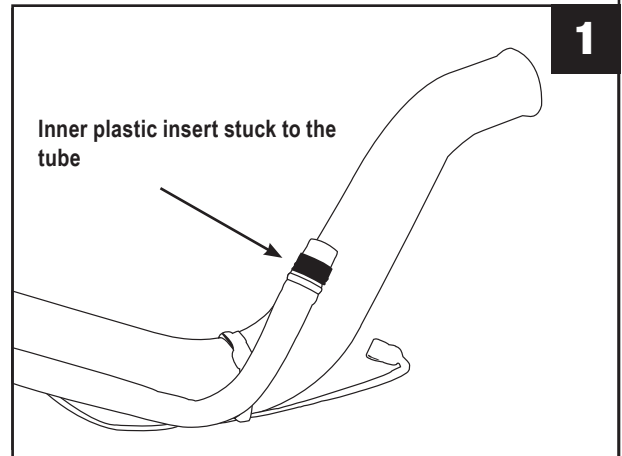
Filler neck

When removing the filler neck, it is possible for the inner plastic insert to be stuck to the vent tube as shown in **illustration 1**. Carefully remove the insert from the vent tube and install in the quick connector.

It was brought to our attention that fuel leaks may occur after the filler neck replacement caused by rust build-up at the quick connects fittings. To correct this situation we supply two seals.

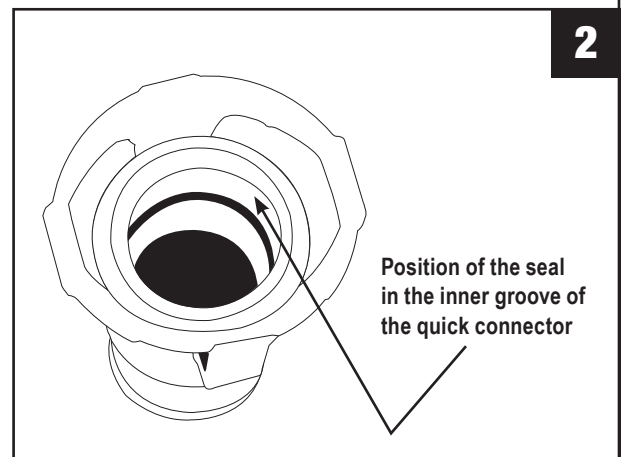
Quick connector

The seals must be installed in the groove found inside the quick connector as shown in **illustration 2**.

**NOTE: It is possible that your filler neck is equipped with two vent tubes quick connectors. Make sure to install both seals to the quick connectors.**
