# SPYDER™

## SKU# 5001771

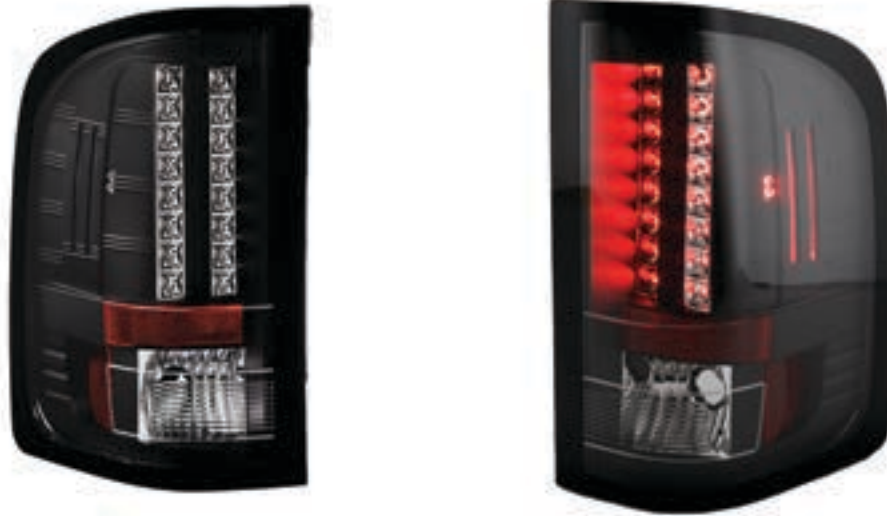
### PACKAGE CONTENTS:

• 2X TAIL LIGHT ASSEMBLIES

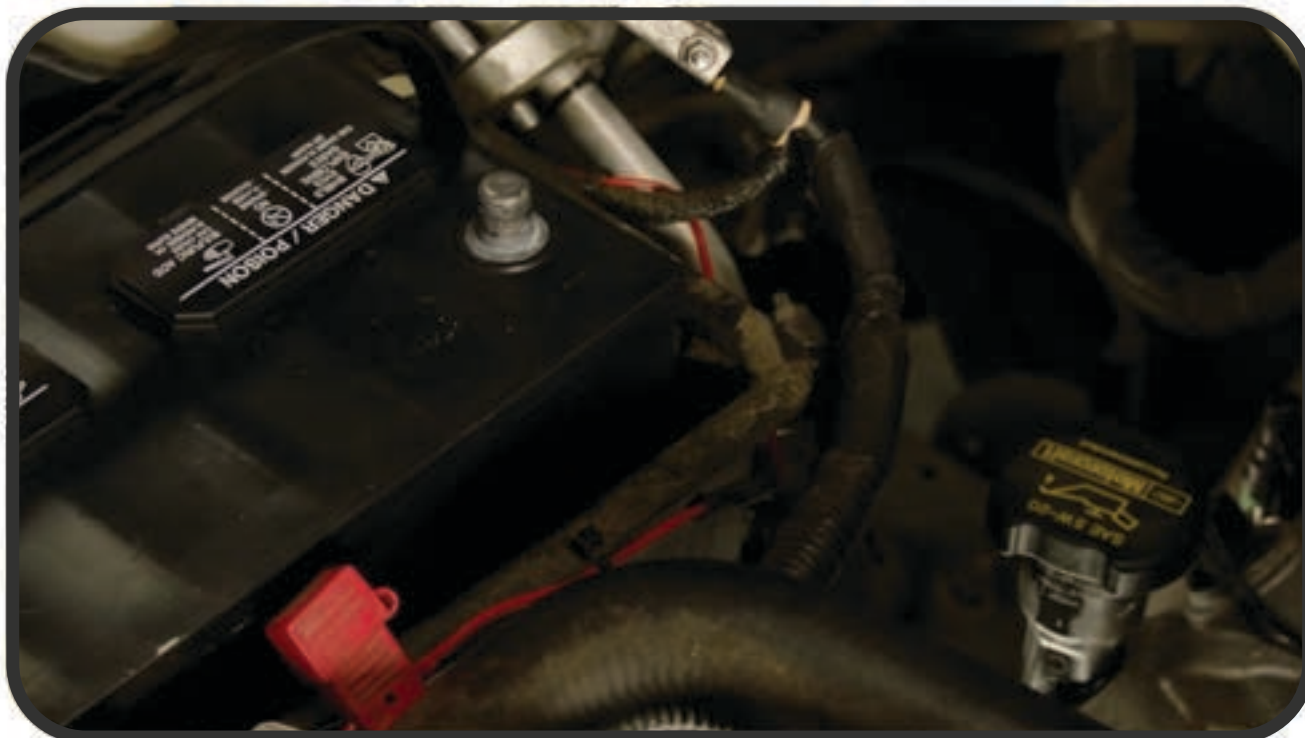
**STEP 1:**

**DISCONNECT THE NEGATIVE BATTERY TERMINAL**

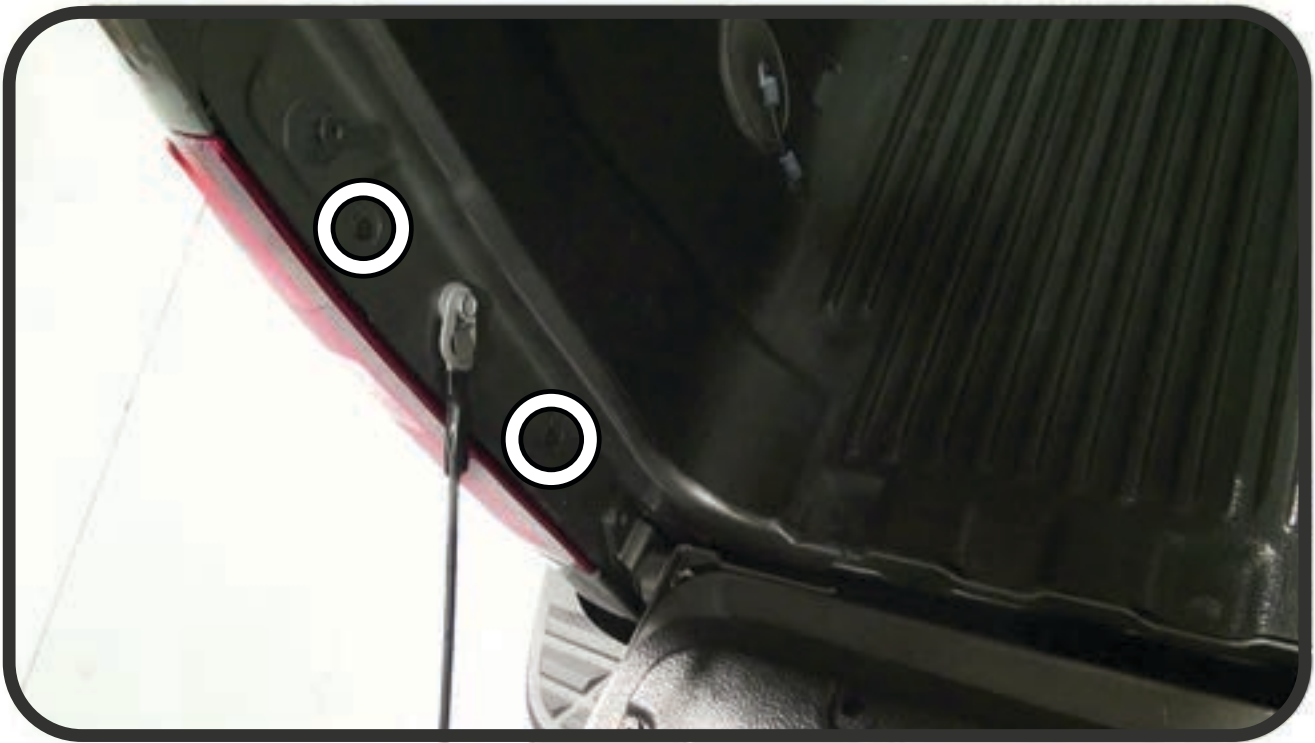
**STEP 2:**

**OPEN THE TAILGATE AND REMOVE (2) PHILLIPS SCREWS SECURING THE TAIL LIGHT**

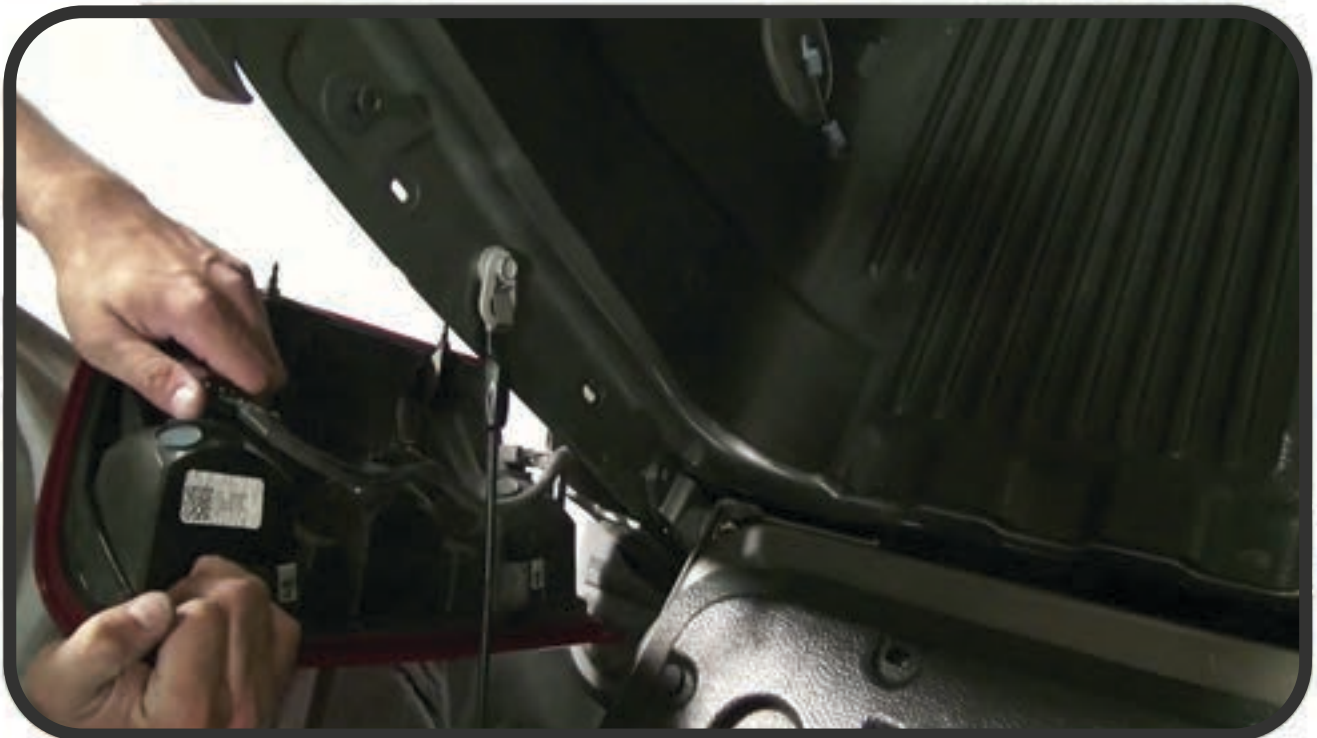
**STEP 3:**

**UNSEAT THE TAIL LIGHT AND REMOVE ALL 3 BULB SOCKETS FROM THE OLD TAIL LIGHT**

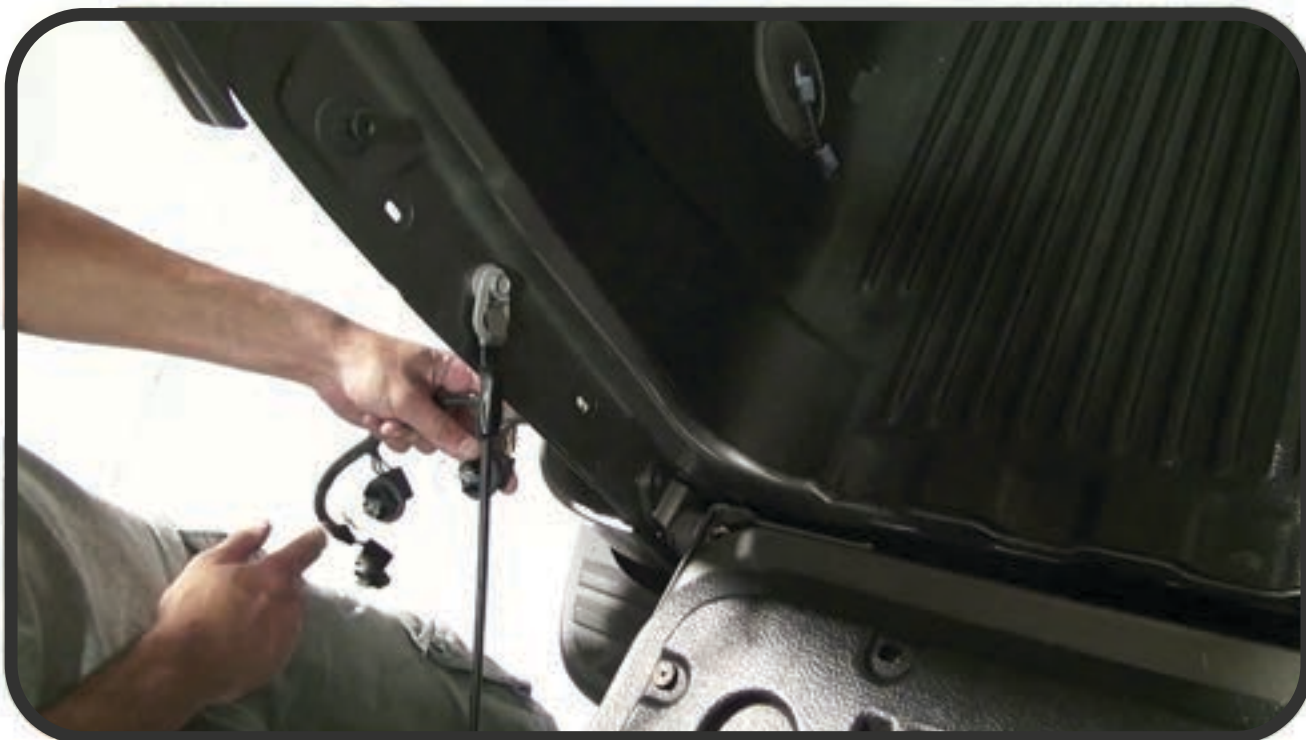
**STEP 4:**

**REMOVE THE BOTTOM SOCKET BULB AND TUCK BEHIND THE BUMPER AS THIS IS NOT USED**

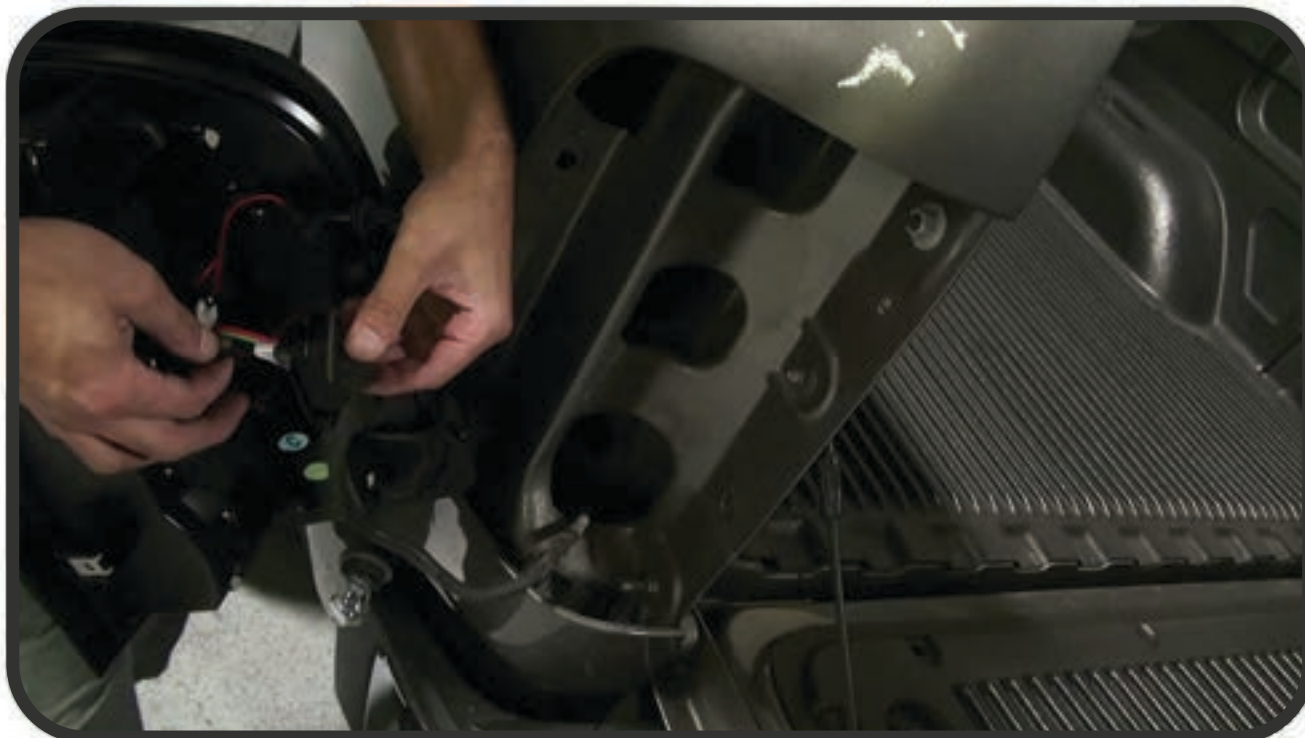
**STEP 5:**

**REMOVE THE BULB FROM THE UPPER SOCKET. CONNECT THE UPPER-MOST SOCKET INTO THE EMPTY BRAKE LAMP SOCKET ENSURING THE BLACK WIRES ALIGN**

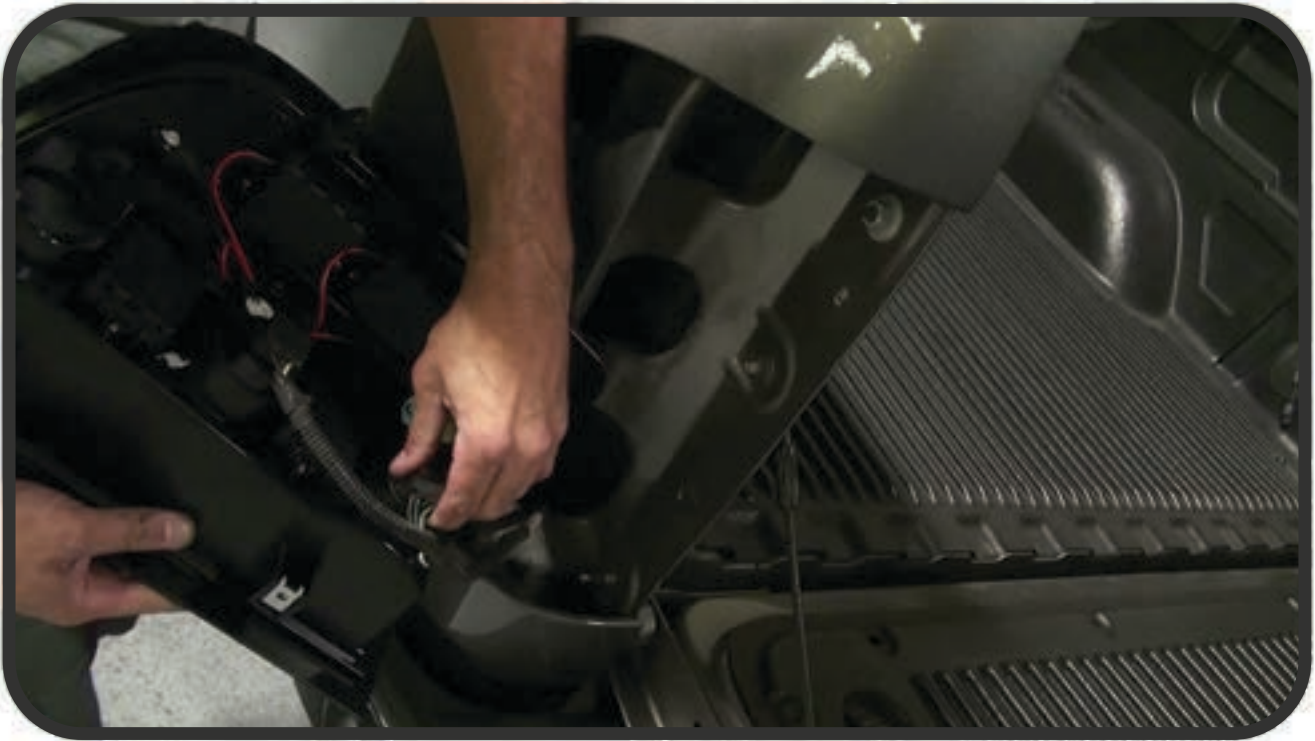
**STEP 6:**

**REINSTALL THE BRAKE BULB SOCKET AND REVERSE SOCKET INTO THE SPYDER TAIL LIGHT HOUSING**

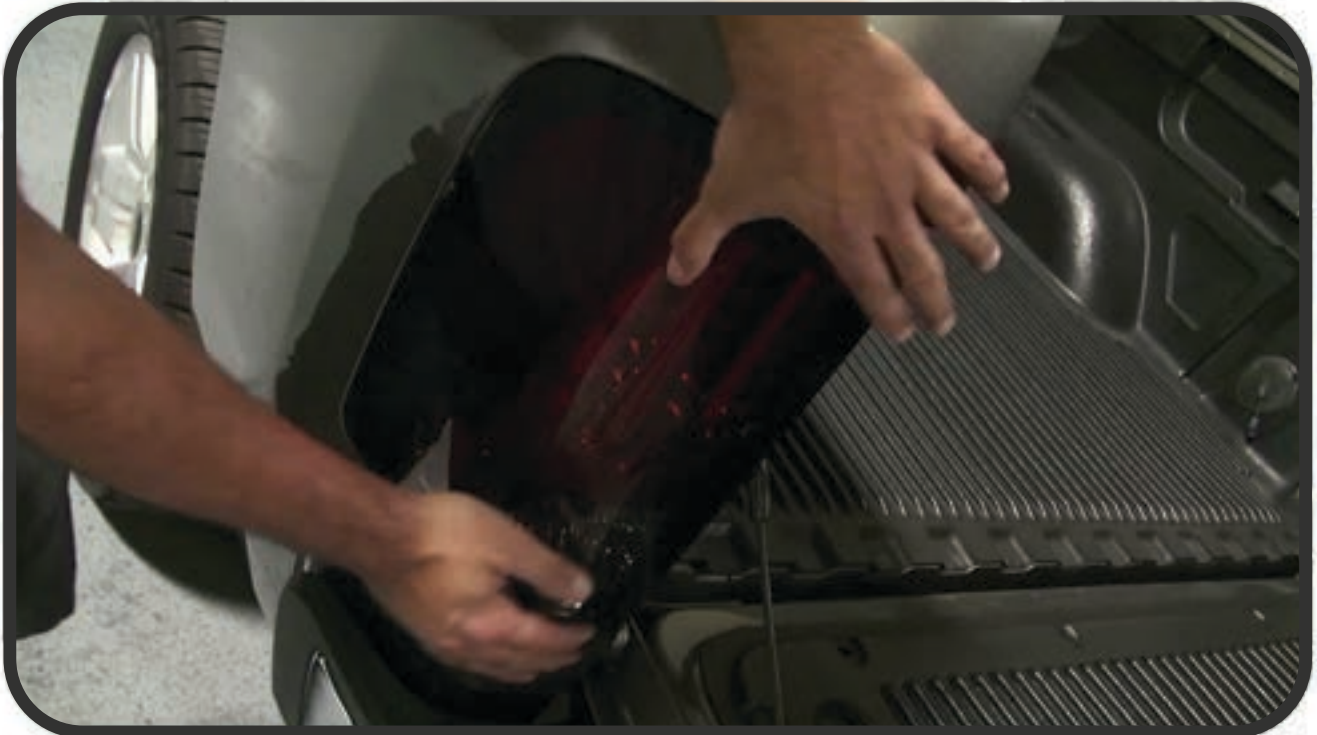
**STEP 7:**

**SEAT THE SPYDER TAIL LIGHT**

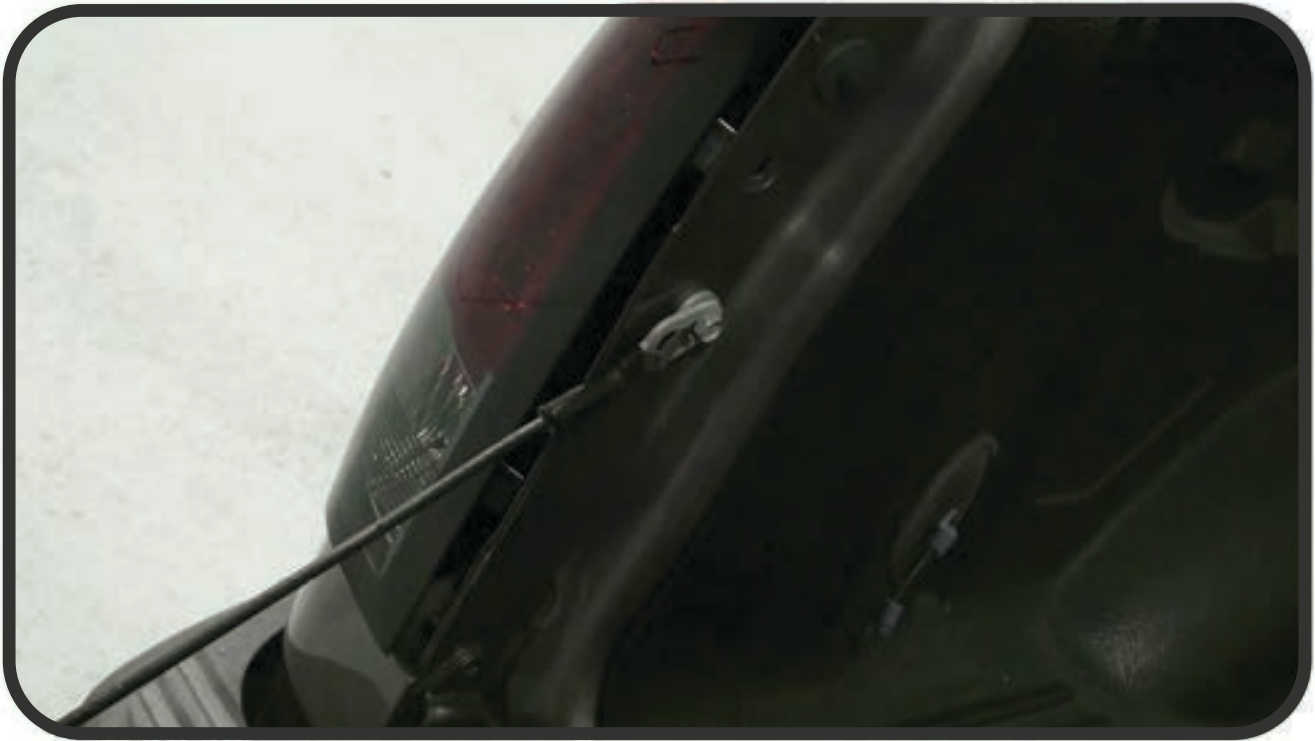
**STEP 8:**

**REINSTALL THE (2) PHILLIPS SCREWS TO SECURE THE TAIL LIGHT**

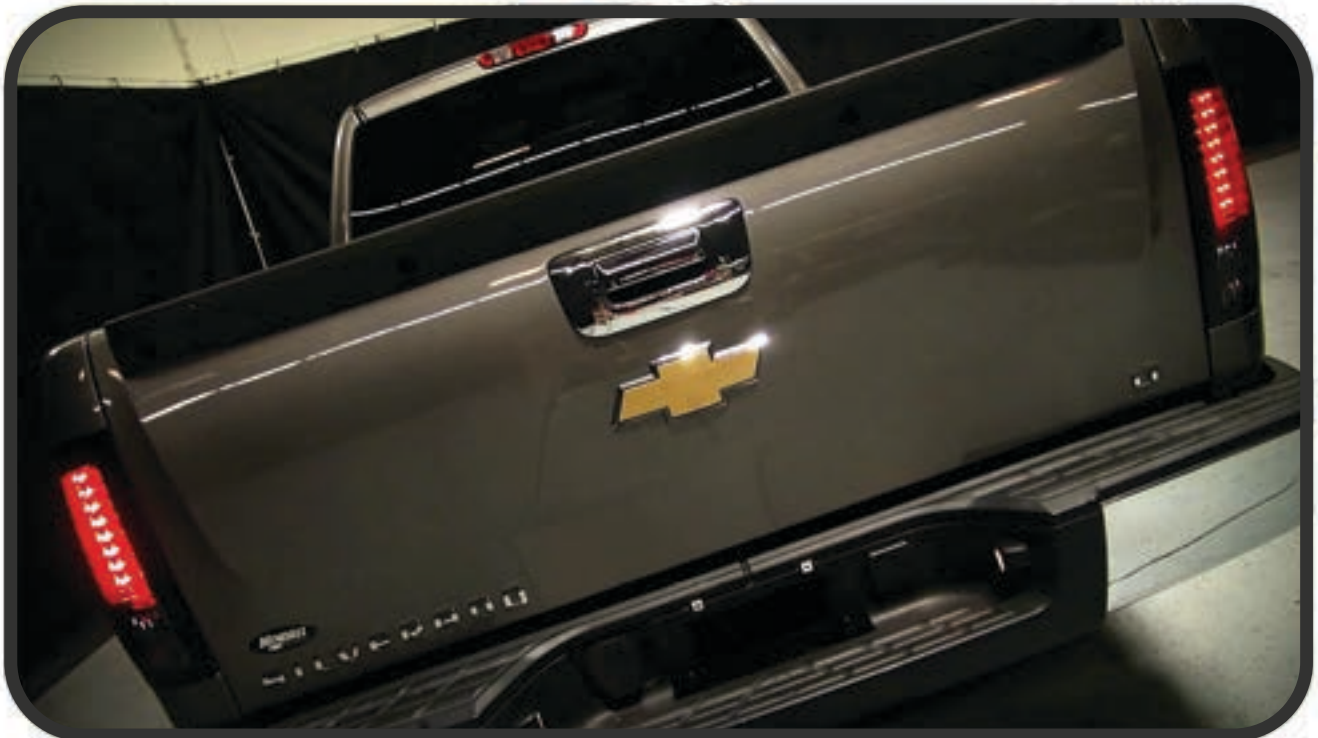
**STEP 9:**

**RECONNECT THE BATTERY AND TEST THE FUNCTIONS TO ENSURE THEY FUNCTION PROPERLY**
