SPYDER™

SKU# 5077530

- 2013-2018 DODGE RAM 1500
- 2013-2018 DODGE RAM 2500/3500 LED TAIL LIGHTS

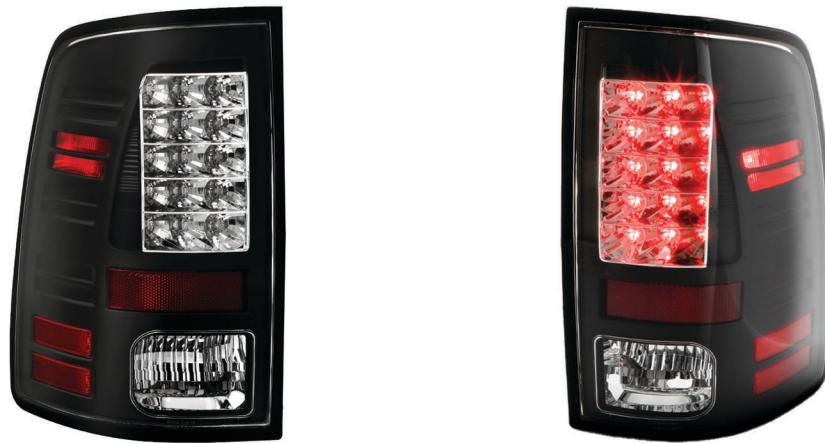
PACKAGE CONTENTS:

• 2X TAIL LIGHT ASSEMBLIES

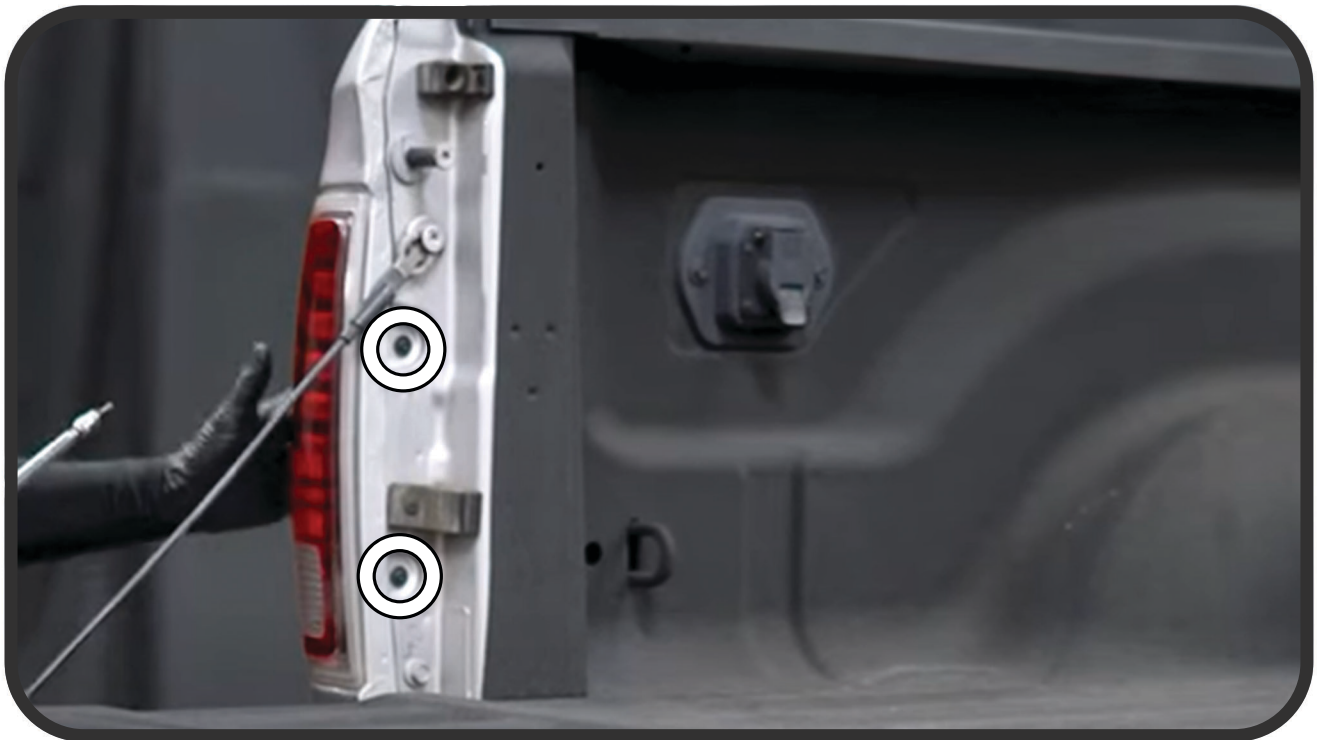
STEP 2:
OPEN THE TAILGATE AND REMOVE (2) T20 TORX SCREWS

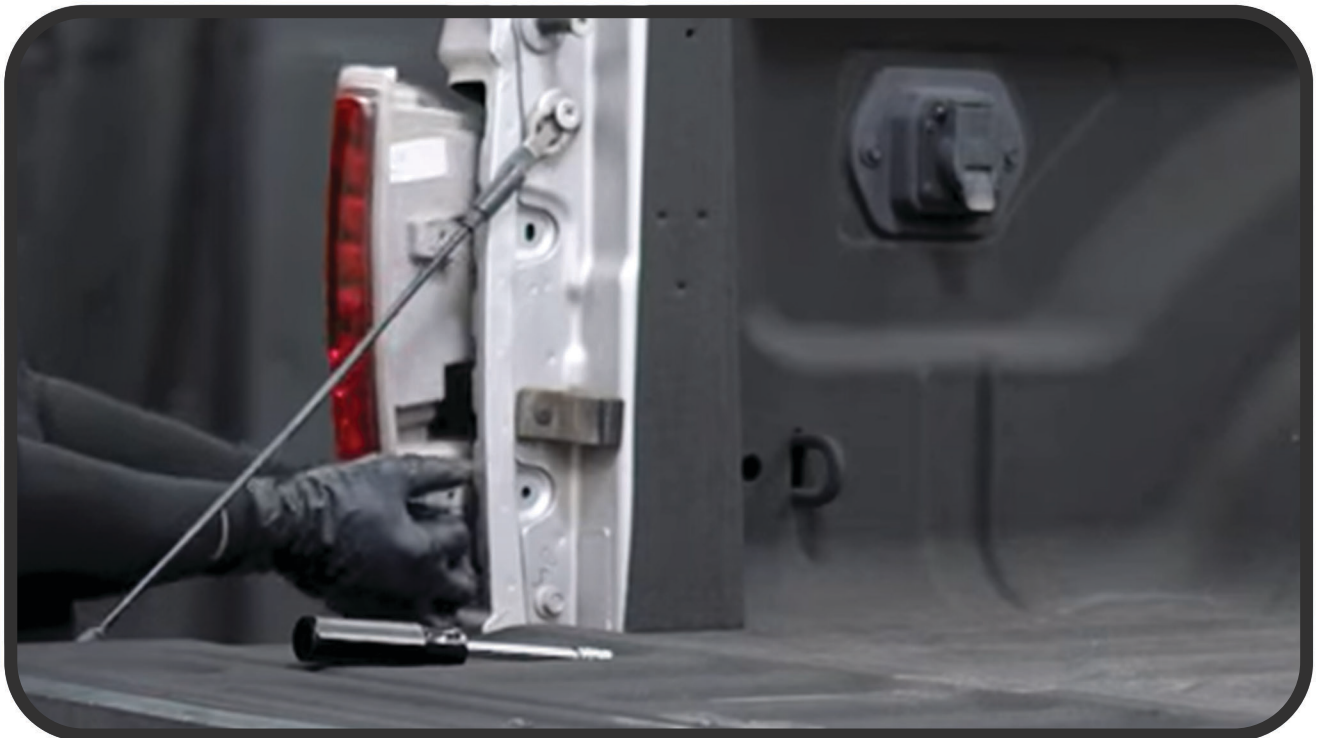
STEP 3:
UNSEAT THE TAIL LIGHT

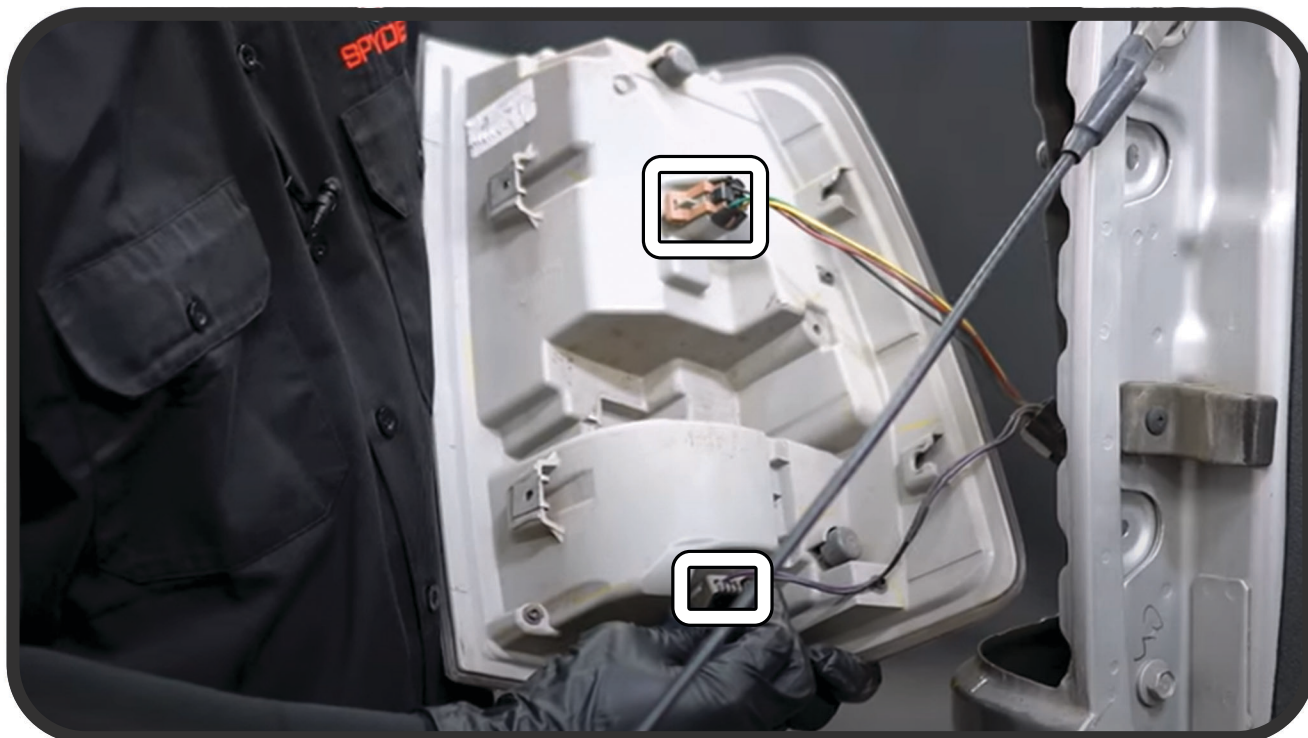
STEP 4:
REMOVE REVERSE SOCKET AND BRAKE LIGHT HARNESS
(NOTE: NEVER TOUCH BULB WITH BARE HANDS)

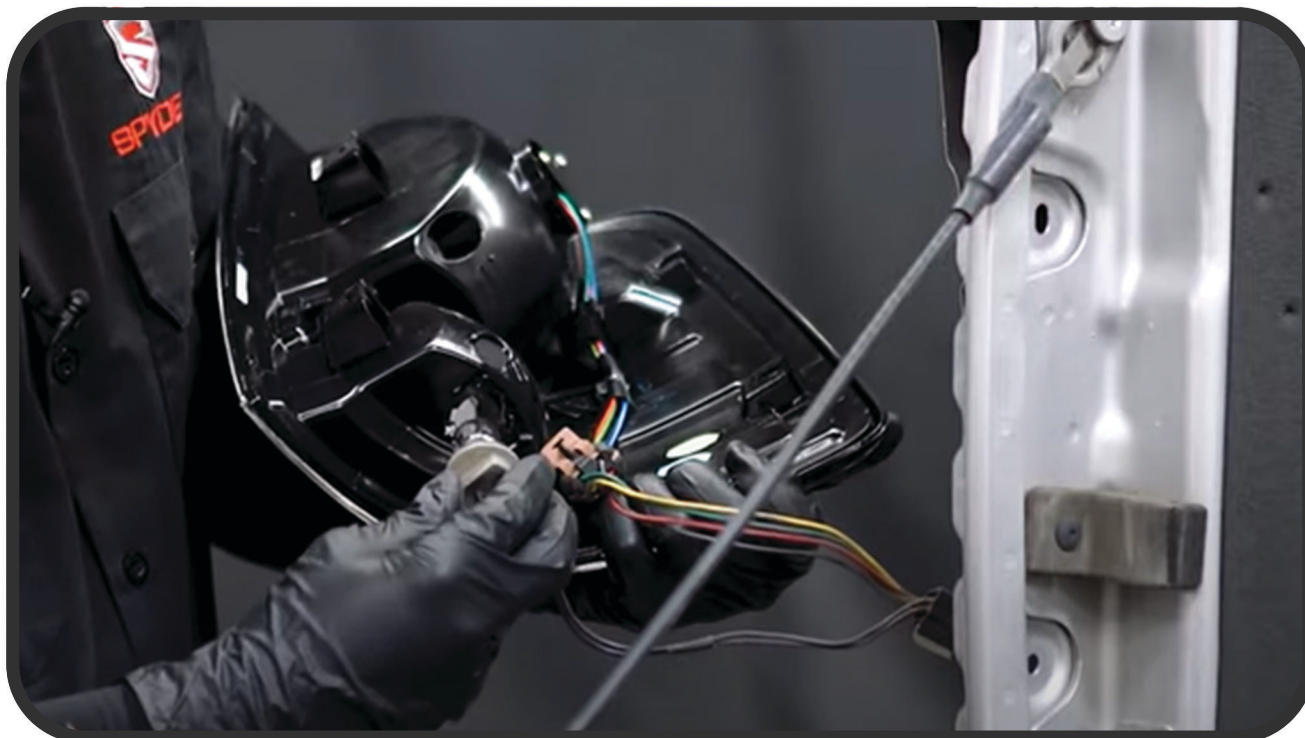
STEP 5:
INSTALL REVERSE SOCKET AND BRAKE LIGHT HARNESS ONTO
SPYDER TAIL LIGHT

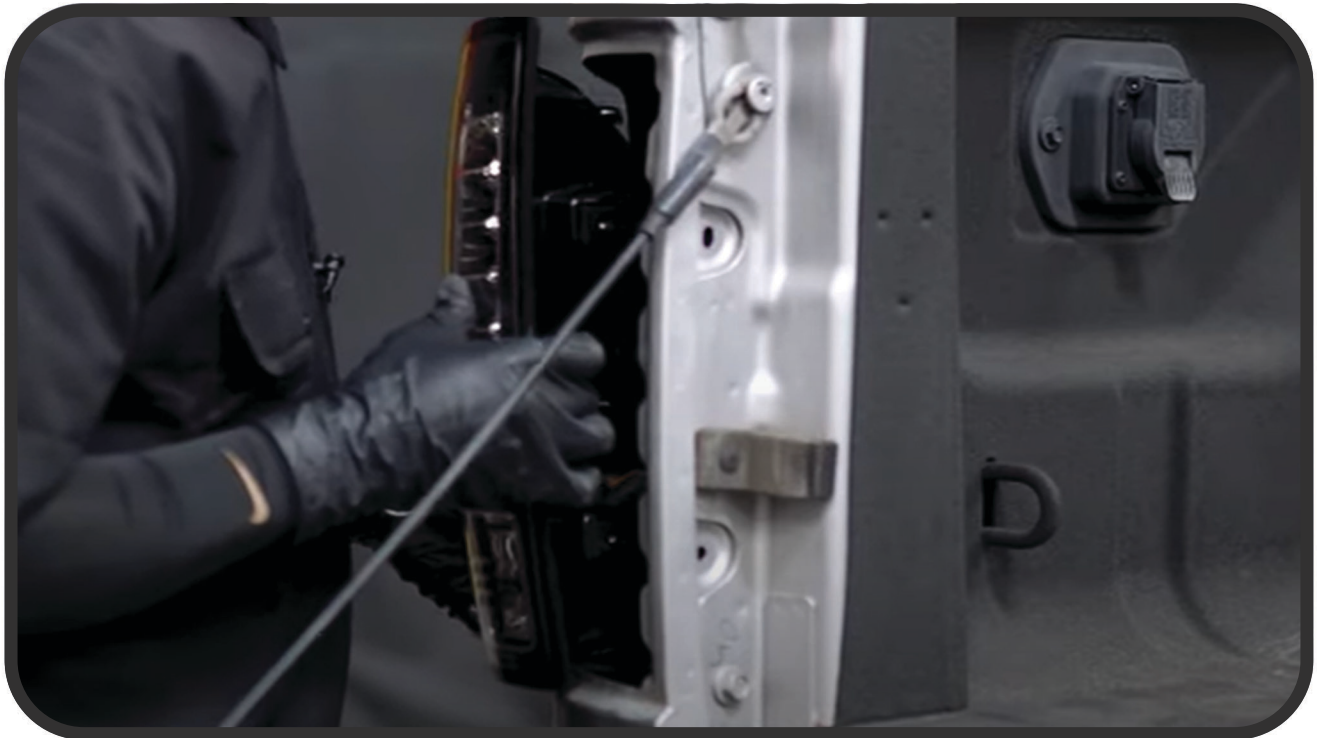
STEP 6:
SEAT THE SPYDER TAIL LIGHT

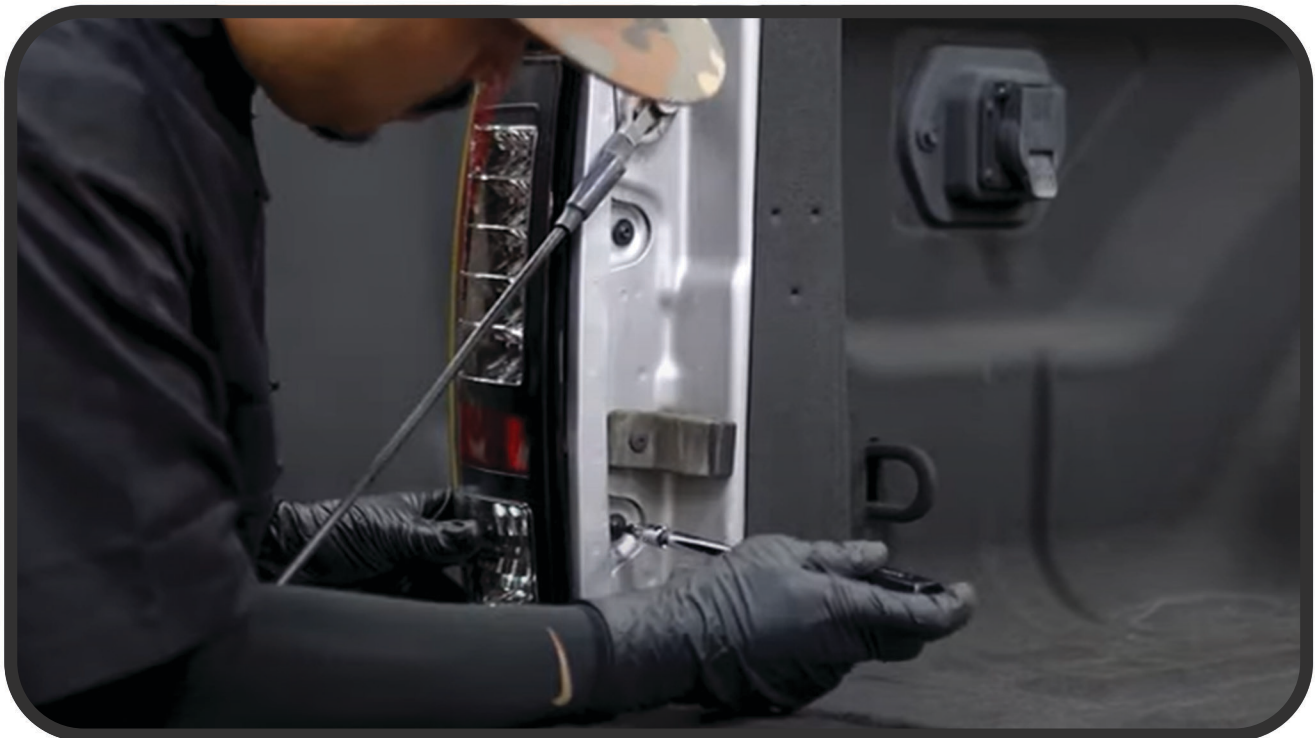
STEP 7:
**REINSTALL THE (2) T20 TORX SCREWS TO SECURE THE TAIL LIGHT.
CLOSE THE TAILGATE**

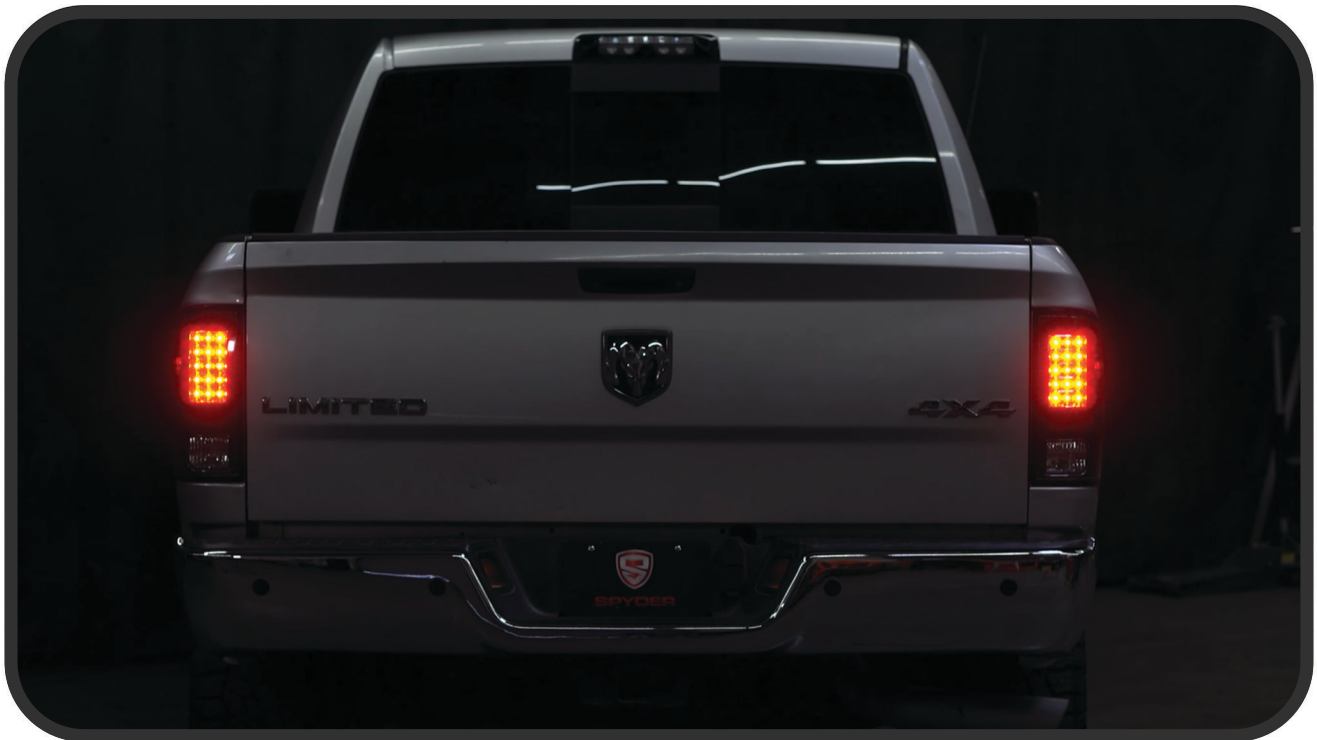
STEP 8:

RECONNECT THE BATTERY AND TEST THE FUNCTIONS TO ENSURE THEY FUNCTION PROPERLY
