SPYDER™

SKU# 5084057

• 2013-2018 DODGE RAM 1500/2500/3500

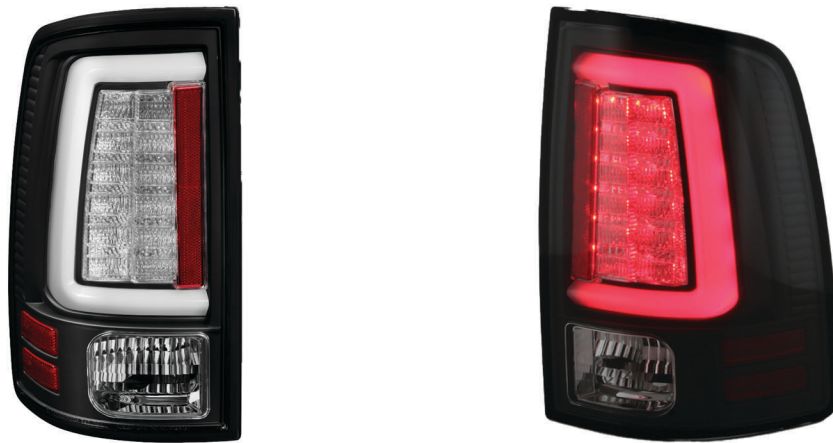
PACKAGE CONTENTS:

• 2X TAIL LIGHT ASSEMBLIES

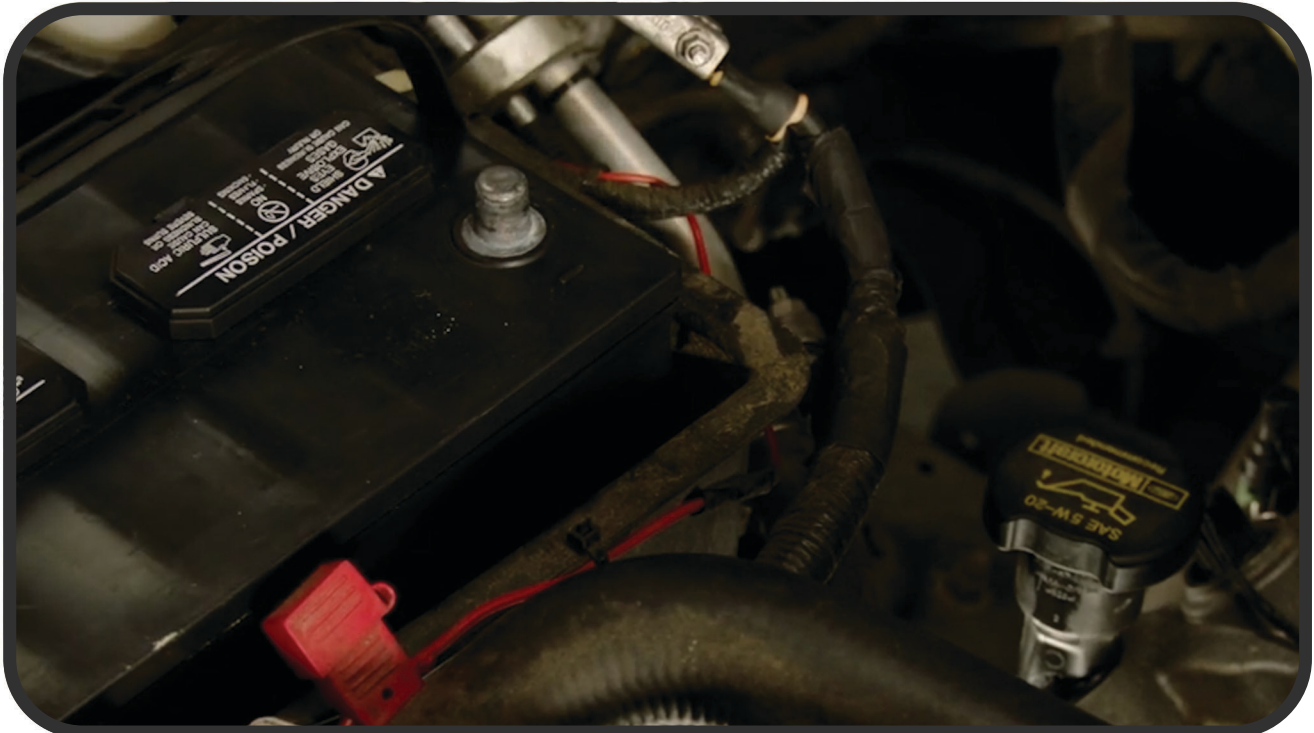
STEP 1:
DISCONNECT THE NEGATIVE BATTERY TERMINAL

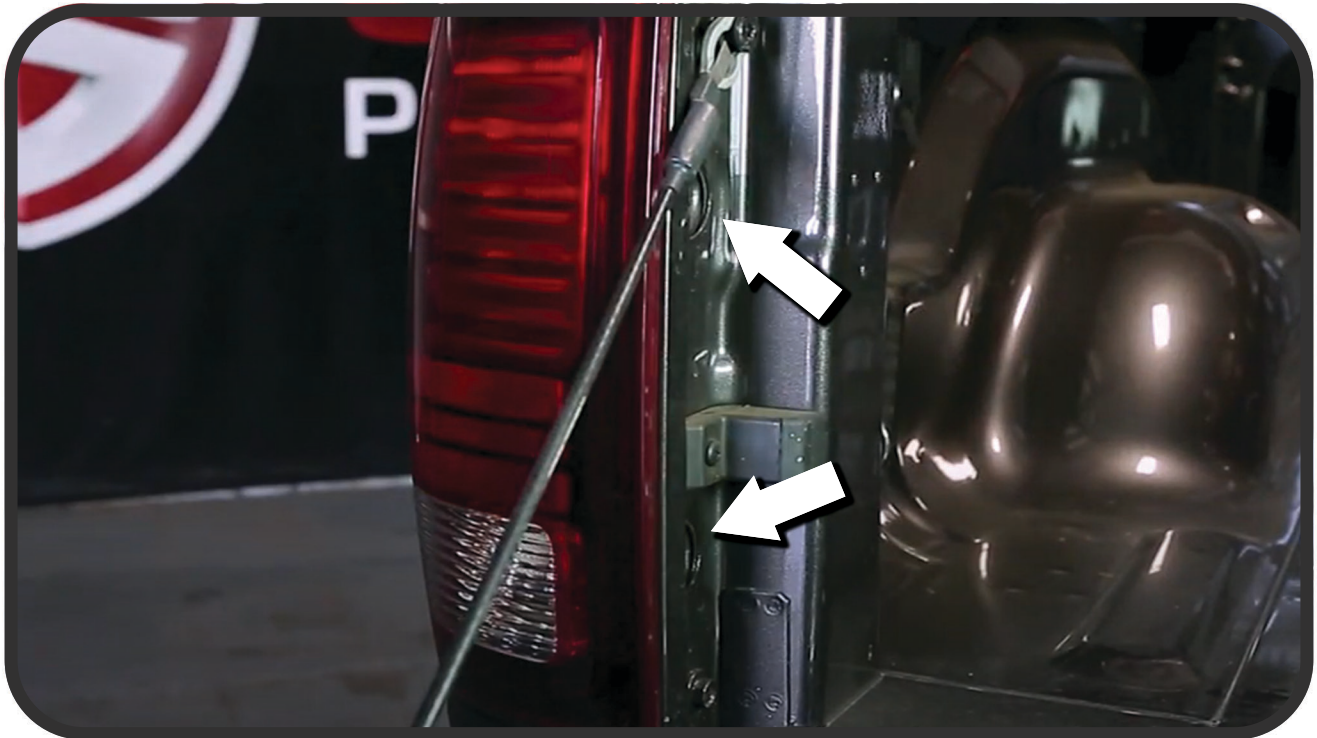
STEP 2:
OPEN THE TAILGATE AND REMOVE (2) T25 TORX SCREWS

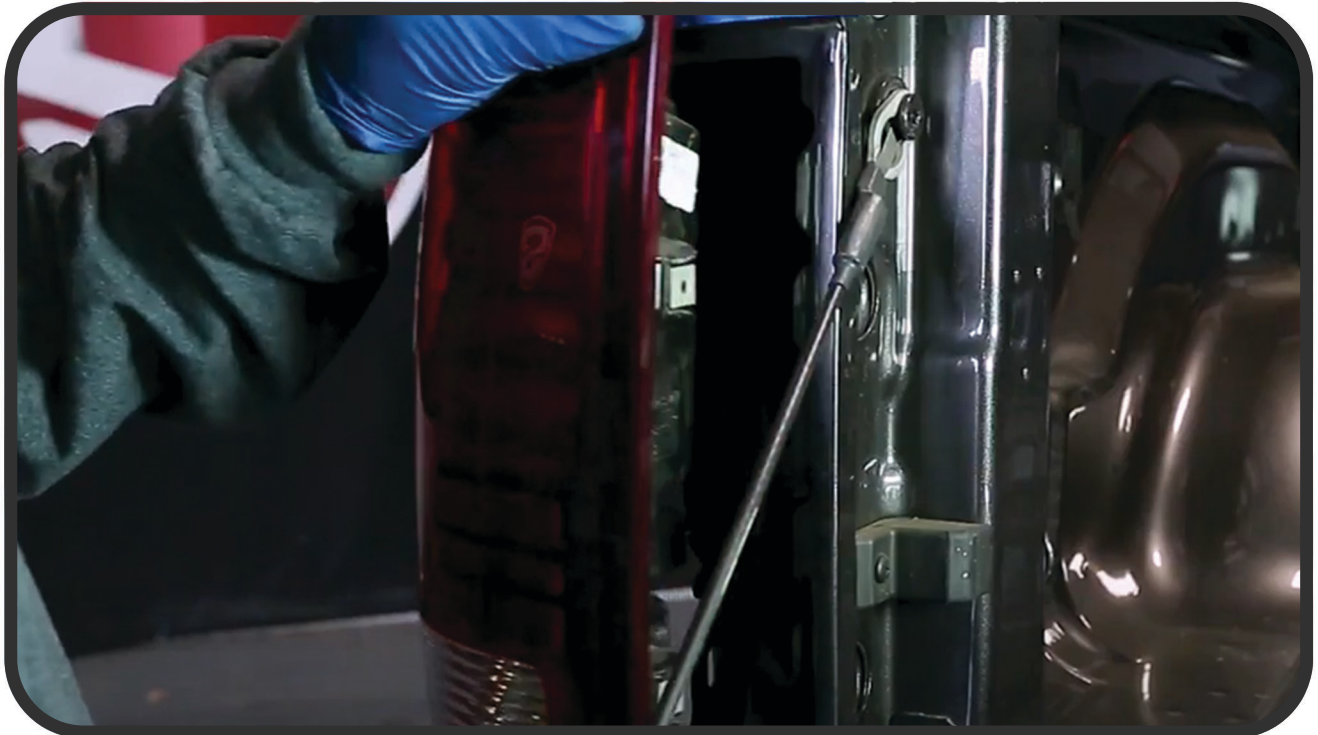
STEP 3:
UNSEAT THE TAIL LIGHT

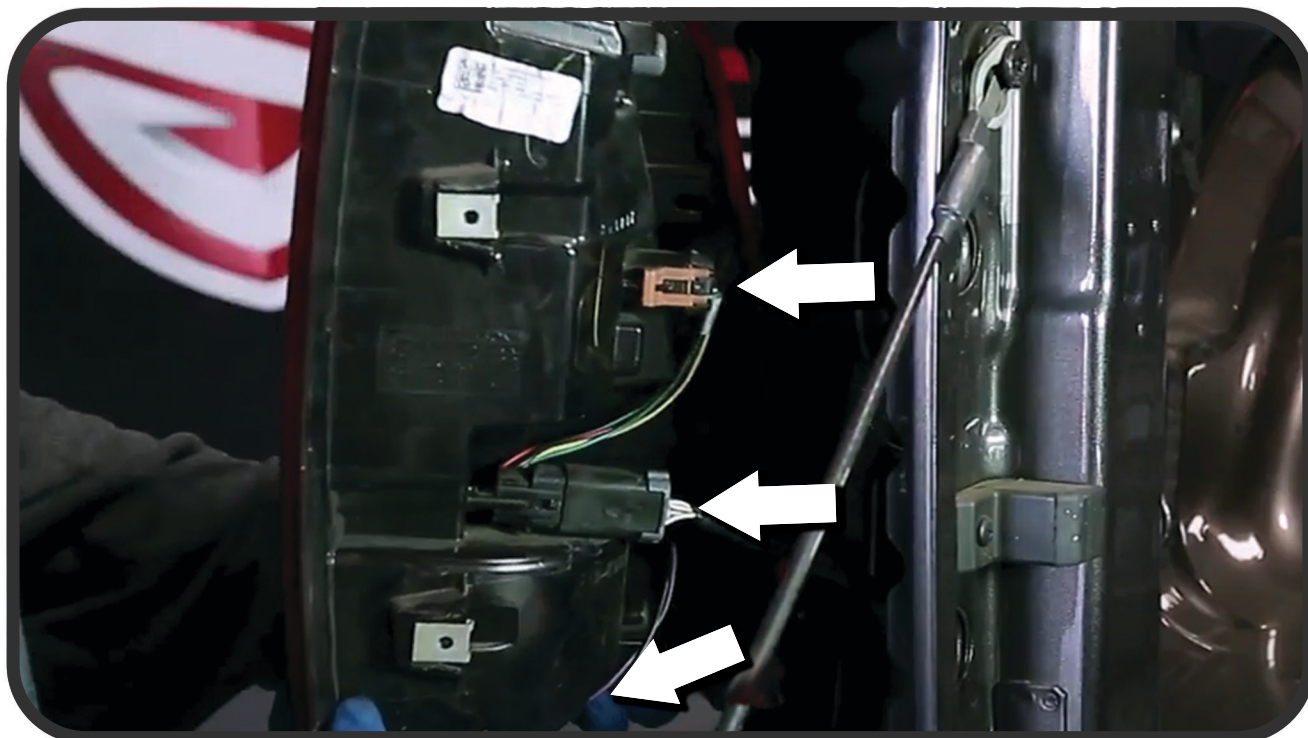
STEP 4:

REMOVE REVERSE SOCKET, BRAKE LIGHT HARNESS, AND THE HARNESS HOLDER

(NOTE: NEVER TOUCH BULB WITH BARE HANDS)

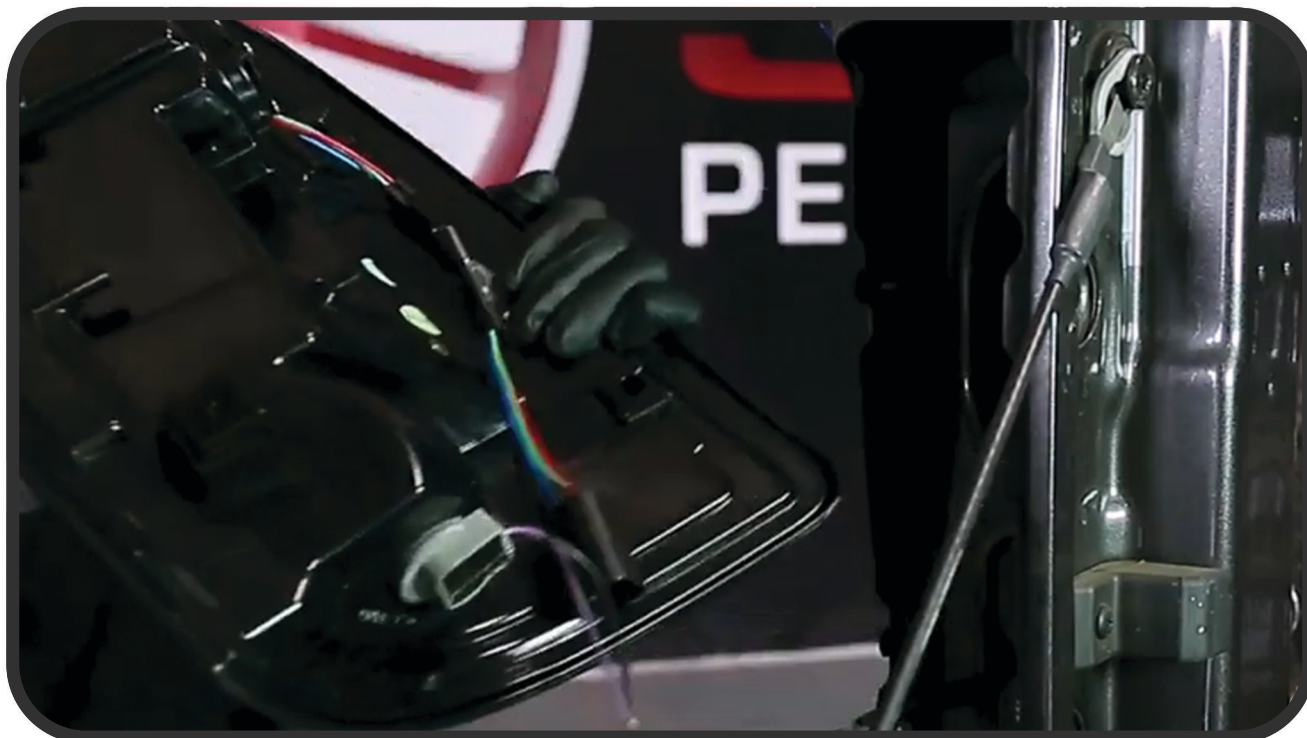
STEP 5:

INSTALL REVERSE SOCKET AND BRAKE LIGHT HARNESS ONTO THE SPYDER TAIL LIGHT

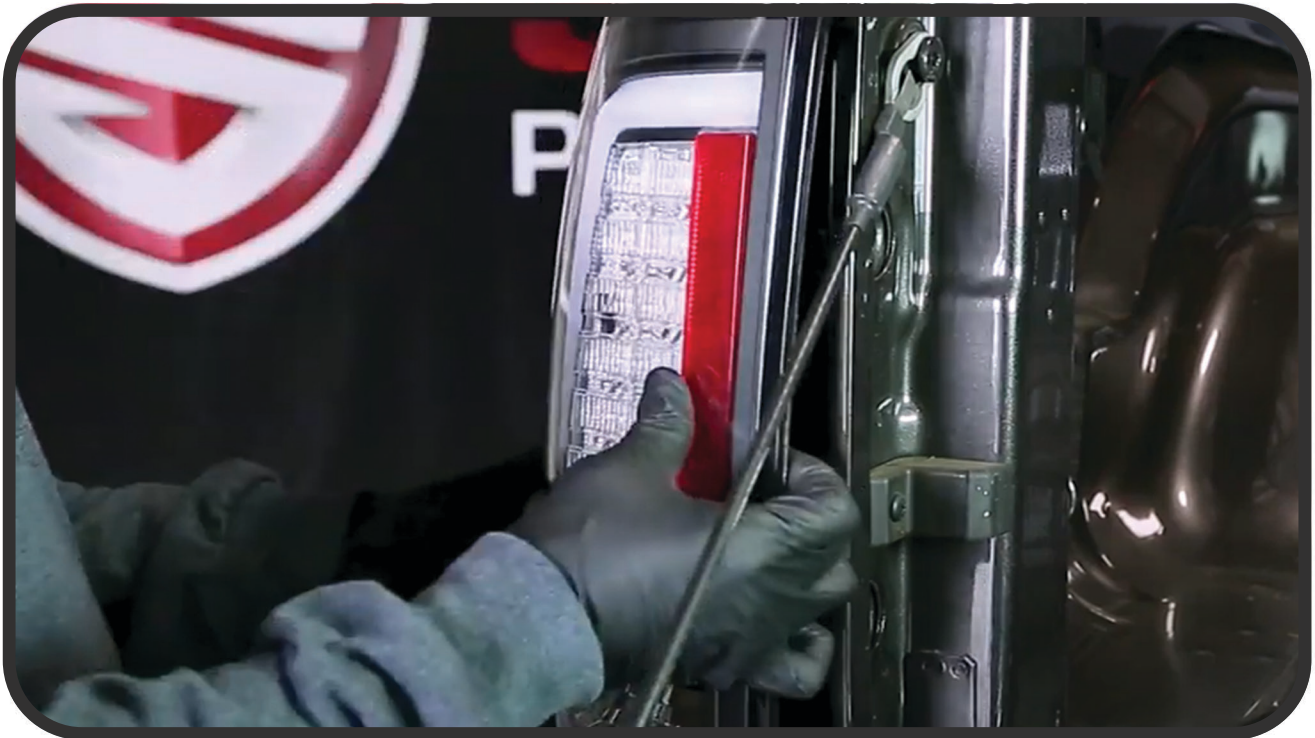
STEP 6:
SEAT THE SPYDER TAIL LIGHT

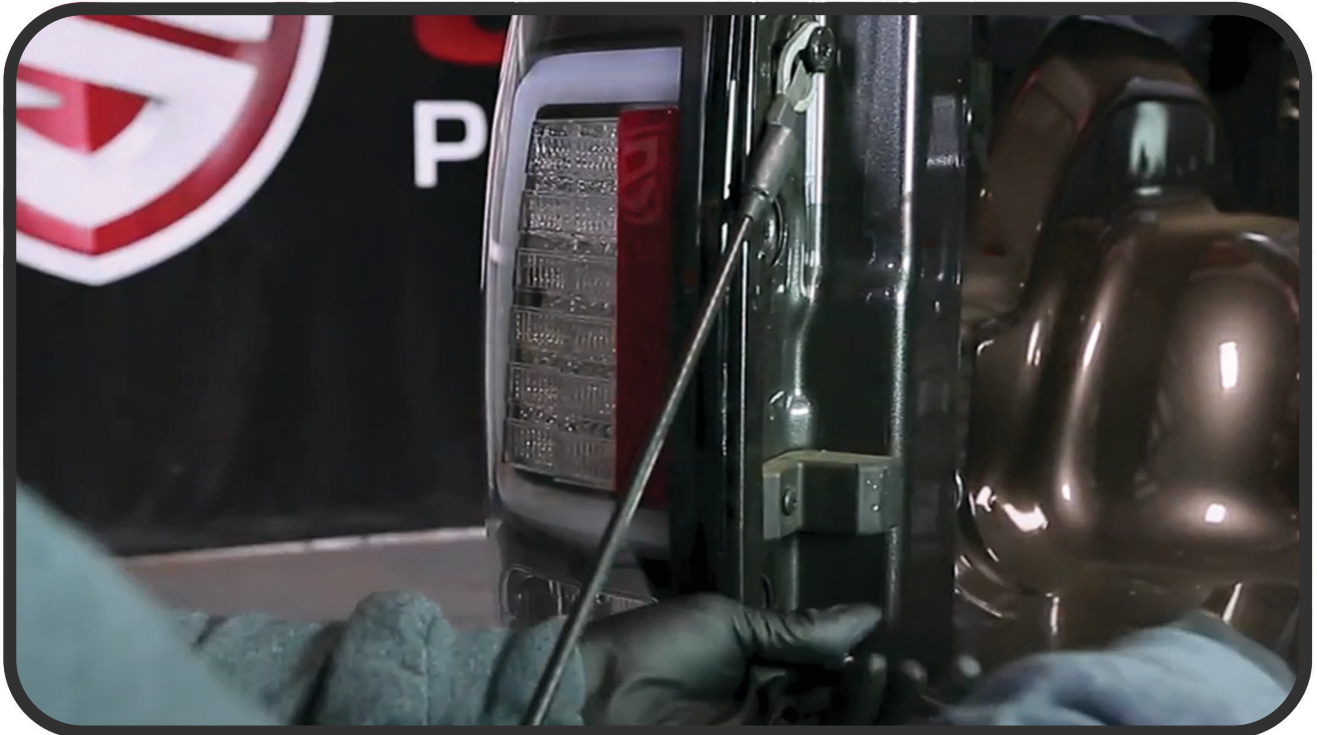
STEP 7:
REINSTALL THE (2) T25 TORX SCREWS

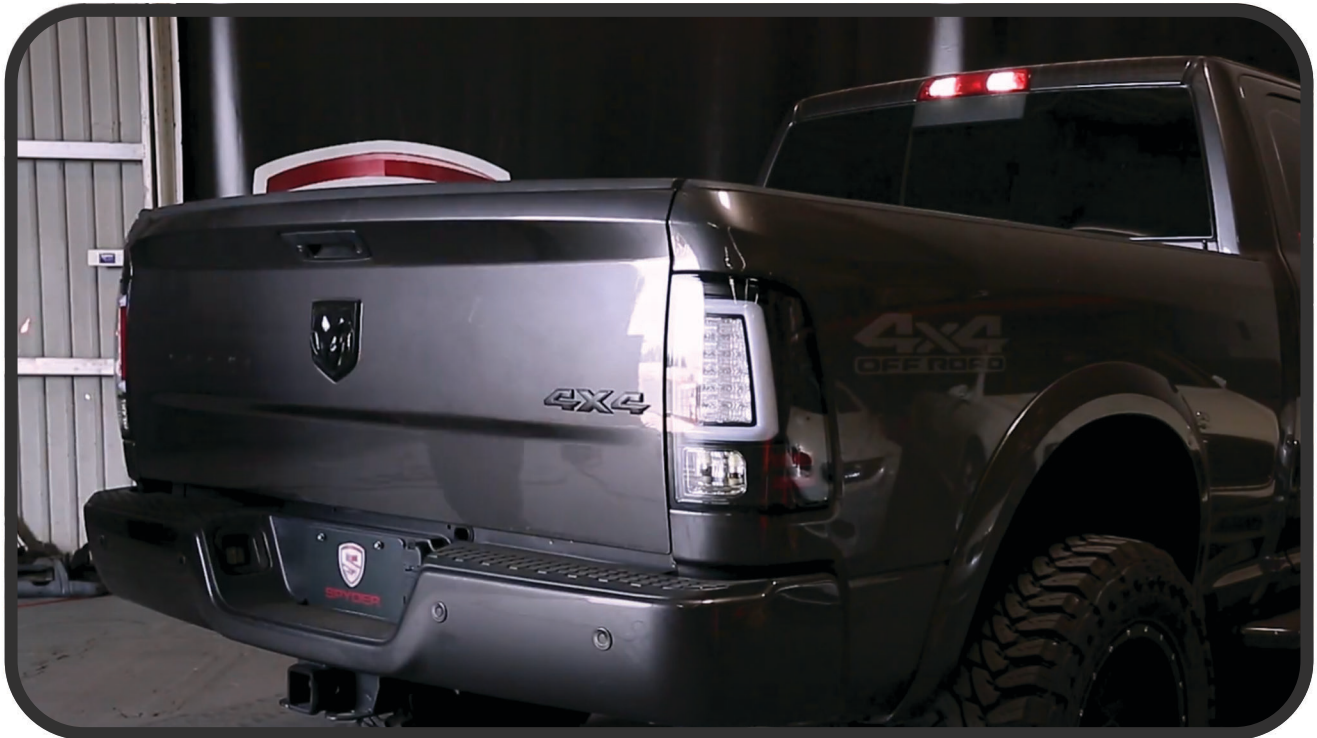
STEP 8:

RECONNECT THE BATTERY AND TEST THE FUNCTIONS TO ENSURE THEY FUNCTION PROPERLY
