SPYDER™

SKU# 5085689

• 2X TAIL LIGHT ASSEMBLIES

- 2018-2020 FORD F150
(NOT COMPATIBLE WITH REAR BLIND SPOT SENSOR MODELS)

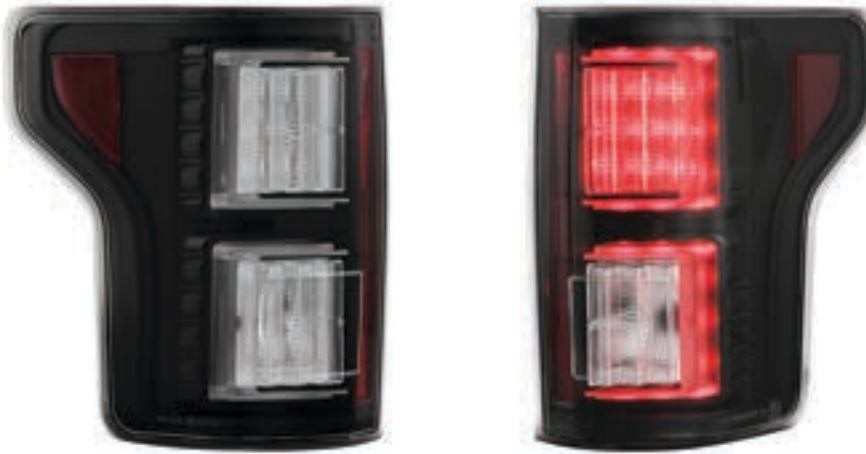
PACKAGE CONTENTS:

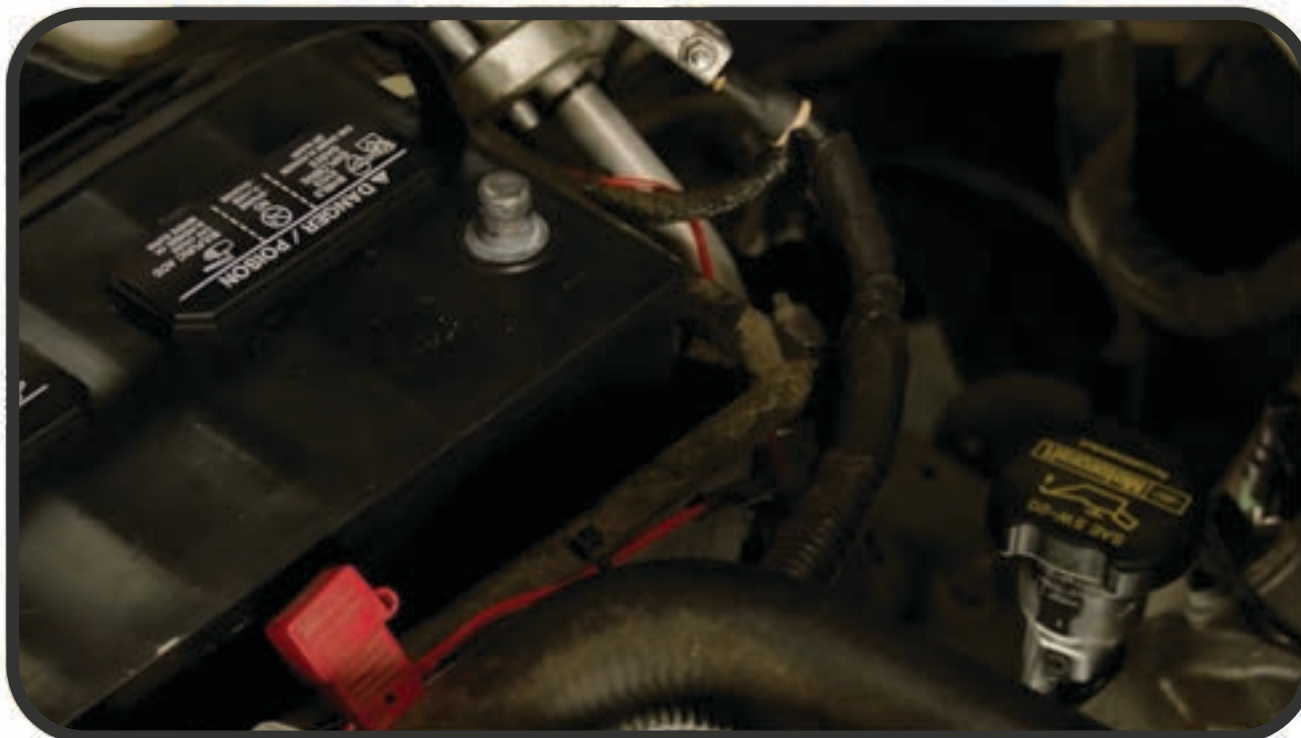
STEP 1:

DISCONNECT THE NEGATIVE BATTERY TERMINAL

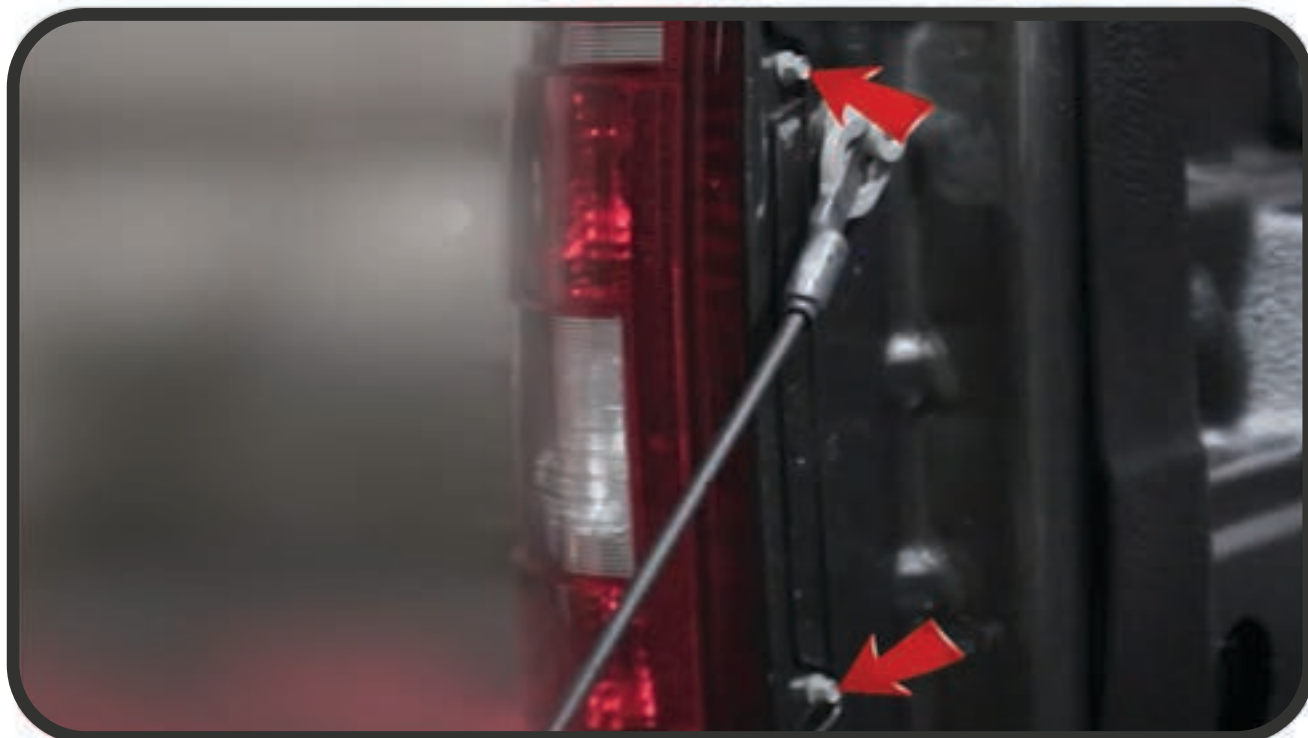
STEP 2:
REMOVE (2) 8MM BOLTS

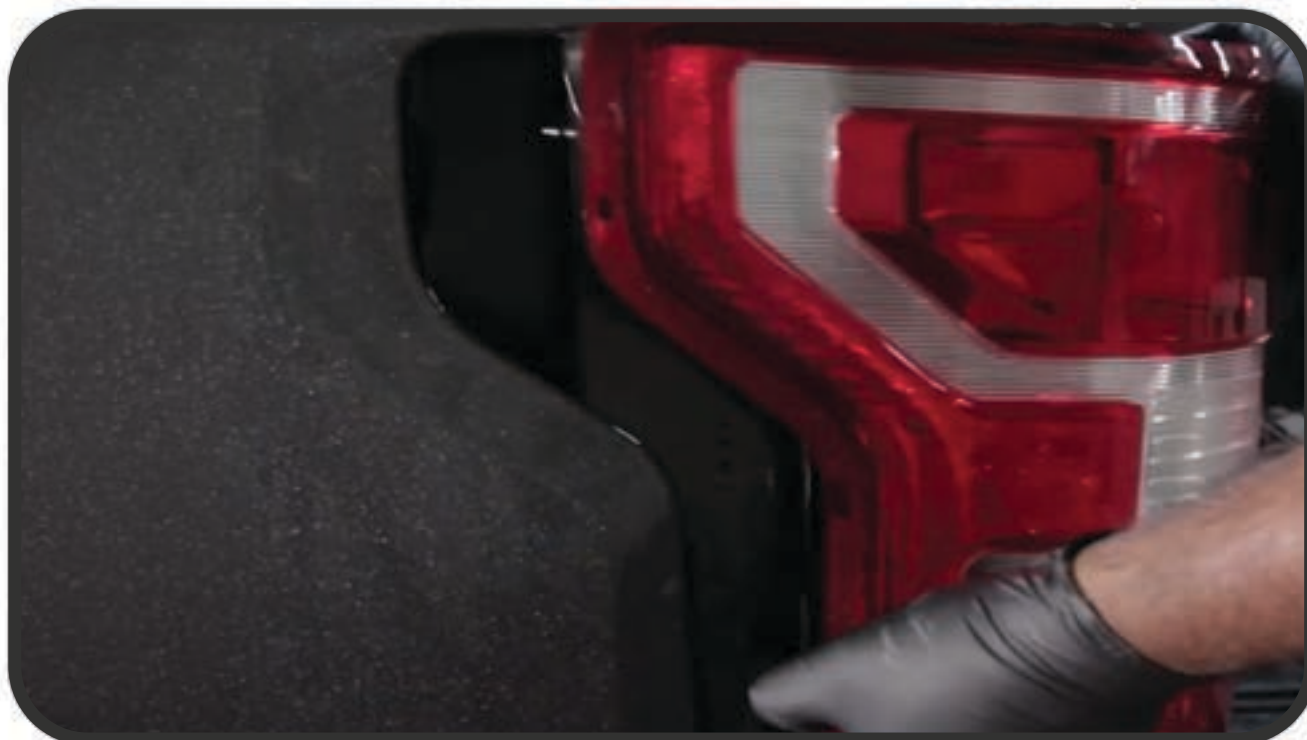
STEP 3:
UNSEAT TAIL LIGHT

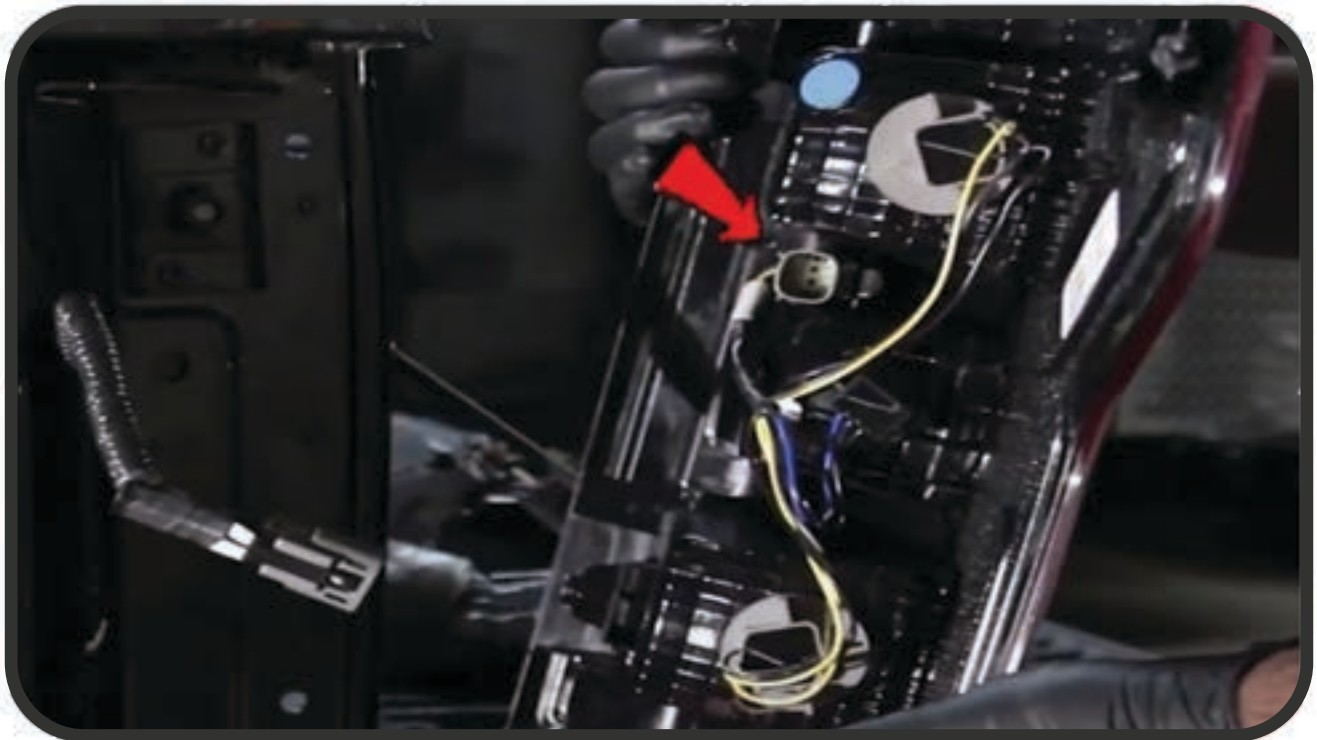
STEP 4:
DISCONNECT FACTORY TAIL LIGHT HARNESS

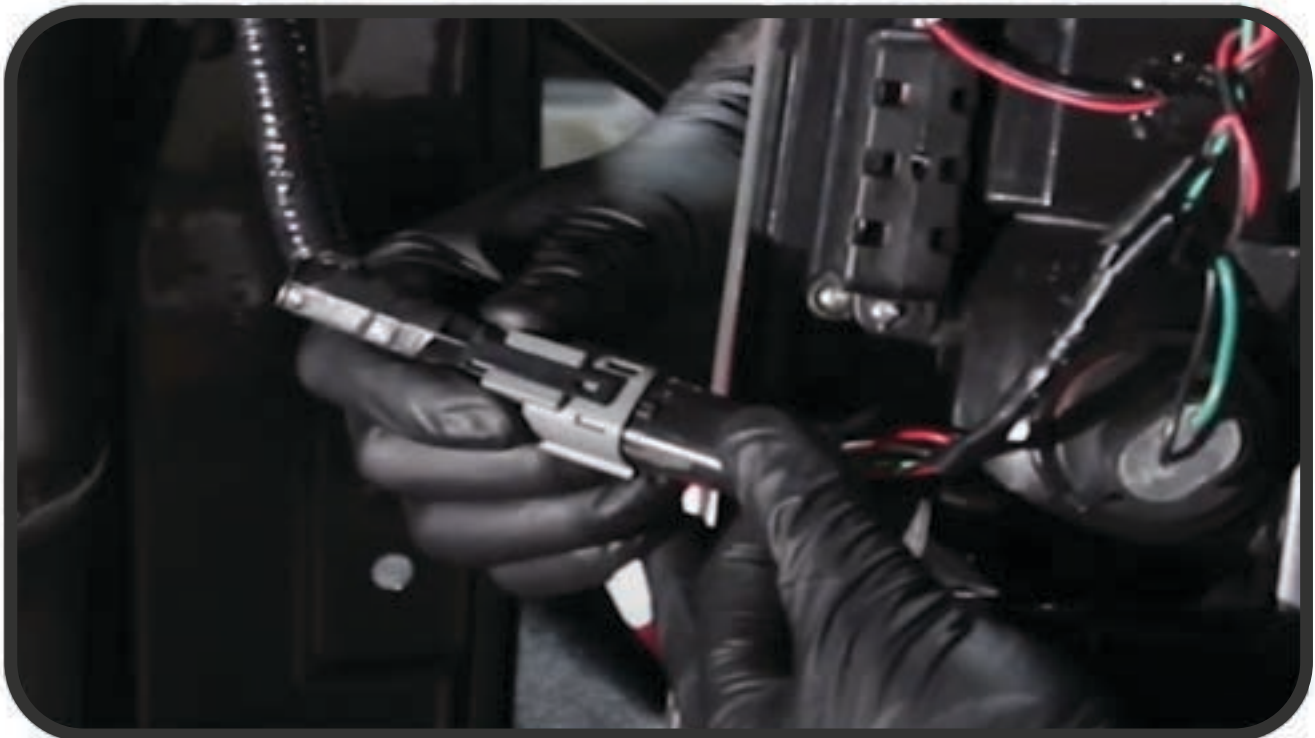
STEP 5:
CONNECT SPYDER LED TAIL LIGHT HARNESS

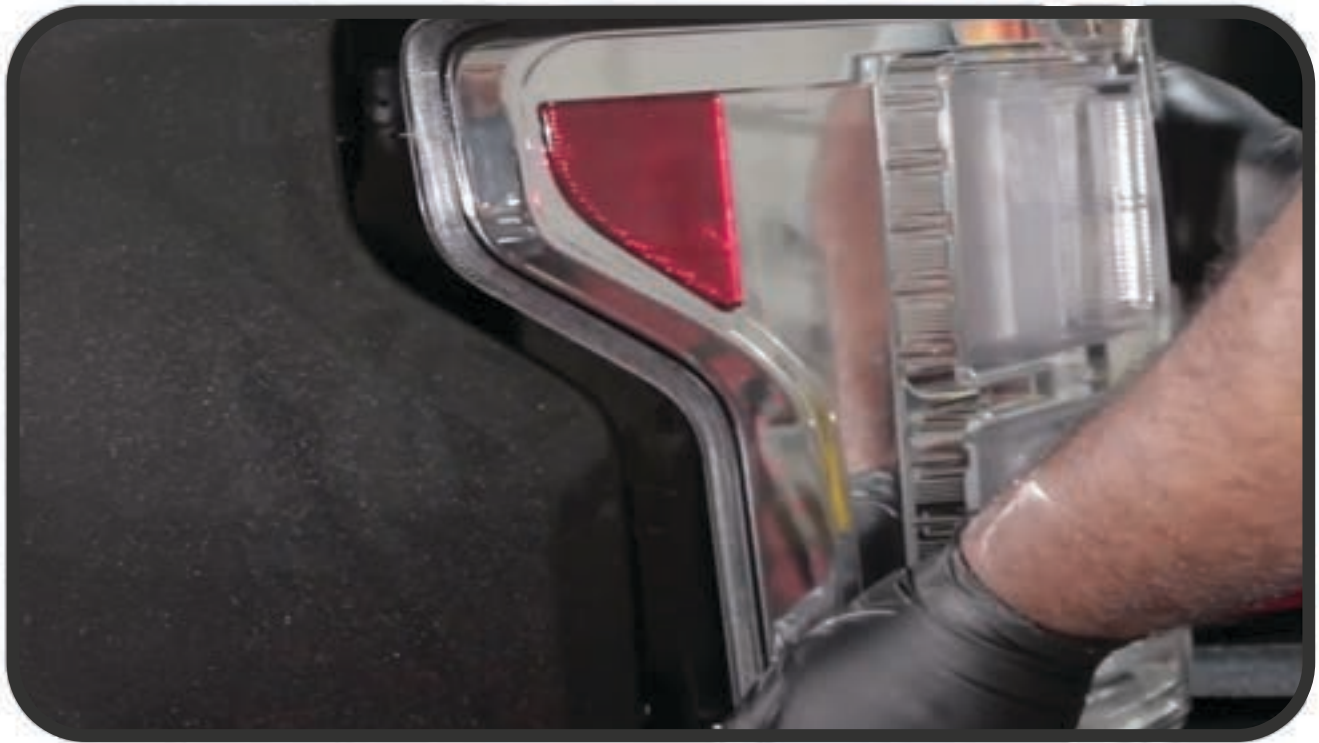
STEP 6:
SEAT SPYDER LED TAIL LIGHT ASSEMBLY IN PLACE

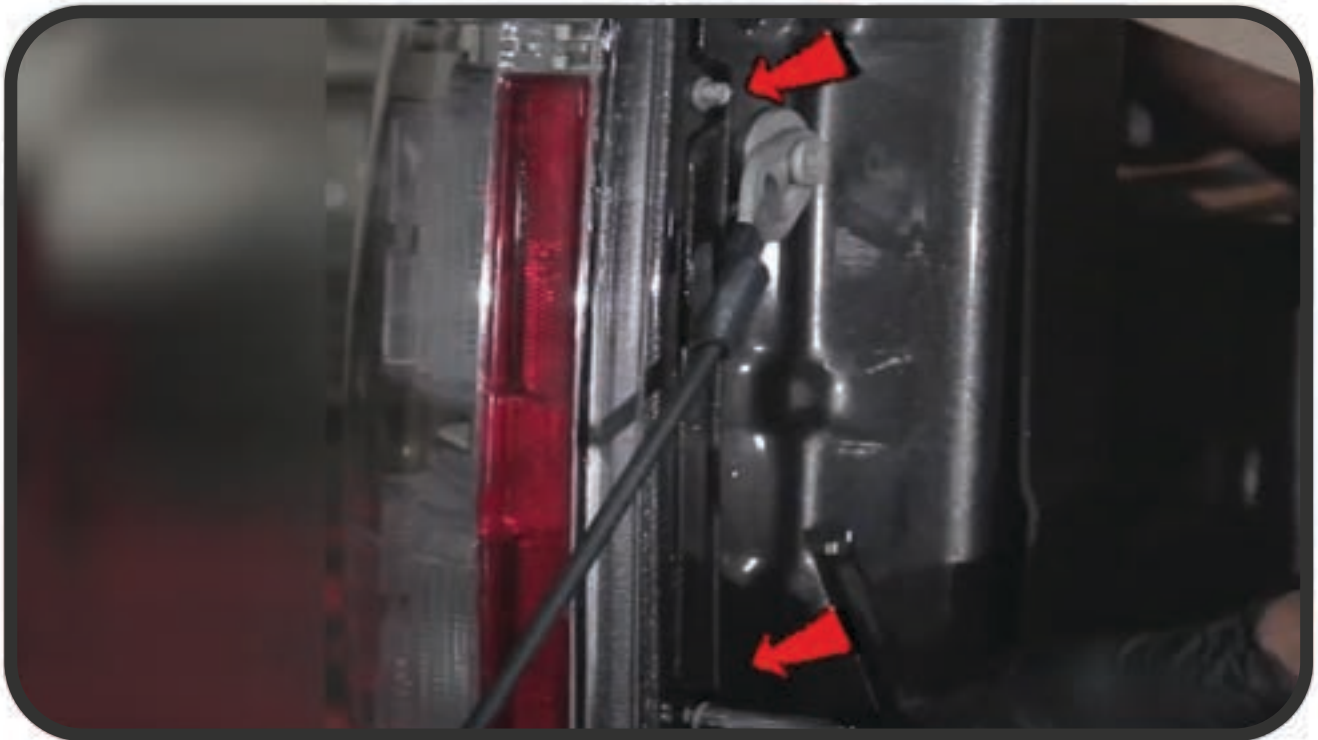
STEP 7:
REINSTALL (2) 8MM BOLTS

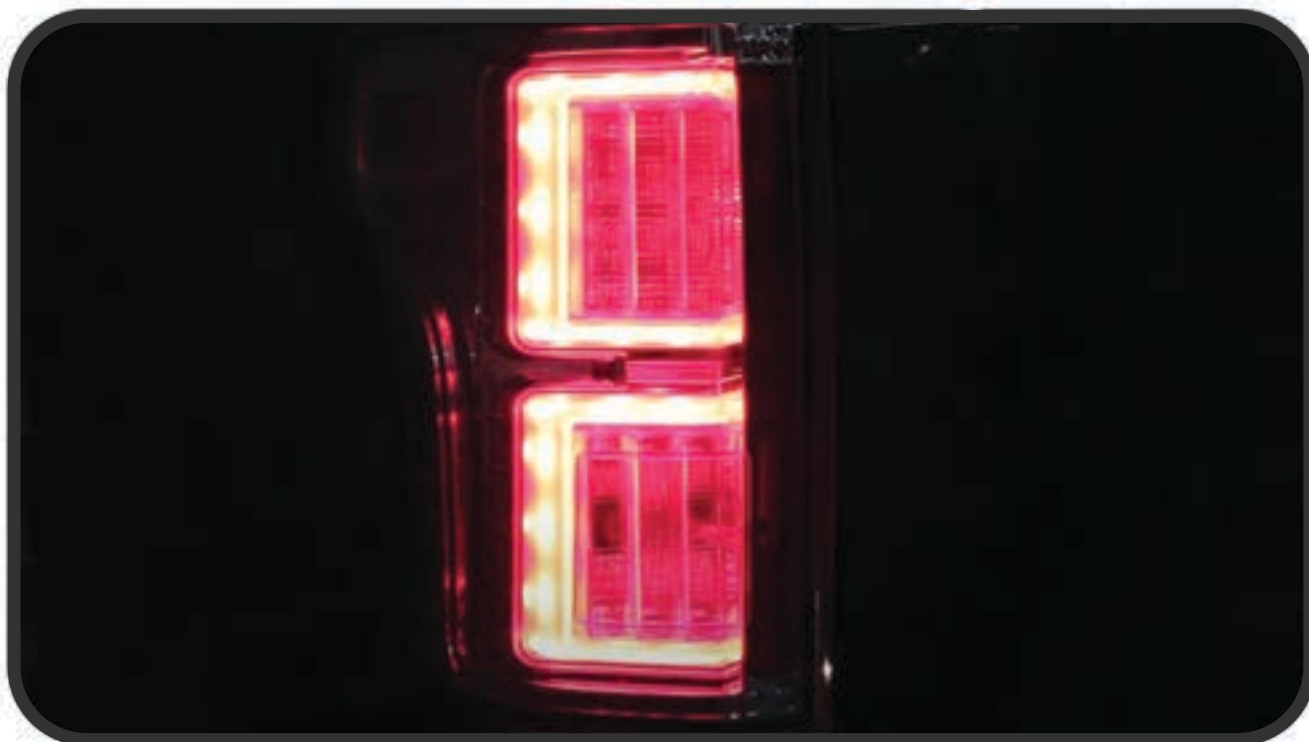
STEP 8:

RECONNECT THE BATTERY AND TEST THE FUNCTIONS TO ENSURE THEY FUNCTION PROPERLY
