Tube Clamp

Part No. G9022B

Fits: **Universal tube clamp for 2" Tube**

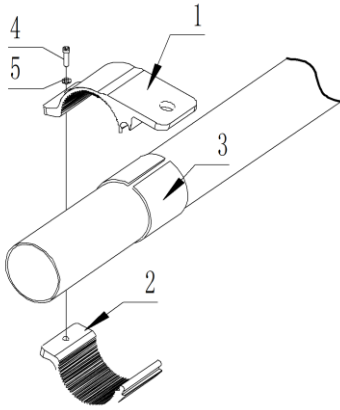
Pic1

First step : Put the plastic ring on the tube and slide the light tab to the suitable position to make it sit around the plastic rings, see Pic1.

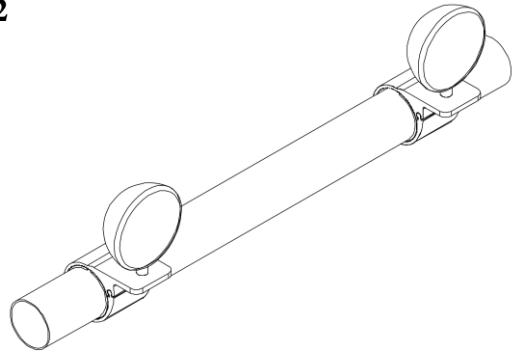
Pic2

Second step: Install the lights on the tabs see pic2.
