## ÜRO Parts Collapsible BMW Coolant Transfer Pipe

**Part# 11 14 1 439 975-PRM**

Design Revision – Eliminated rear spacer piece and changed front seal

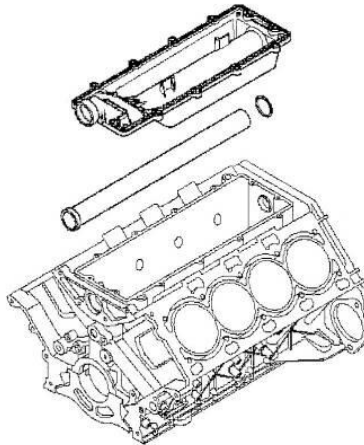
Late model BMW V8 models fitted with the N62 engine can suffer from a failure of the front seal of the water transfer feed pipe located under the intake valley pan gasket.

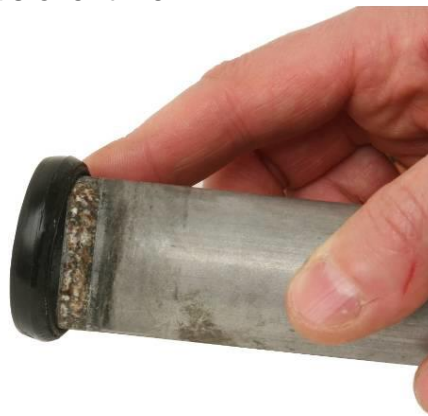
The original bonded seal fails primarily due to corrosion caused by an electro chemical reaction between the materials over time.

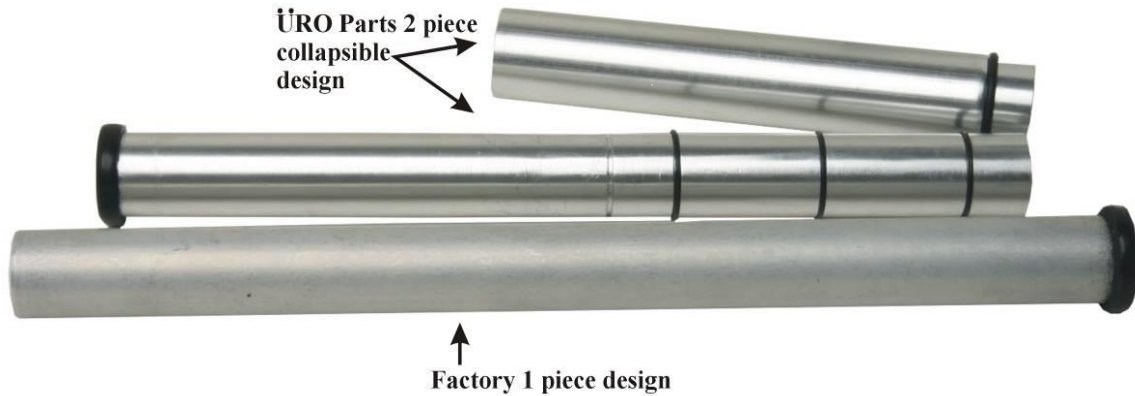
The factory design is a long tube which can only be fitted from the front of the engine with the timing cover removed; a job that can cost upwards and take over 20 hours of shop time.

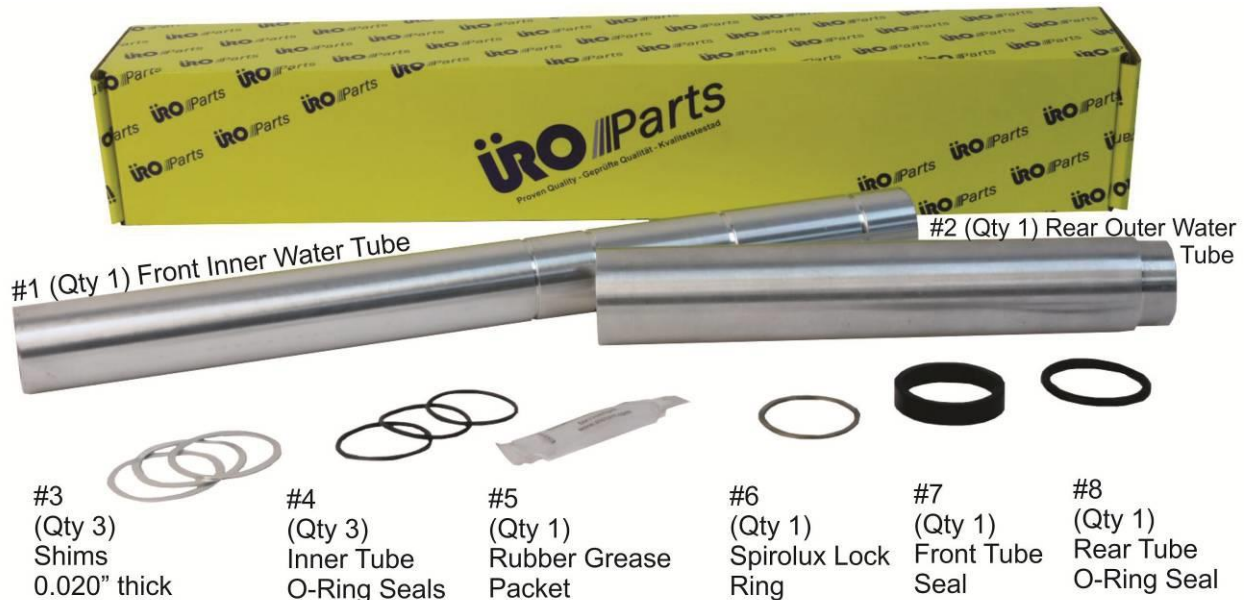
The URO Parts designed water pipe collapses allowing the same repair to be completed without removing the timing cover, saving thousands in labor costs and many hours of down time.

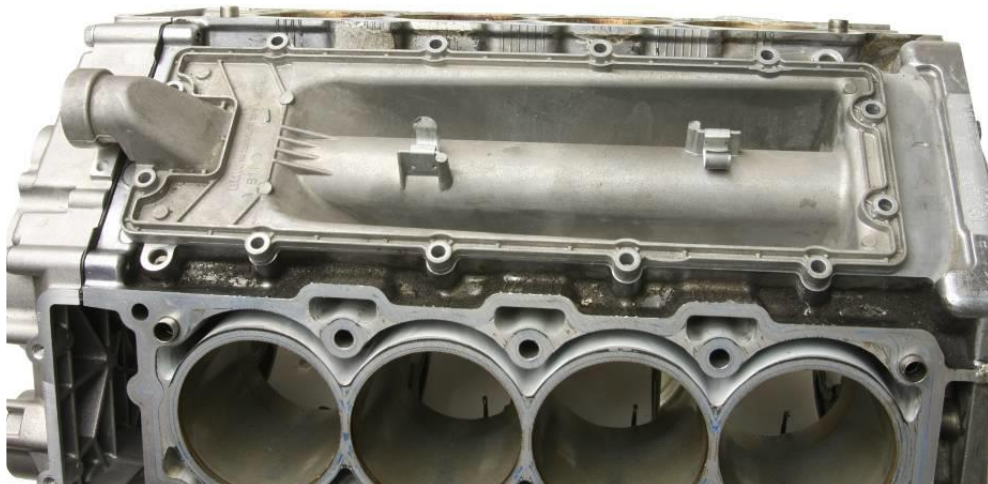
1. After draining the cooling system, remove the intake manifold and other related components to expose the intake valley pan.

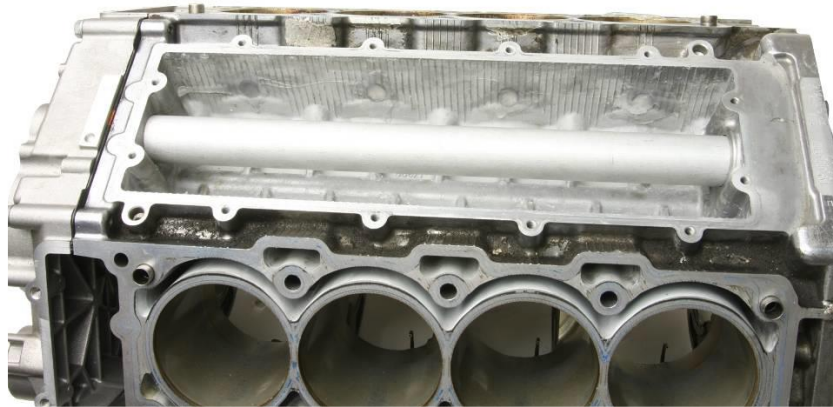
2. Remove the intake pan so the factory 1 piece coolant pipe will now be exposed.

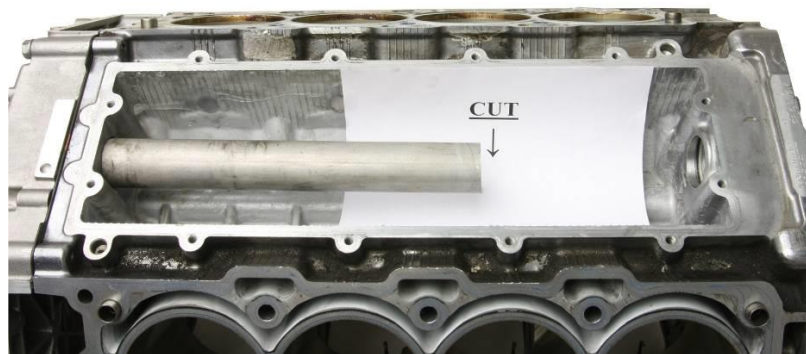
3. The existing pipe can now be cut in the center with a small air saw or cut off wheel.\*

\*Important note: Care must be taken at all times to keep debris and cuttings out of the engine.

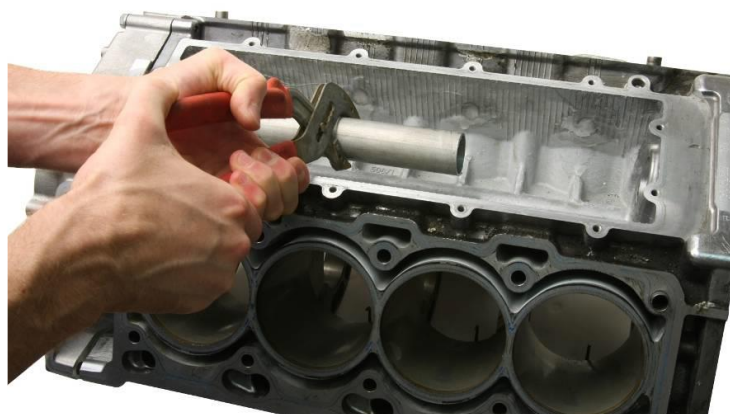
4. Remove the factory pipe in 2 pieces. The front will require some twisting or careful prying to break the bond of the front seal.

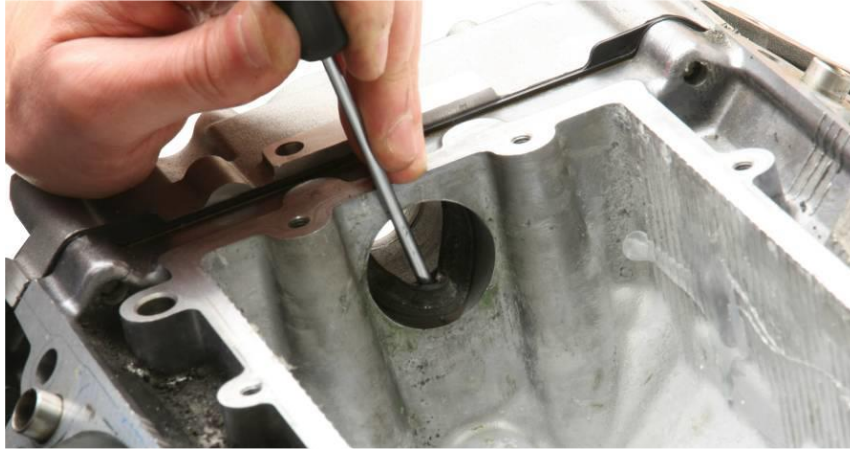
5. Remove the remaining front seal material with a pick and wire brush taking care not to damage the seal housing.

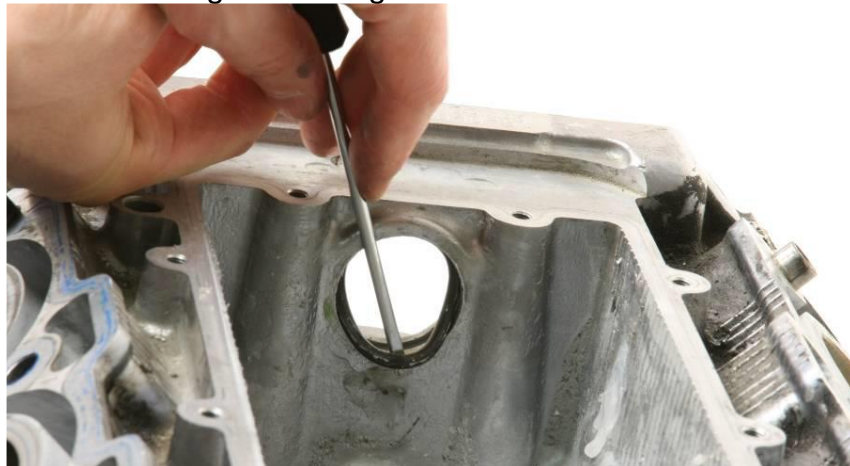
6. Remove the old rear o-ring seal taking the same care.

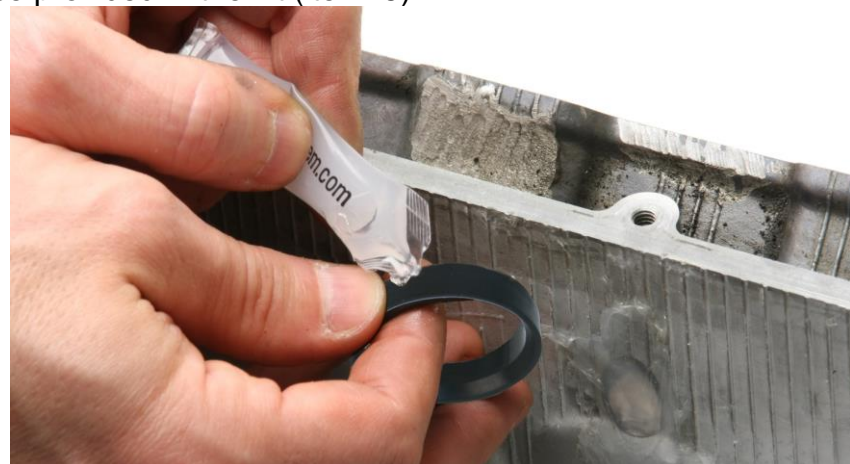
7. Carefully clean the front seal gallery. Lubricate all surfaces of the front seal liberally with the grease provided in the kit (item#5).

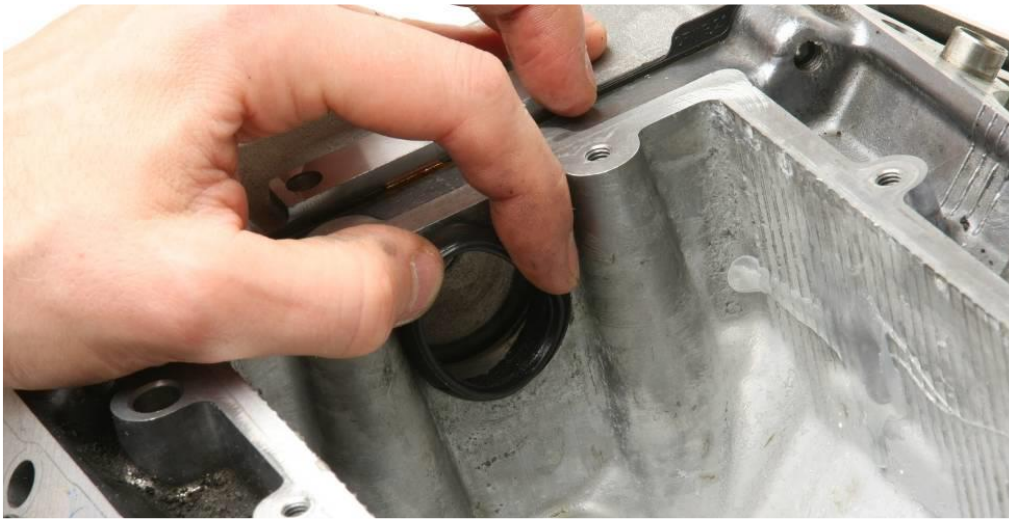
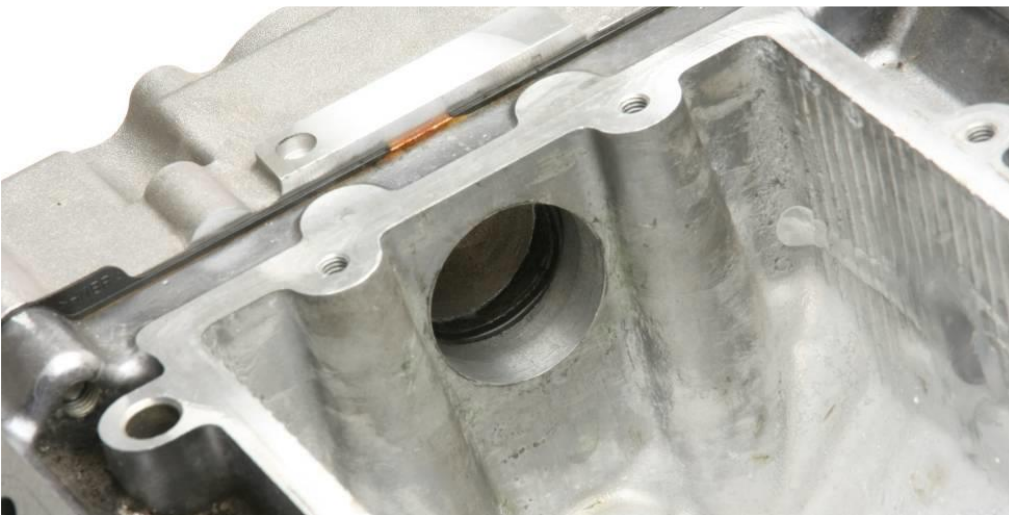
8. Fully fit front seal (item#7) into housing taking care to make sure the \*flat profile of the seal faces the timing cover (forward). (**\*this is critical to a proper installation**).

Note: Above picture shows seal installed in place.

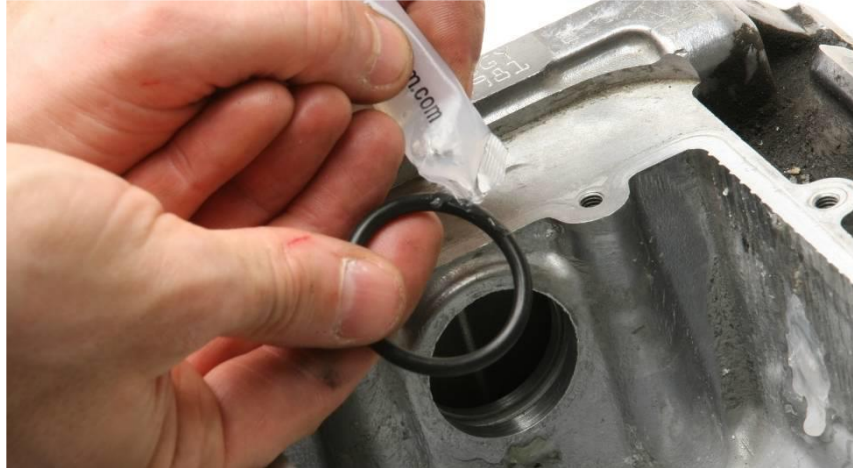
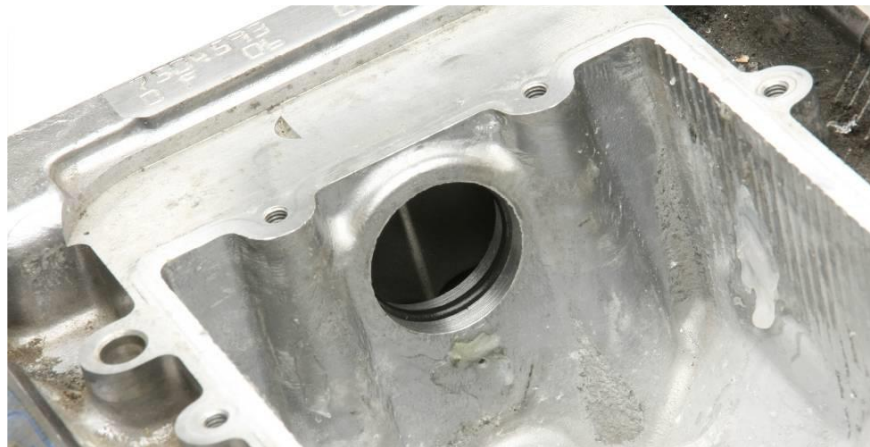
9. Perform the same lubricating and fitting operation to the rear o-ring (item #8); noting however there is no orientation necessary for this seal.

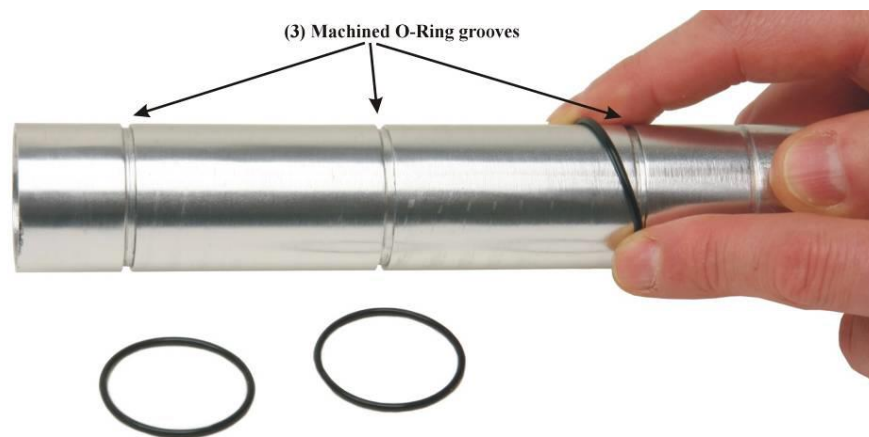
10. Fit the 3 supplied inner tube o-rings (item #4) carefully to the front tube section so each is fully seated into the machined grooves on the tube; lubricate with provided grease.

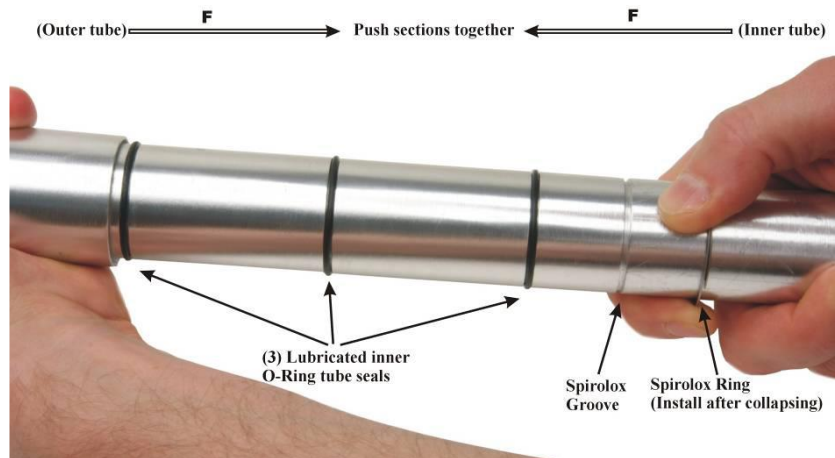
11. Fit inner (item #1) and outer tube (item #2) sections together taking care not to pinch or damage any of the pipe sealing rings & collapse completely.

Then install the spirolox (item #6) around the smaller inner tube and position it by sliding it up against the end of the larger outer tube.

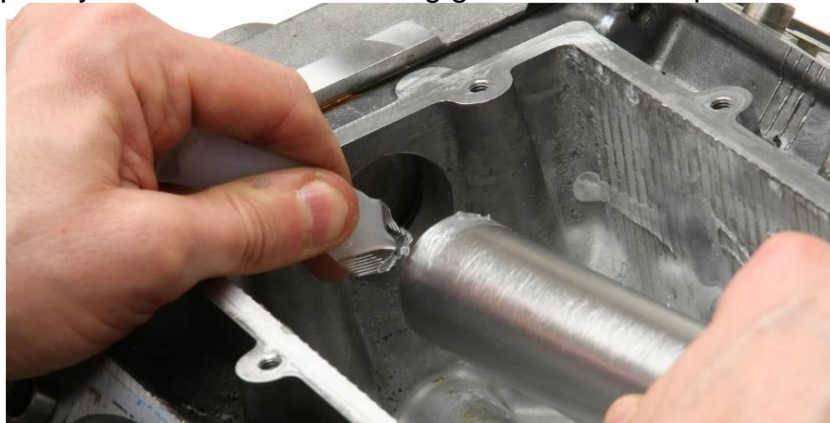
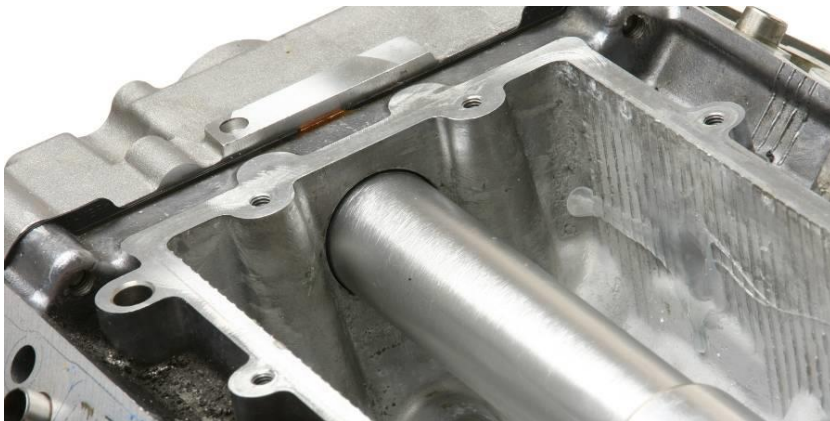
12. Taking the assembled and collapsed pipe grease the front tube (smaller diameter pipe) and fit squarely into the front seal taking great care not to pinch or damage it.

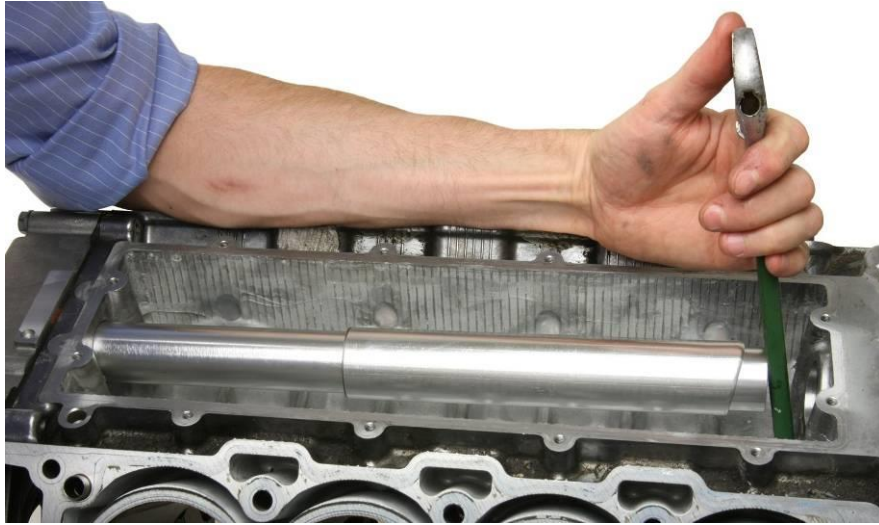
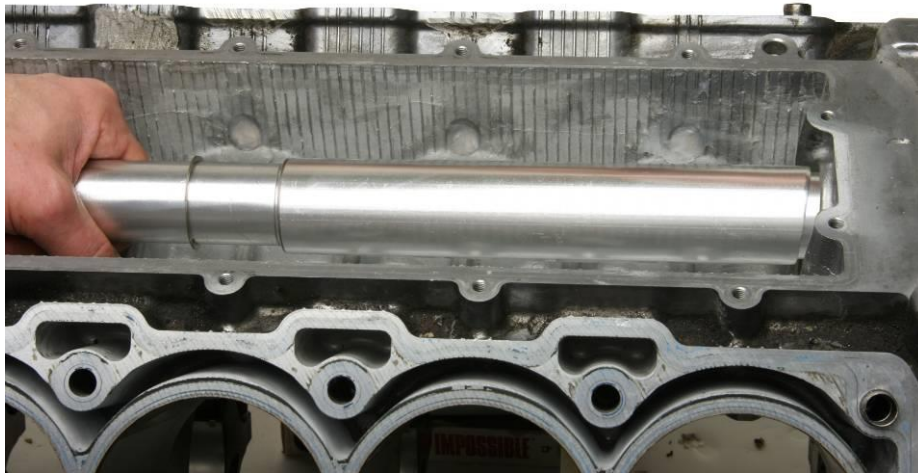
13. With a soft faced pry tool, lever the tube forward until it stops against the timing cover.

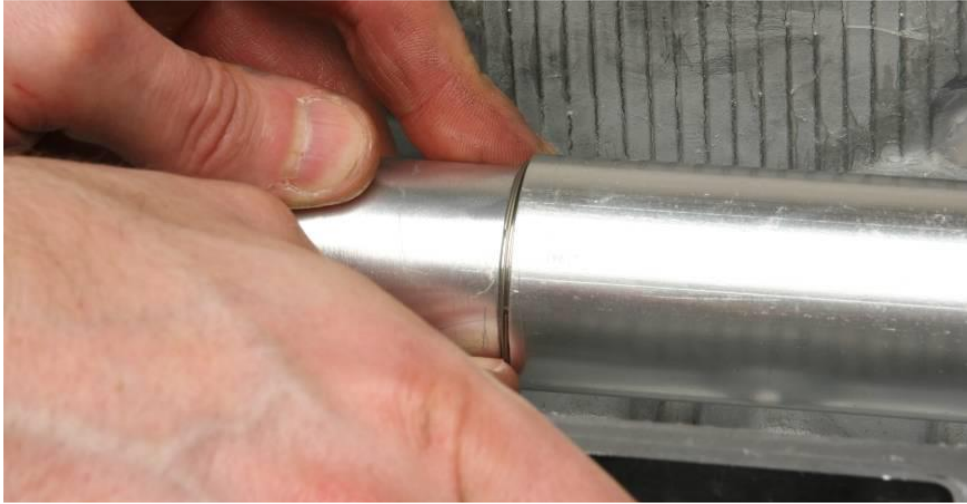
14. Grabbing both sections of the tube firmly, hold the front half in place taking care to position the rear tube with the wide angle step facing upwards. Then slide the rear section back into the block until it clicks home, exposing the Spirolux locking groove.

15. This should just expose the ring groove allowing the pre-installed locking ring to be slid forward into place.

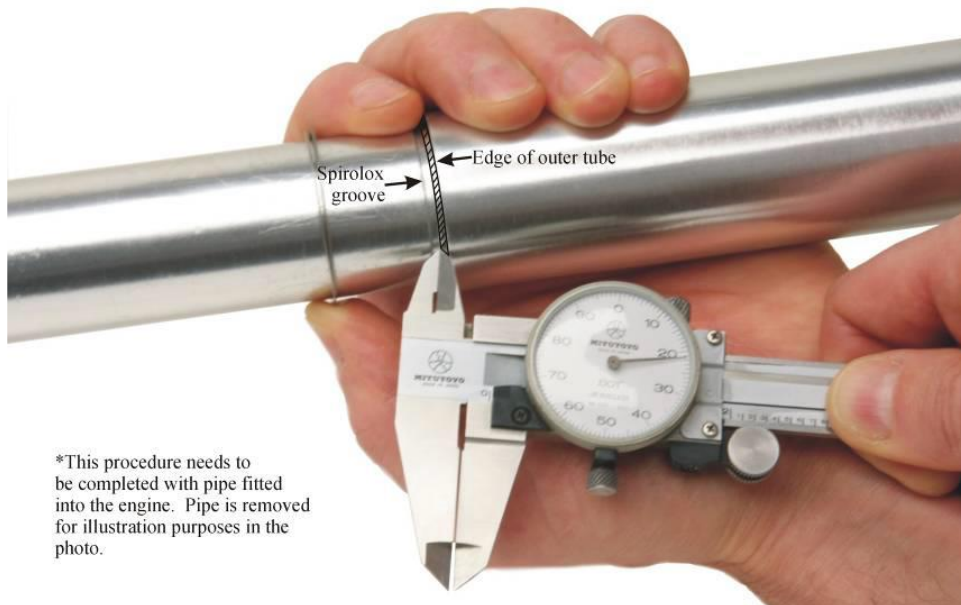
16. \*Measure the distance from the rear edge of the ring groove to the rear tube end in thousandths of an inch.

\*This procedure needs to be completed with pipe fitted into the engine. Pipe is removed for illustration purposes in the photo.

**\*Only as required:** If after fully seating the tube into the block the snap ring groove is beyond the end of the rear tube half, installation of shims will be required. Casting variations during block manufacturing may make this simple procedure necessary.

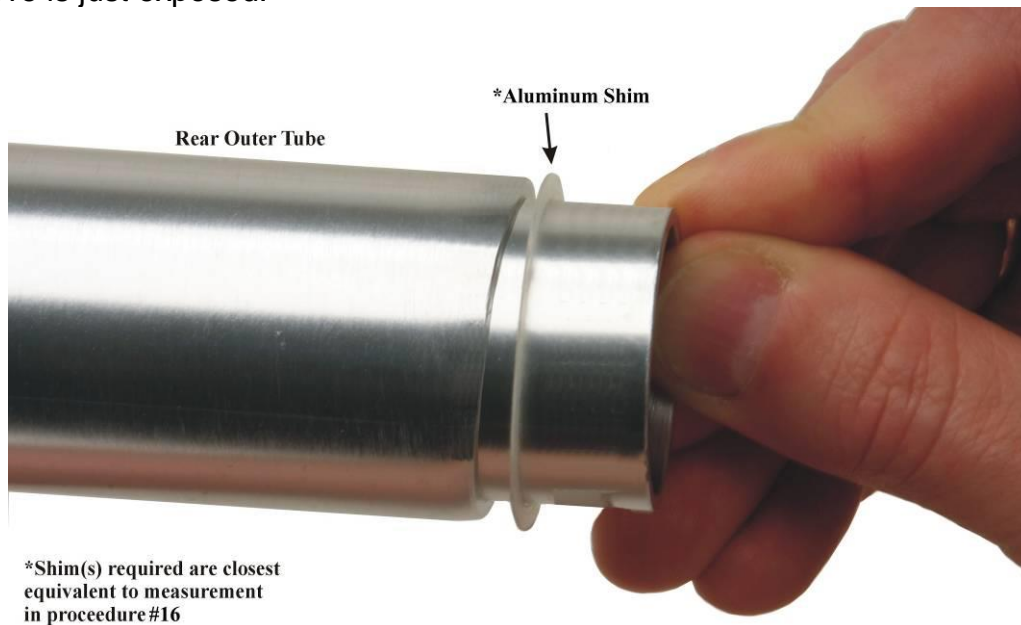
17. \*Slide rear tube section forward again, fit the appropriate shim stack (item #3) (equaling the previous measurement) and slide rear tube back into block until Spirolux ring groove is just exposed.

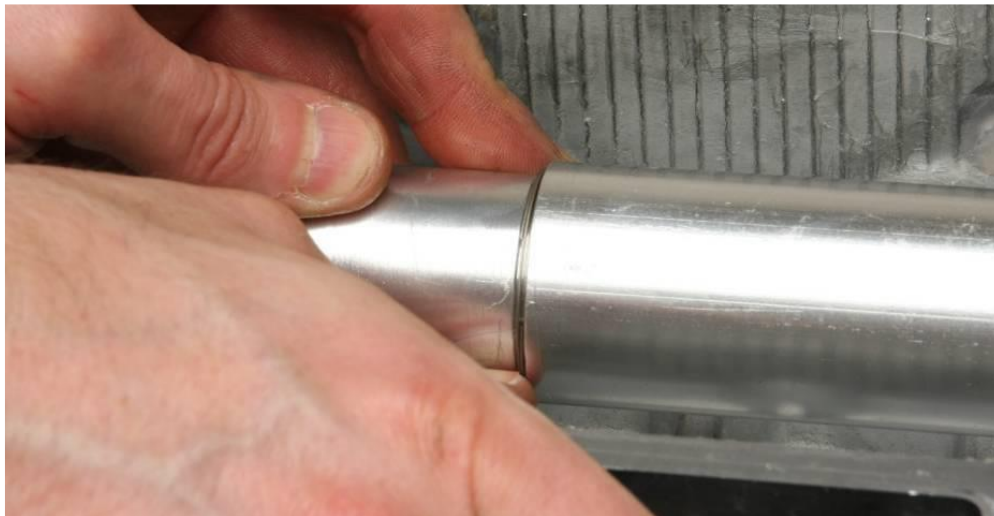
18. \*After re-seating the tube in the block the lock ring groove should now be exposed with no slop; push spiral lock ring forward into groove locking tube in place.

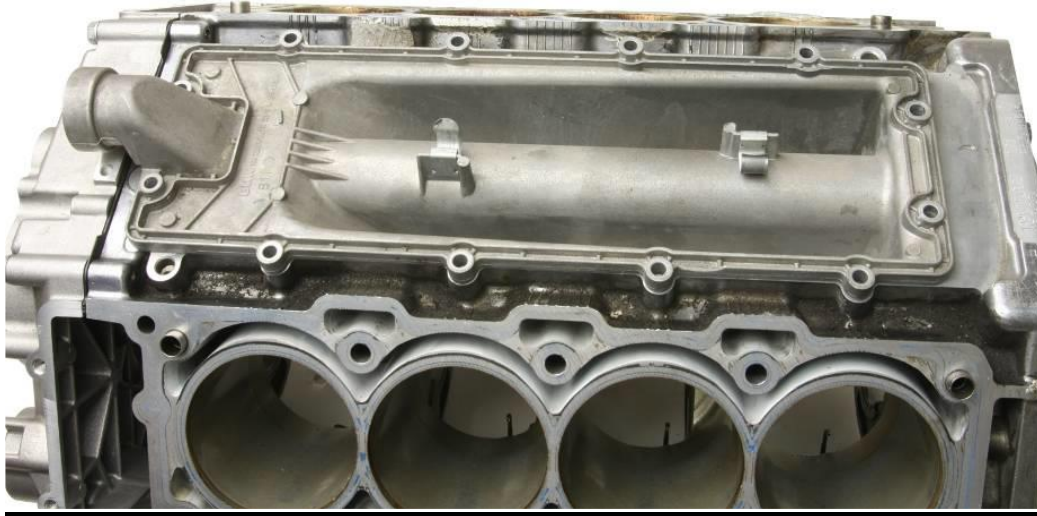
19. Fit new intake pan gasket # 11 14 7 507 278 (not provided) and reassemble per the factory workshop manual.\*

**\*Important note:** A cooling system pressure check is recommended once all the appropriate components are installed to ensure pipe was installed correctly.
