## **INSTALLATION INSTRUCTIONS**

**VGUBG-0987-1229SS**

**01-07 TOYOTA HIGHLANDER PARTS**

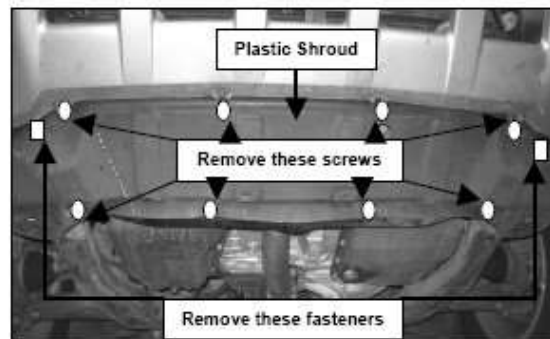
Figure 2

**2.** Carefully remove the plastic shroud underneath the vehicle by removing the  
(4) screws on top,  
(4) screws on bottom, and (1) fastener on each side (Figure 2).

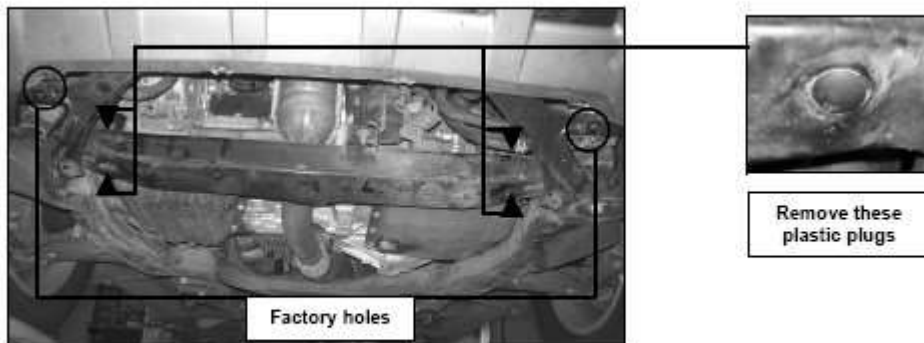
Figure 3

**3.** Remove the plastic plugs on the cross bar member. There is one on  
the passenger side and one on the driver side, top and bottom of cross  
member bar (Figure 3).

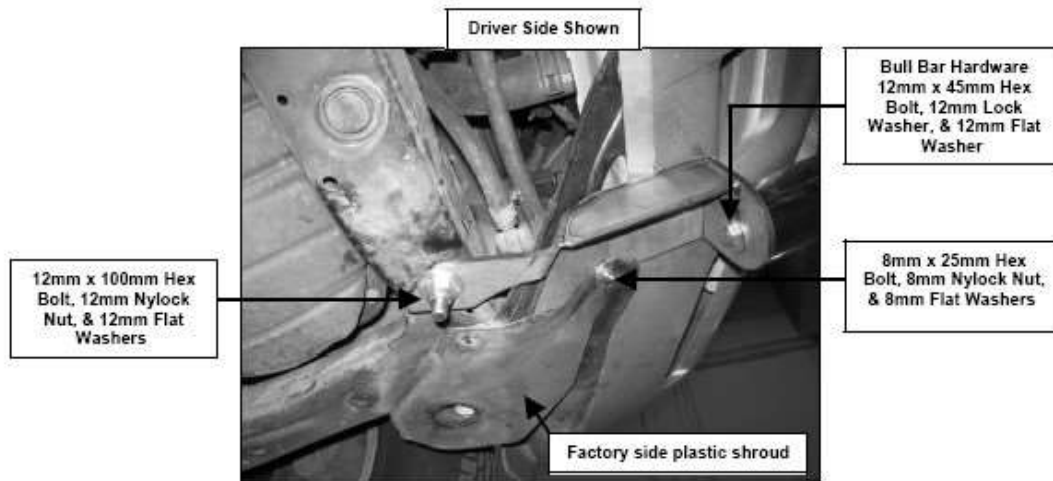
Figure 4

**4.** Position Driver Side Mounting Bracket to vehicle and align holes on  
the bracket to factory  
holes. The rear most hole to the Mounting Bracket mounts to the cross bar  
member using (1)  
12-1.75mm x 100mm Hex Head Bolt, (1) 12mm Nylock Nut, and (2) 12mm Flat  
Washers. The  
front hole on the Mounting Bracket mounts to the factory bumper support by  
using (1)  
8-1.25mm x 25mm Hex Head Bolt, (1) 8mm Nylock Nut, and (2) 8mm Flat  
Washers, use this

hardware to re-attach the side factory plastic shroud (Figure 4). **NOTE:** To ease the installation insert bolts with flat washer listed in this step through the top of the cross bar member and bumper support. Do not tighten at this time. Repeat this step for passenger side.

5. Position Bull Bar onto Mounting Brackets and loosely attach it with the included (2) 12-1.75 x 45mm Hex Head Bolts, (2) 12mm Flat Washers, and (2) 12mm Lock Washers (Figure 4).

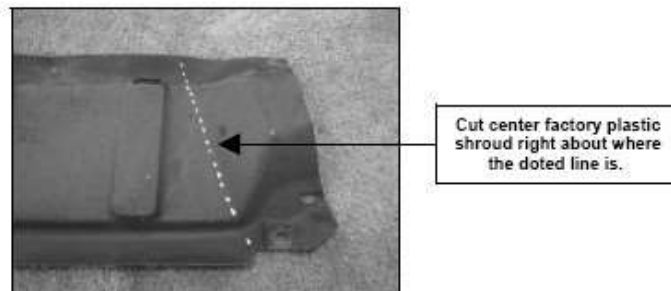
7. In order to re-install the plastic shroud, some cutting is necessary. Once the Bull Bar is fully mounted, place the center plastic shroud to its original position and mark where it needs to be cut (Figure 5). Re-install plastic shroud with factory hardware removed in step 1.
