TECHNICAL BULLETIN

PART NUMBER 22331

2004-2010 Dodge Ram
2500, 3500 5.9L, 6.7L Diesel

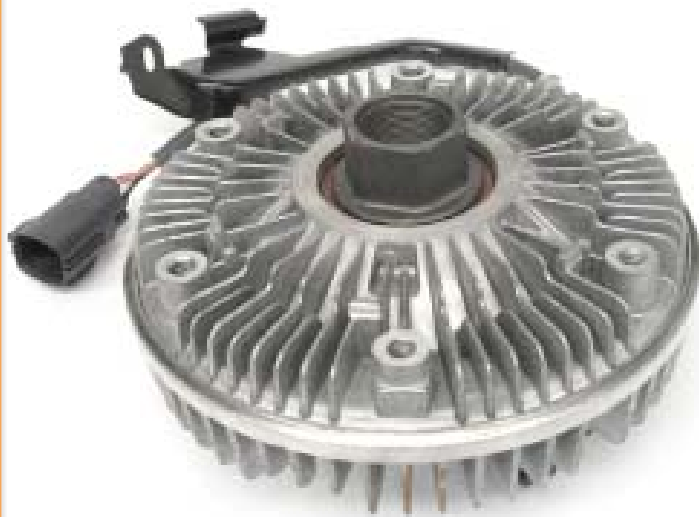
PROBLEM - Reports from the field, across all manufacturers replacement parts, including OEM, experience a high incident rate of cooling fan blades contacting the cooling fan clutch wires, resulting in damage to the fan clutch and cooling fan (fig 1-4). Usually found in higher mileage vehicles, the incidents are reported as occurring while traversing water, towing, and other high engine load conditions and at fan clutch replacement start-up or soon after. The OEM vehicle design places the fan clutch wire harness, that mounts to the fan shroud, very close to the fan blades. The fan shroud and brackets can become loose over time, causing the fan shroud to move and bring the fan clutch wires into the path of the fan blade.

SOLUTION - Inspect and secure the fan shroud and brackets before and after replacing the fan clutch (fig 7-8). Replace the fan shroud if damaged.

CAUTION - The cooling fan blades should also be inspected. Inspect for fatigue cracks, or chipped blades or any marks indicating contact with other engine compartment components. Replace fan blade assembly if any of these conditions are found.
