Subject: Brake Rotor Plate Thickness Variation

Vehicles: All Passenger Cars and Light Trucks

WINHERE

Technical Service Bulletin

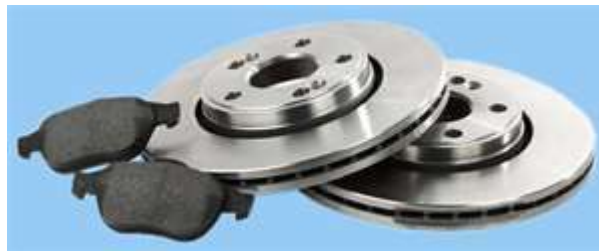
Condition: All new brake pads need to be properly “bedded-in” with the rotor braking surface, to maximize brake performance and minimize noise or vibration. The bed-in process involves a gradual buildup of heat in the rotors and the brake pad compound. Essentially it is the process of depositing an even layer of brake pad material, on the braking surface of the rotor. If the bed-in process is not performed correctly, uneven pad deposits will occur on the rotor surface and cause thickness variation. Thickness variation, in turn will lead to brake vibration (Judder or Pulsation). It only takes a small amount of thickness variation (.0051mm/ .0002”) to start a brake vibration. The vibration will not be immediately felt, but as the pad starts wearing on the high spots, more and more thickness variation will occur, until it is felt as a vibration. ***This is often misdiagnosed as a warped rotor.***

1. **30 moderate to firm (not locking wheels or causing ABS to engage) stops from 60 km/h (30 mph) down to 8 km/h (5 mph), not coming to a complete stop during entire process**
2. **Allow 30 seconds of cooling between stops**
3. **Avoid panic stops or severe braking situations for 300 kilometers (200 miles)**
