OE SOLUTIONS™

FLUID RESERVOIRS COVERAGE GUIDE

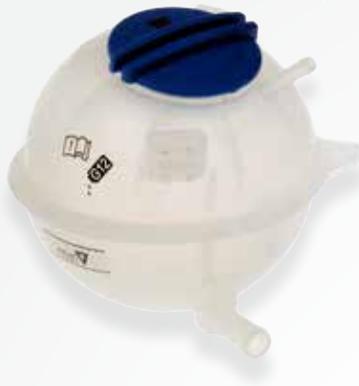
603-350
VW Beetle 2010-98

LOCATION

- Typically located along fender, in front of strut

COMMON REASON FOR FAILURE

- Crack in reservoir leading to loss of fluid and eventual engine overheating
- Cap failure (not releasing pressure or not properly attached)
- Collision damage

TECH TIPS

- Ensure fluid cools before opening cap
- Ensure level sensor is operating properly (if applicable)

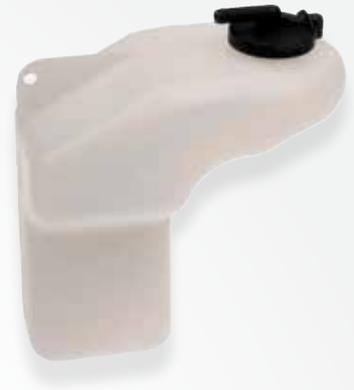
603-392
Chrysler Sebring, Dodge Stratus, 2005-01
Mitsubishi Eclipse 2005-98

LOCATION

- Located next to, or attached to radiator; or radiator fan shroud

FAILURES

- Use of fluids other than coolant fluid
- Damaged during replacement of other items (radiator, radiator fan, etc.)
- Collision damage

TECH TIPS

- Ensure radiator is operating properly
- Ensure reservoir is filled only to cold level

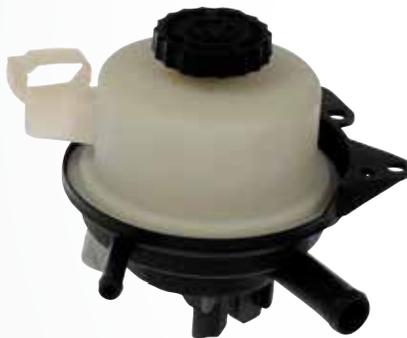
603-934
2007-01 Chrysler Caravan, Grand Caravan,
Town & Country, Voyager

LOCATION

- Typically Located behind engine, next to or attached to Power Steering Pump

COMMON REASON FOR FAILURE

- Damaged during power steering pump removal
- Where applicable, o-rings deteriorate creating bad seal
- Where applicable, screen clogs with debris prohibiting free flow of fluid
- Collision damage

TECH TIPS

- Ensure proper seal to power steering pump
- Ensure power steering pump is operating correctly

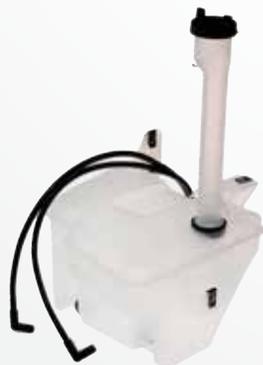
603-159
Ford Explorer 2010-02, Lincoln Aviator 2005-03,
Mercury Mountaineer 2010-02

LOCATION

- Typically located behind one of the headlights

COMMON REASON FOR FAILURE

- Use of fluids other than wiper fluid
- Road debris puncturing bottle
- Cap may be cracked, missing or improvised as a result of regular DIY fluid maintenance
- Collision damage

TECH TIPS

- Always use Windshield Wiper Fluid. Water expands when frozen and may crack reservoir.
- Some installations may require wheel and wheel well liner removal
