INSTRUCTION MANUAL
CAT-BACK STAINLESS SINGLE EXHAUST
CHEVY TRUCK 3502/4WD
1990 454 2WD
STANDARD CAB, SHORT BED
PART # 615571

EXHAUST INSTALLATION PART #615571

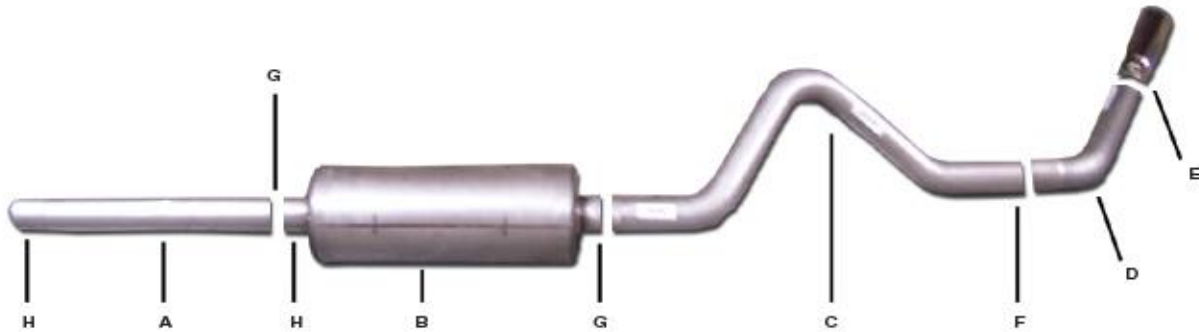
ITEM	PART #	QUANTITY	DESCRIPTION
A	136-500450S	1	3" STAINLESS HEADPIPE
B	420887	1	3" SUPERFLOW STAINLESS MUFFLER
C	130-50030RS-C	1	3" OVERAXLE STAINLESS TAILPIPE
D	117-50032RS	1	3" TURNOUT STAINLESS PIPE
E	500360	1	3-1/2" STAINLESSS STEEL TIP
F	500033	1	O.E HANGER W/CLAMP
G	500551	2	O.E HANGER W/ANGLE BRACKET
H	OHD300	1	3" CLAMP

SLIP FIT CONVERTER

1. Lay out the GIBSON EXHAUST SYSTEM on the floor so it looks like the drawing.
2. Raise vehicle and support with stands. Remove stock hangers leaving all rubber mounting grommets in place. Cut stock tailpipe for easy removal.

3. Connect head pipe #A behind the stock converter. Use jack stands to support converter, so it won't drop and connect with clamp #H.
4. Connect muffler #B with inlet towards the converter to the head pipe. Use a jack stand to support the muffler and connect clamp using hanger #G. DO NOT TIGHTEN. Muffler inlet is looking into louvers.

5. Install the over axle tailpipe #C, connect to the muffler and clamp using hanger #G.
6. Connect turnout exit pipe #D to the rear of overaxle pipe. Roll turnout pipe until you have it at the correct angle for your truck and connect clamp using hanger #F.

7. Install stainless steel tip. Clamp down. To clean stainless tip use a scott brite pad and any stainless steel or aluminum cleaner.
8. When you have everything in place, firmly tighten all bolts and clamp down securely.
