PART #	DESCRIPTION
217802CP	14-UP RAM 2500 2.5" FRONT 2.5 VS RR CDCV SHOCKS

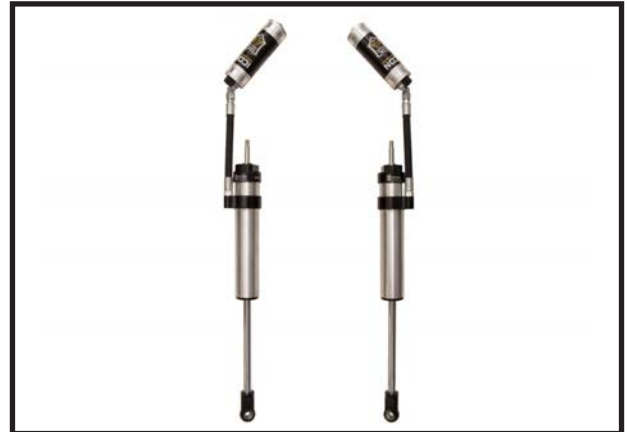
2. THE DRIVER SIDE SHOCK IS SHOWN ON THE RIGHT SIDE IN THE PHOTO.

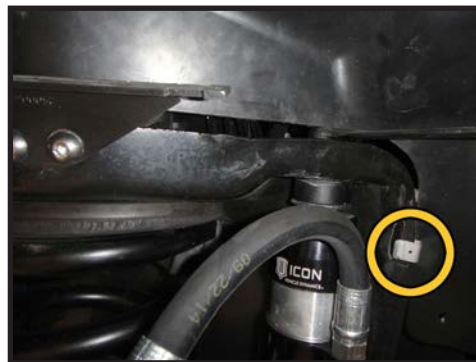
FIG.1

- Using a properly rated jack, raise the front of the vehicle and support the frame rails with jack stands. Ensure the jack stands are secure and set properly before lowering the jack. NEVER WORK UNDER AN UNSUPPORTED VEHICLE.
- Support the front axle with a jack and remove the driver side and passenger side front shocks using a 21mm socket/wrench for the lower shock mount and 19mm socket/wrench for the stem.
- Install the shock using the (254200) stem washer on the stem, followed by a (255200) bushing and then inserting the shock stem into the factory mount. Install the supplied (255200) 9/16" bushing and then a (254200) washer on top of the bushing followed by the taller m12 nut. Install the nut only a few turns so the upper assembly is loose. (FIGURE 1)

NOTE: Take care not to wedge the reservoir hose against the clip referenced in (FIGURE 1) as it will cut the hose casing.

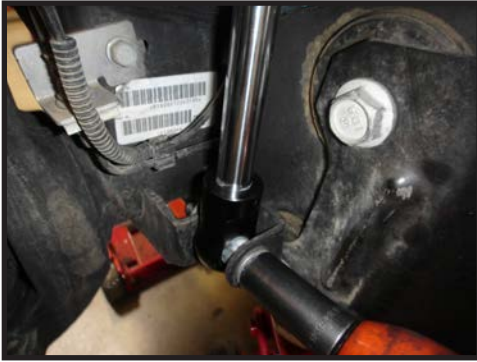
FIG.2

4. With the upper assembly loose, line up the shock in the lower mount using the jack to position the axle at the right height to install the factory lower shock bolt with a 21mm socket/wrench. [Torque to factory spec] (FIGURE 2)

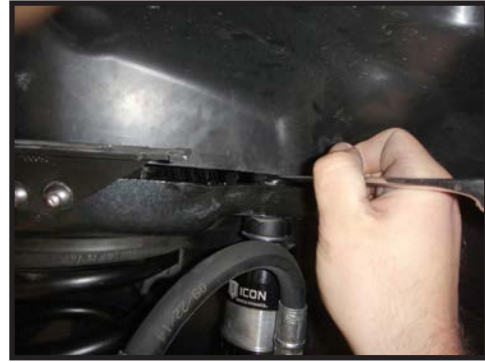
FIG.3

5. Fasten the supplied (605810) large nut until 2-3 threads are showing and then install the supplied (605809) thin jam nut to lock it against the tall nut. [Torque the jam nut to 50ft-lbs] (FIGURE 3)

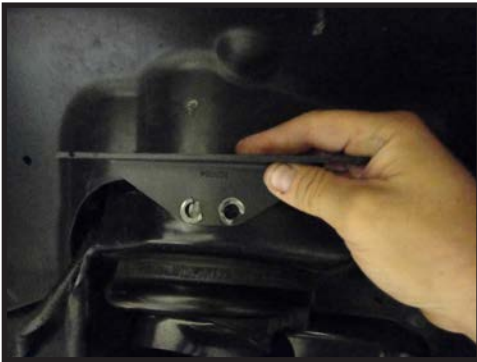
FIG.4

6. Locate the reservoir bracket and clamp it to the coil bucket to mark the two holes that need to be drilled. (FIGURE 4)

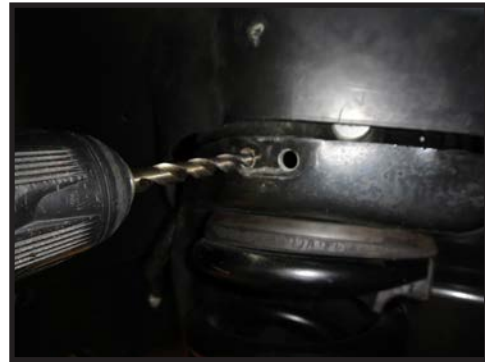
FIG.5

7. Remove the bracket and protect the backside of where you will be drilling thru. Drill two holes with a 7/16" drill bit. (FIGURE 5)

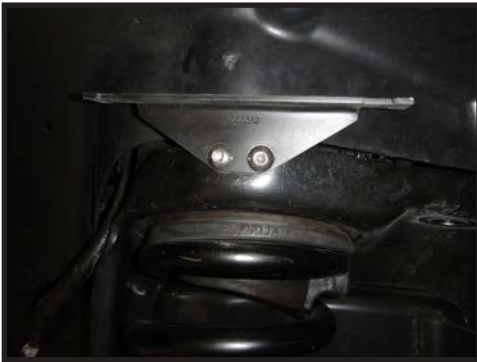
FIG.6

9. Install the bracket with supplied 3/8" button head screws, washers and lock nuts. Use a 7/32" allen wrench and 9/16" socket/wrench to tighten. [Torque to 30 ft-lbs] (FIGURE 6)

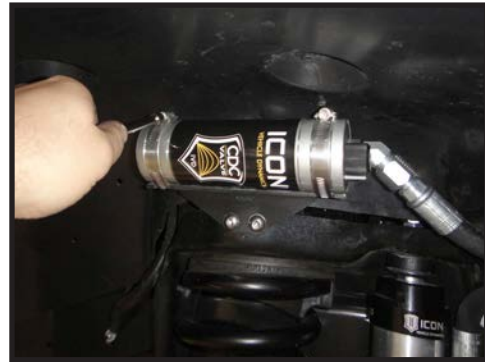
FIG.7

10. Attach the reservoir to the bracket using the supplied hose clamps and a 5/16" nut driver. Roll the reservoir into the clamps to roll the hose inward, this will make the compression adjuster knob more accessible. (FIGURE 7)
