WARNING! WARNING!

Are You Really Getting What You're Paying For?

“Airing” Our Grievance: Why More Air is a Problem

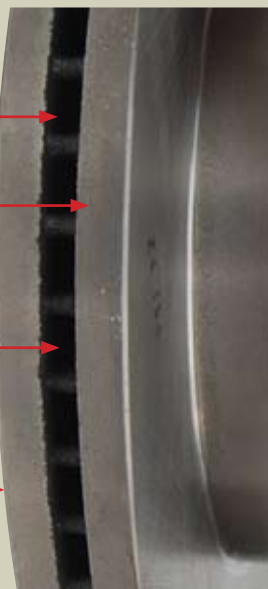
RAYBESTOS® ROTOR

AIR GAP MATCHES OE

Properly dissipates and absorbs the heat

PLATE MATCHES OE

Maximum rotor life; can be machined; resistant to premature “warping”

VANE SIZE MATCHES OE

Maximized cooling and proper harmonic design reduces brake noise

MATERIAL MATCHES

OE SPECIFICATIONS (G3000)

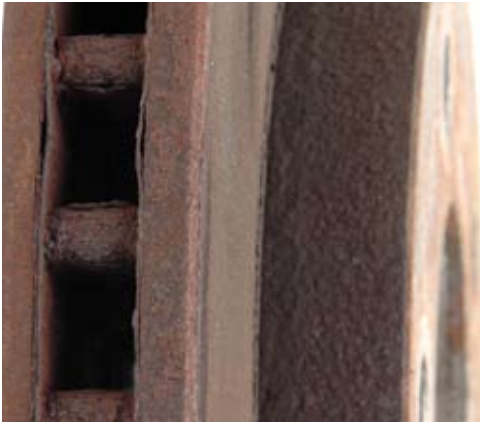
ROTOR WITH SEVERE RUST IN THE VANES

In severe climate conditions where rust is prevalent and vane dimensions have been reduced, the deterioration rate of the vanes can be accelerated with exposure to salt or calcium chloride commonly used in winter road conditions. Such conditions, combined with reduced vane sizes, can seriously reduce rotor life while simultaneously increasing the potential for failure.

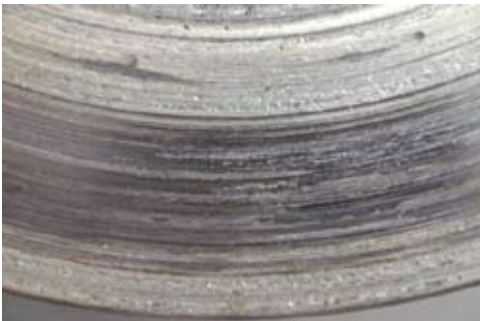
In a braking system, Raybestos® brand rotors act as a conduit to dissipate heat. Brake pads are designed to perform best at optimal temperatures. As rotor dimensions and materials vary from Original Equipment specifications, brake pad performance is directly impacted by heat. Overheating of the brake system causes brake pads to have excessive and premature wear, friction material transfer, an unresponsive pedal caused by brake fade and the potential for significant increase in noise and poor brake performance.

BRAKE PAD WEAR/FAILURE AND ROTOR SCORCHING

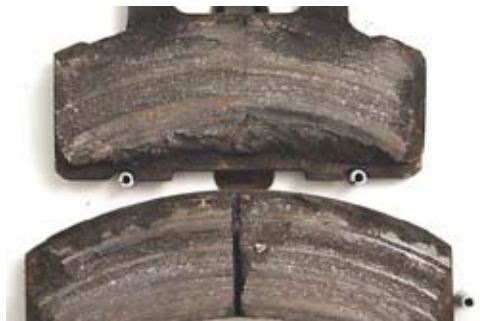
Brake noise or squealing is most often associated with brake pads, but by increasing the air gap, changing the vane configuration, reducing the weight and changing the material (to take cost out)....the harmonics of the rotor have been changed from the OE design and as a result, the “lightweight” competitors product will be significantly more noisy!
