# SPYDER™

## SKU# 5001412

### FITMENT:

- 2004-2013 CHEVY COLORADO
- 2004-2013 GMC CANYON

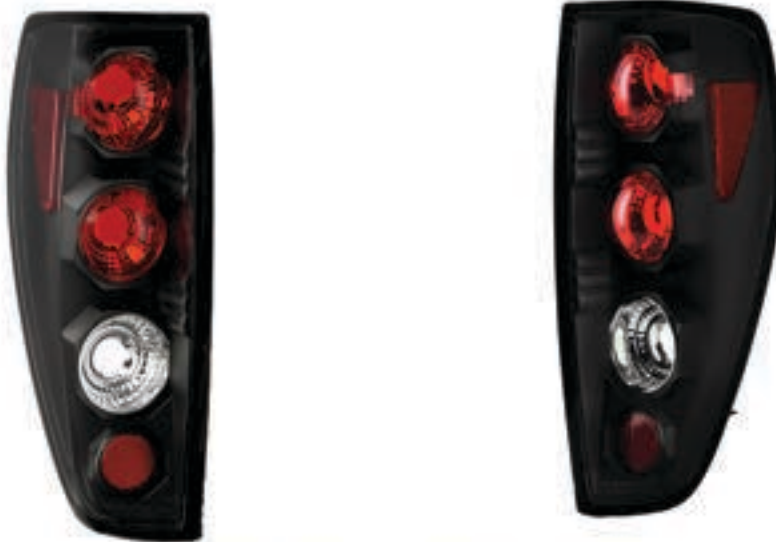
### PACKAGE CONTENTS:

• 2X TAIL LIGHT ASSEMBLIES

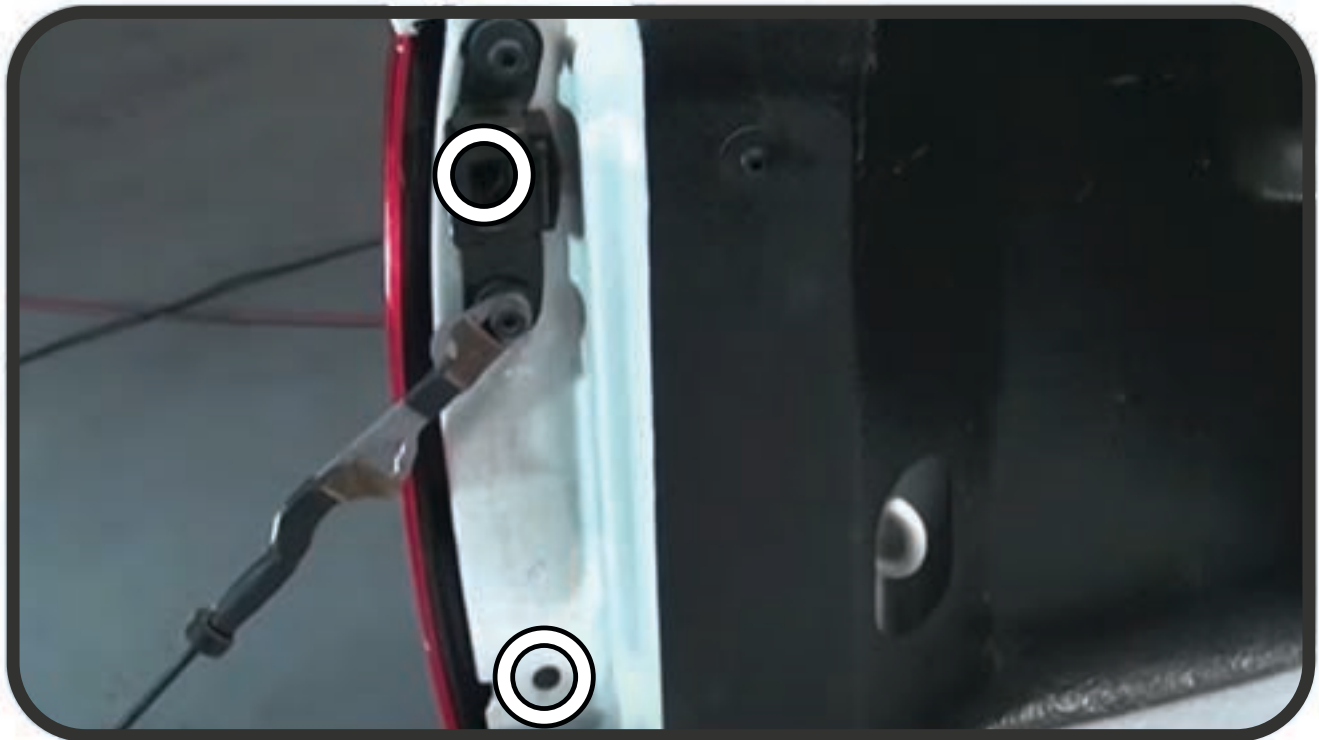
**STEP 2:**  
REMOVE (2) PHILLIPS SCREWS

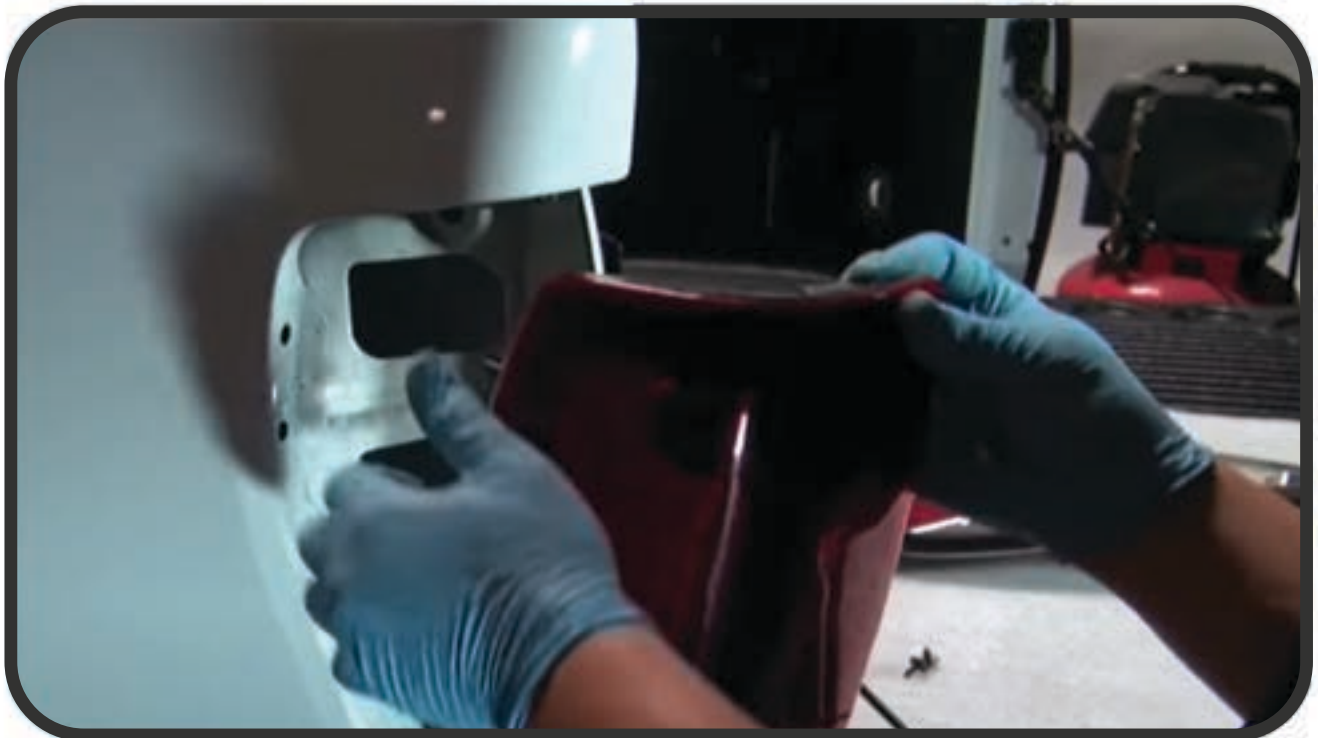
**STEP 3:**  
UNSEAT TAIL LIGHT

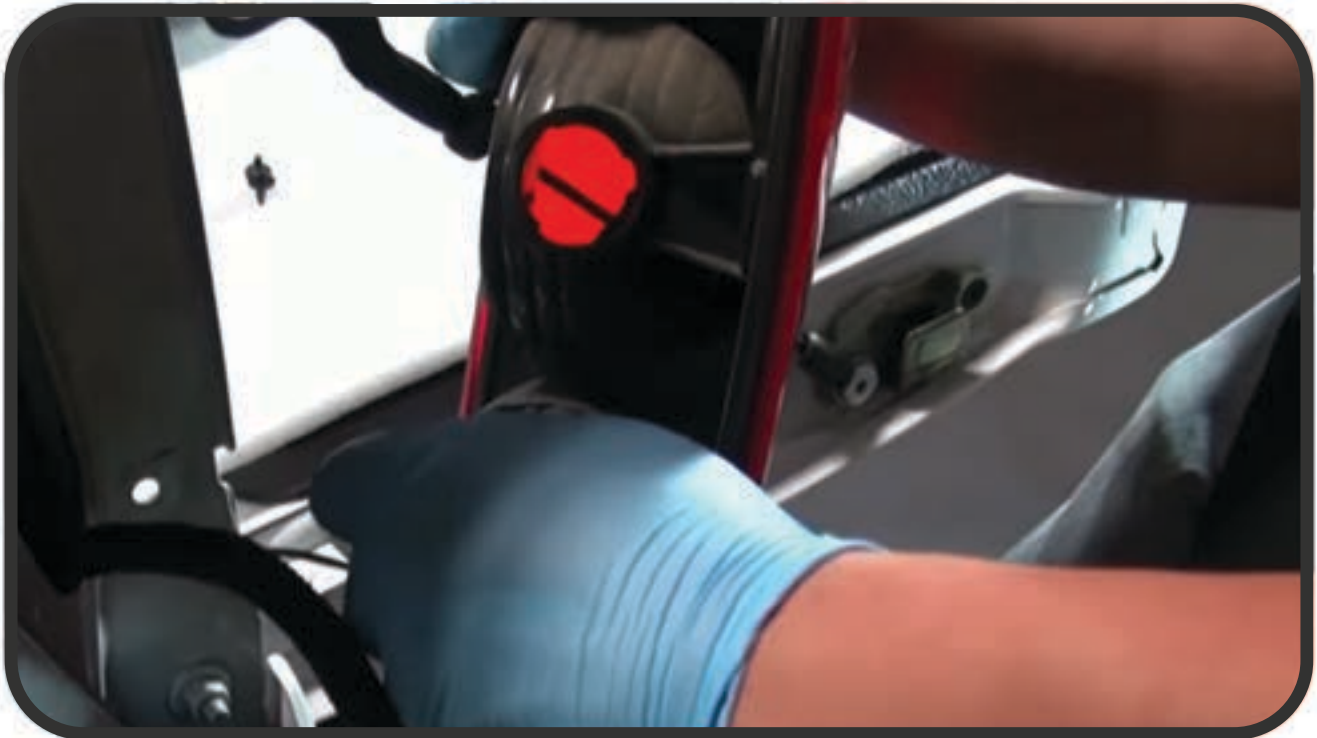
**STEP 4:**  
**REMOVE (3) BULB SOCKETS FROM THE TAIL LIGHT**  
**(NOTE: NEVER TOUCH BULBS WITH BARE HANDS)**

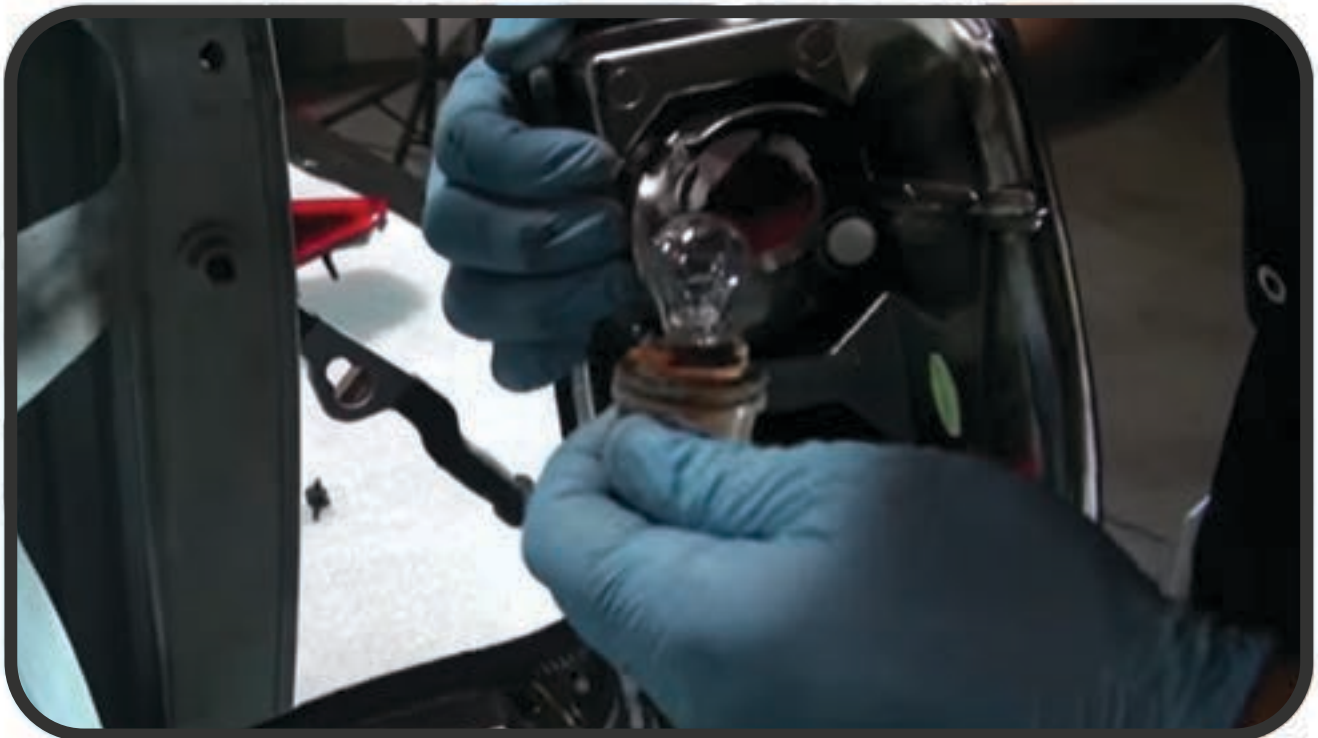
**STEP 5:**  
**INSTALL THE (3) BULB SOCKETS INTO SPYDER TAIL LIGHT**

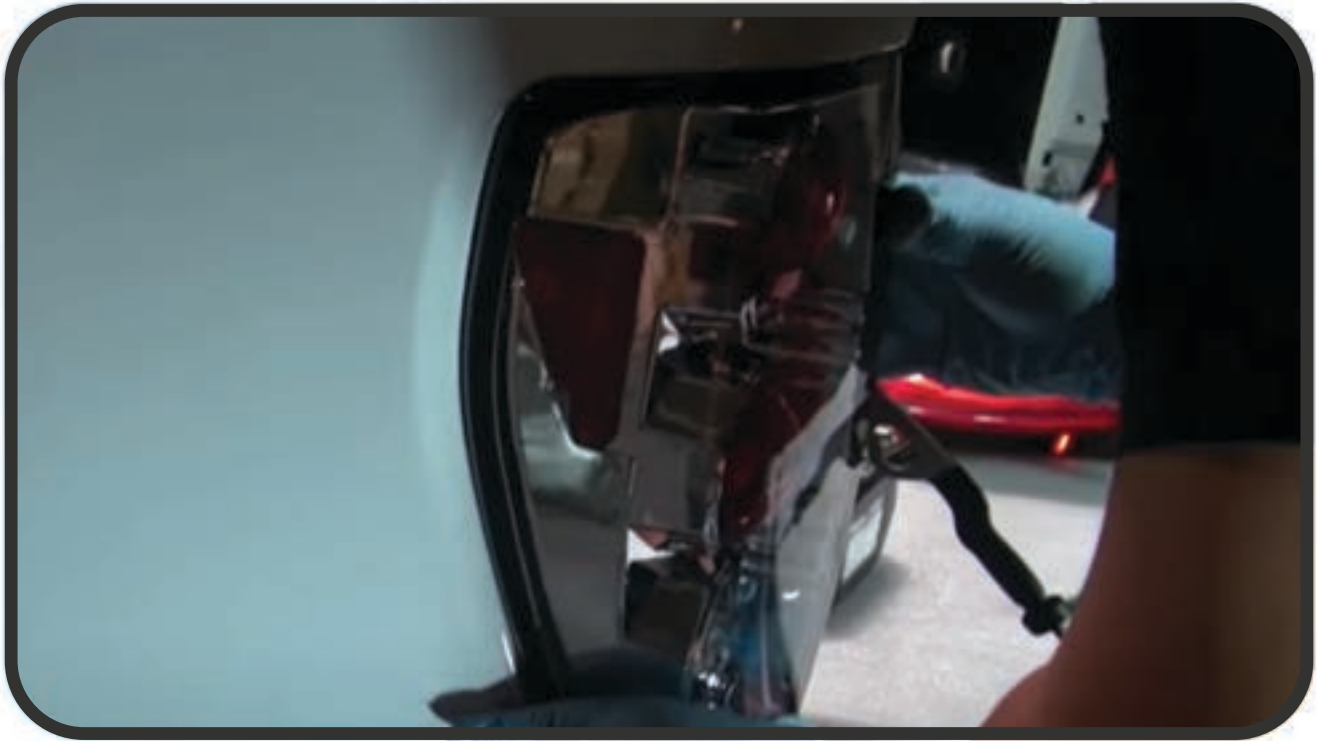
**STEP 6:**  
**SEAT SPYDER TAIL LIGHT MAKING SURE NOT TO PINCH THE HARNESS**

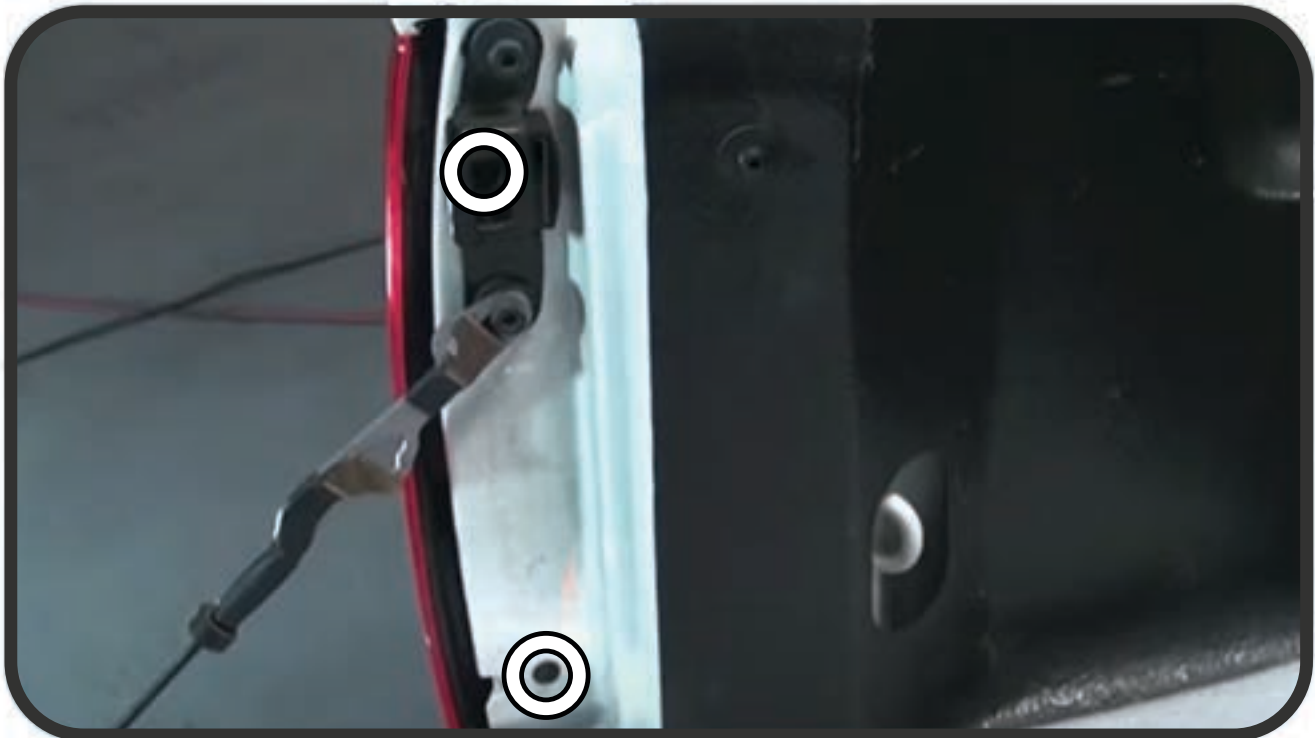
**STEP 7:**  
**REINSTALL THE (2) PHILLIPS SCREWS**

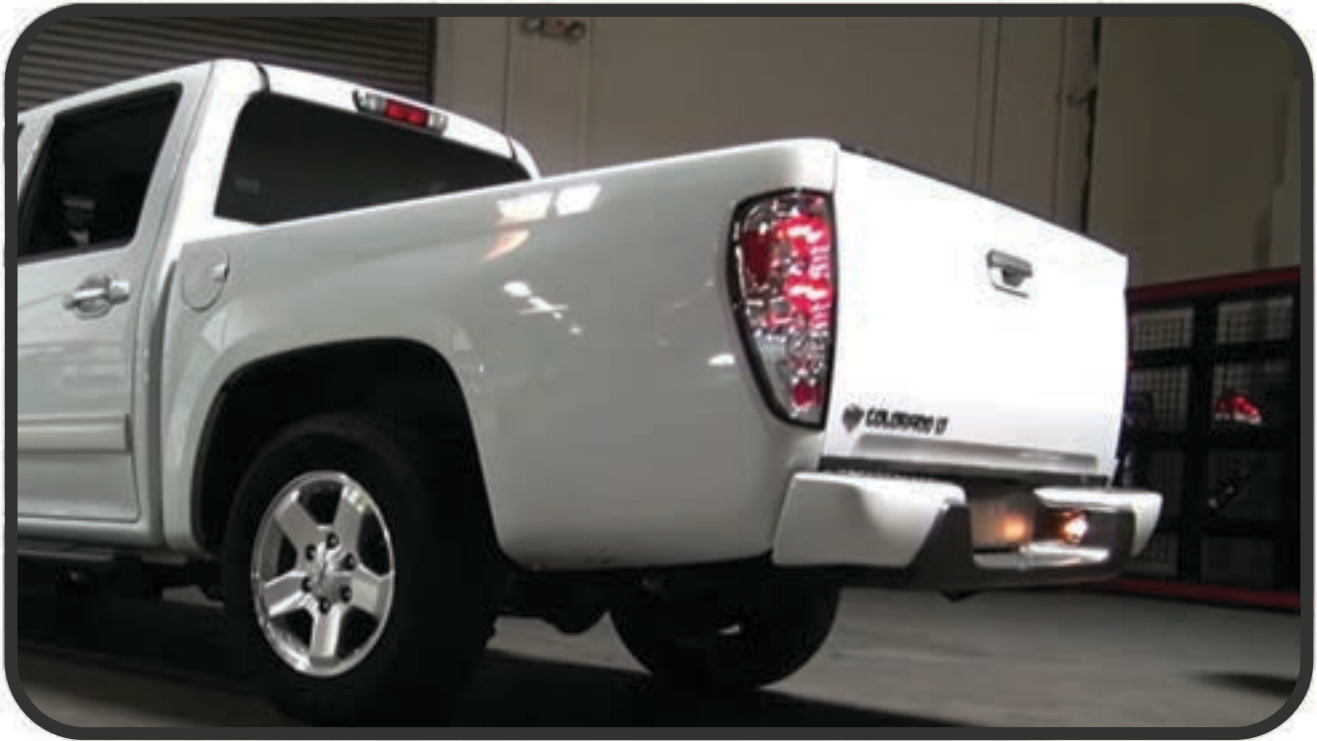
**STEP 8:**

**RECONNECT THE BATTERY AND TEST THE FUNCTIONS TO ENSURE THEY FUNCTION PROPERLY**
