# SPYDER™

## SKU# 5081766

### FITMENT:

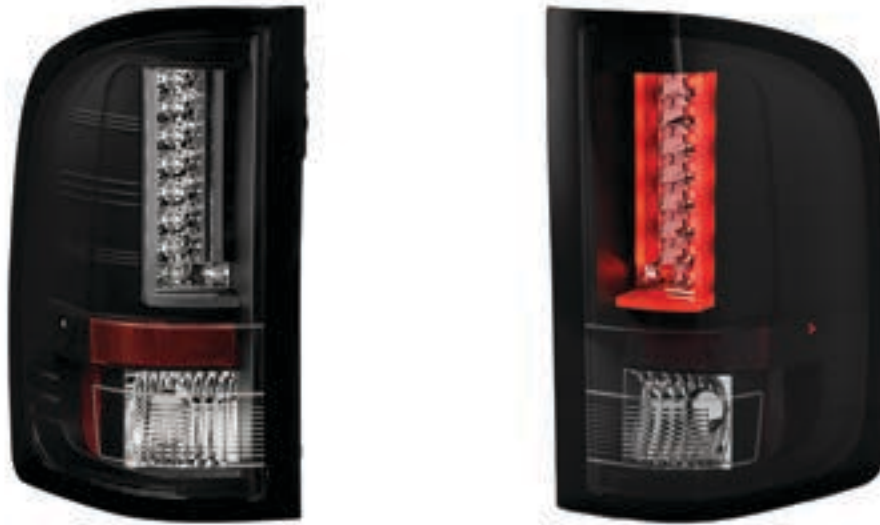
### PACKAGE CONTENTS:

• 2X TAIL LIGHT ASSEMBLIES

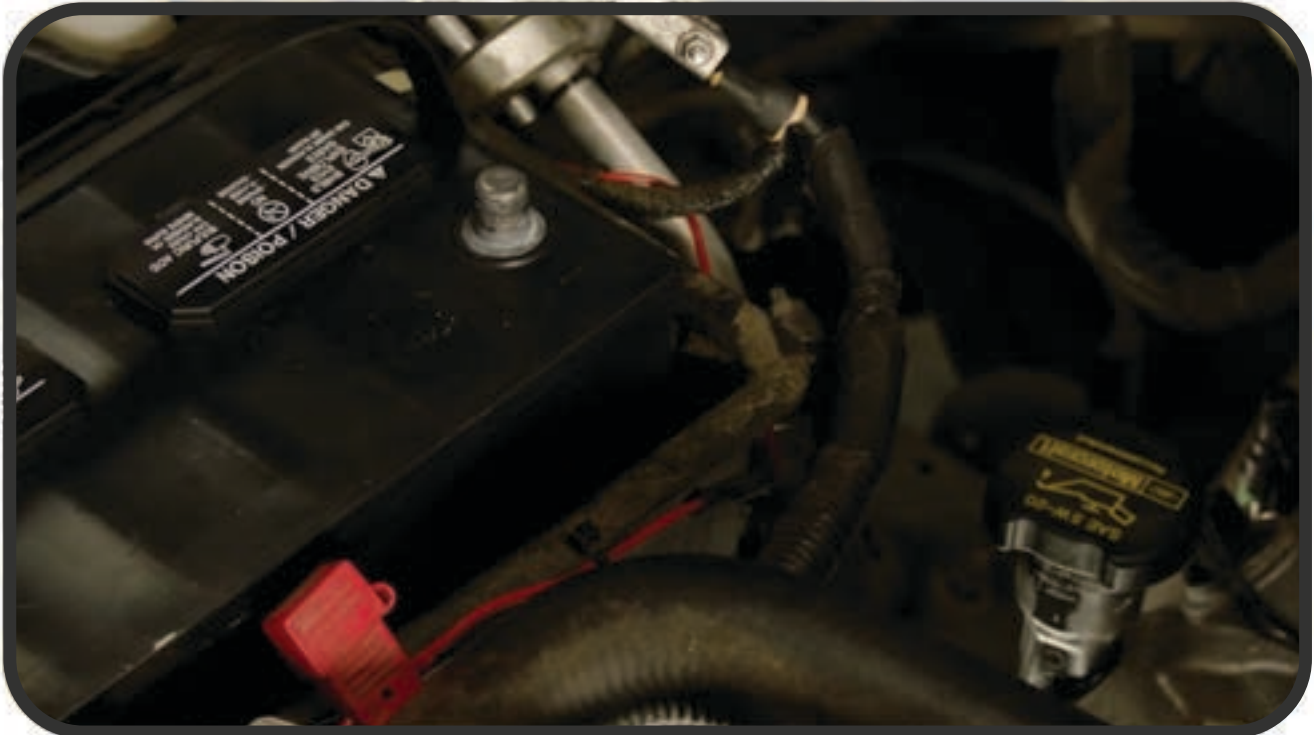
**STEP 1:**  
**DISCONNECT THE NEGATIVE BATTERY TERMINAL**

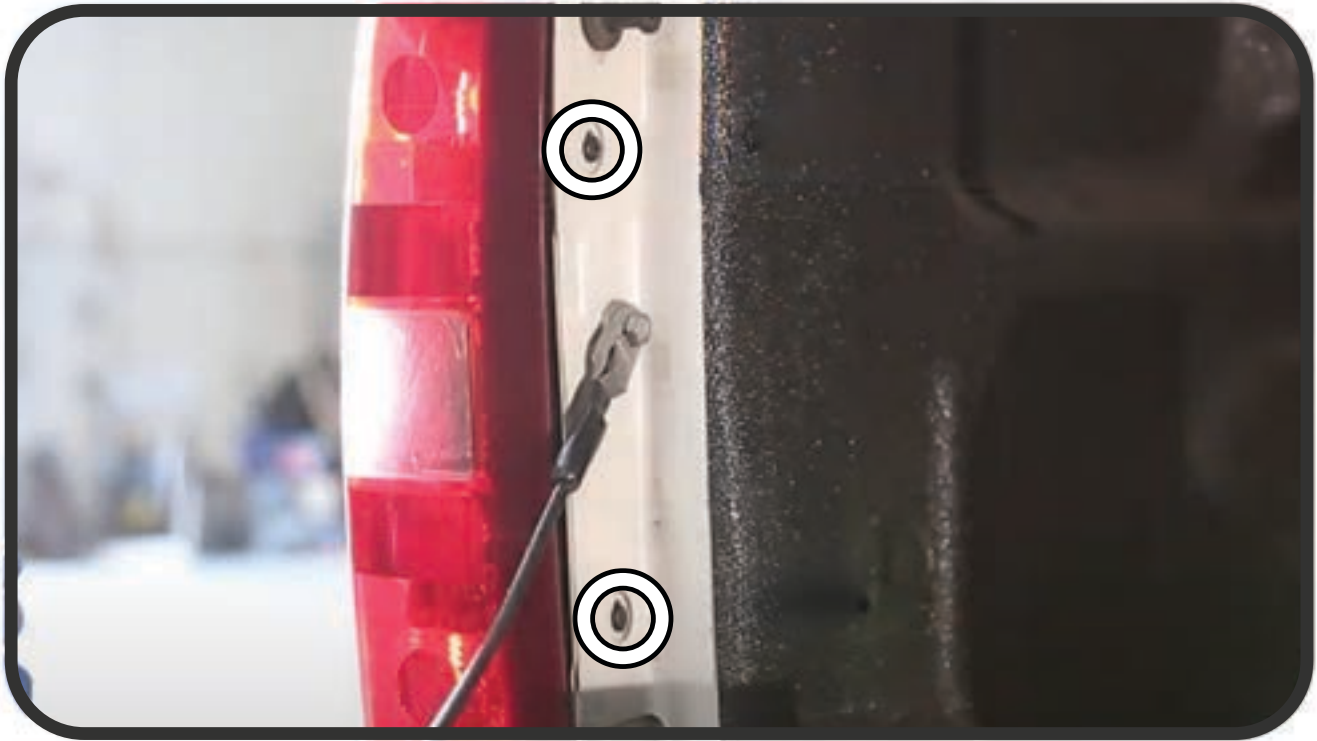
**STEP 2:**

**OPEN THE TAILGATE AND REMOVE (2) PHILLIPS SCREWS SECURING THE TAIL LIGHT**

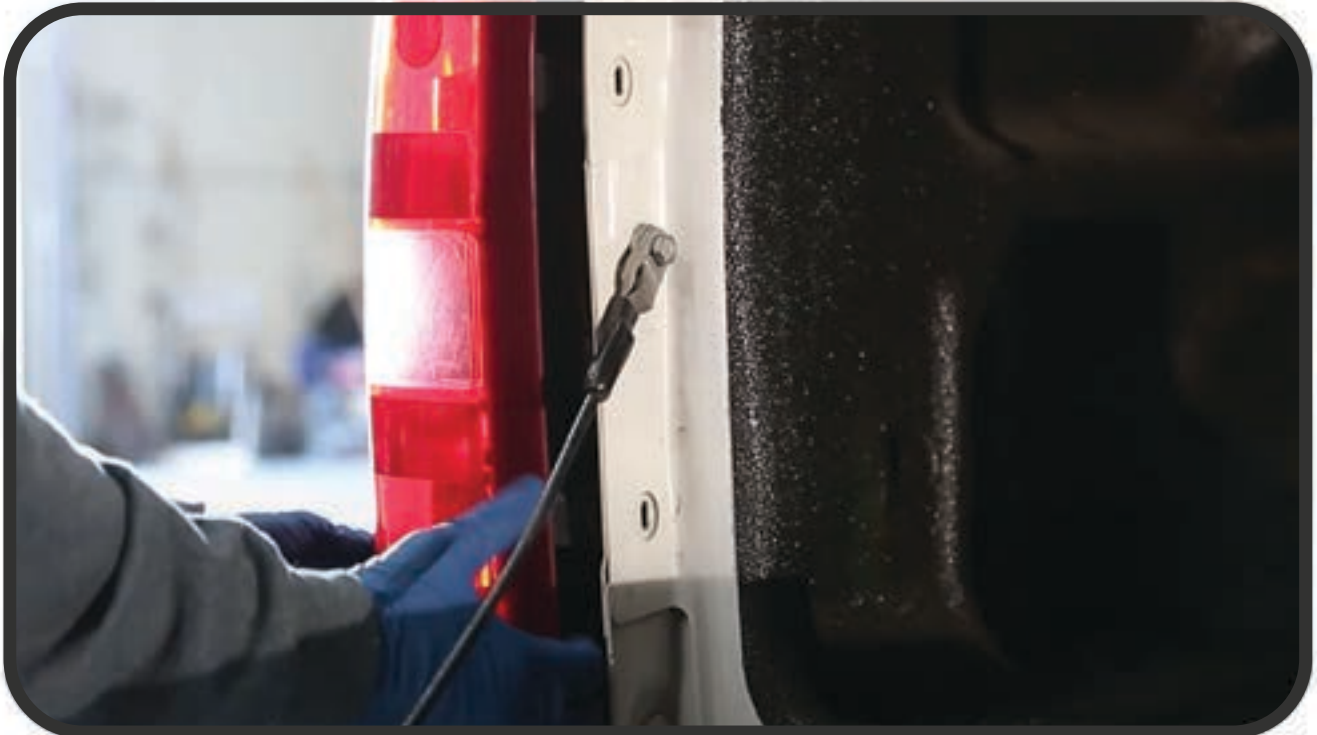
**STEP 3:**

**UNSEAT THE TAIL LIGHT AND REMOVE ALL 3 BULB SOCKETS FROM THE OLD TAIL LIGHT**

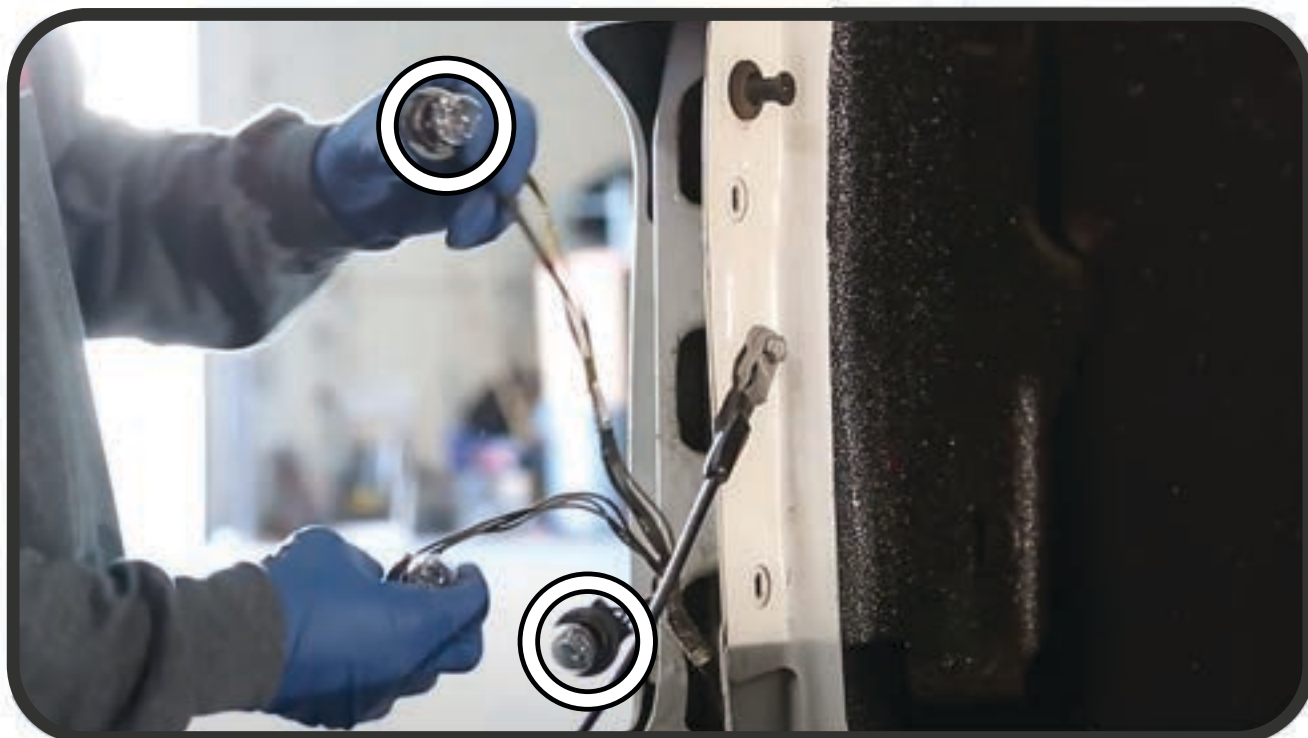
**STEP 4:**

**REMOVE TOP (BRAKE LIGHT) AND BOTTOM (BRAKE LIGHT) BULBS FROM SOCKETS. THE BOTTOM SOCKET IS NO LONGER NEEDED FOR THE REMAINDER OF THIS INSTALL**

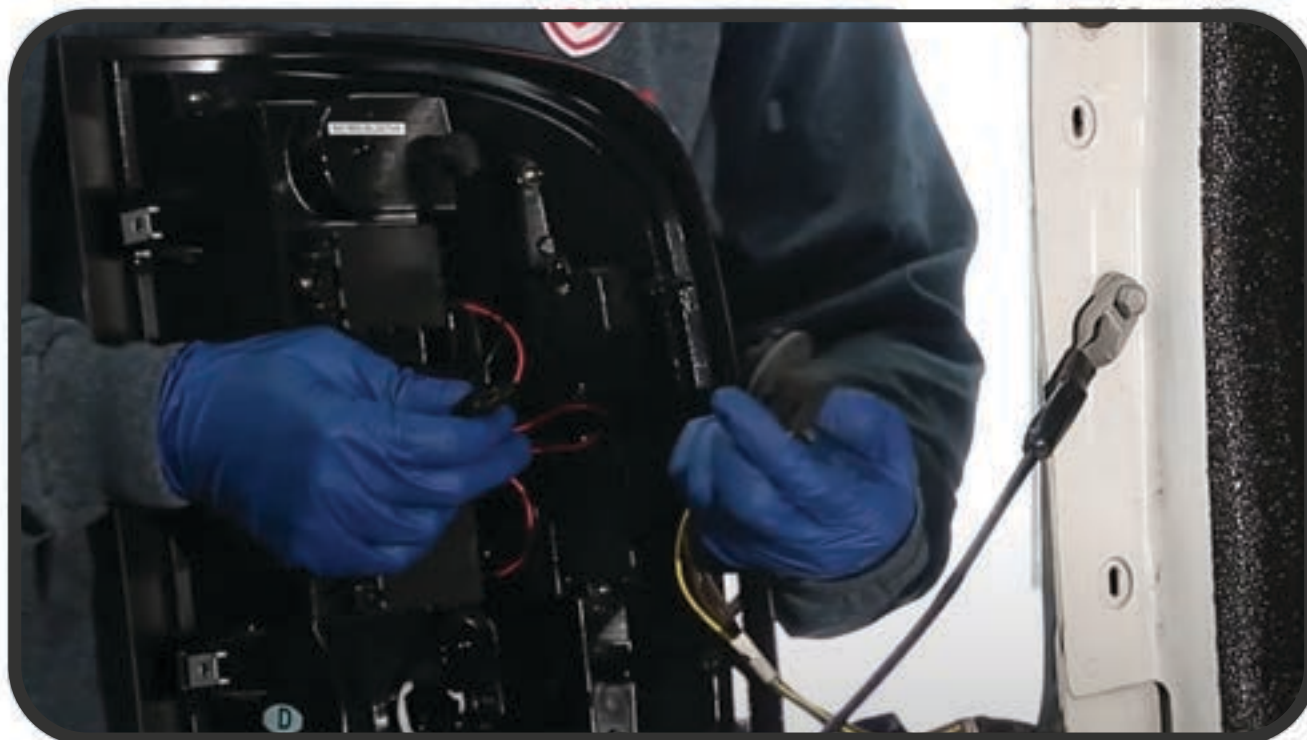
**STEP 5:**

**INSTALL TOP BRAKE LIGHT SOCKET PLUG INTO SPYDER TAIL LIGHT AND ENSURING THAT THE BLACK WIRE MATCHES ON BOTH THE SOCKET PLUG AND SOCKET**

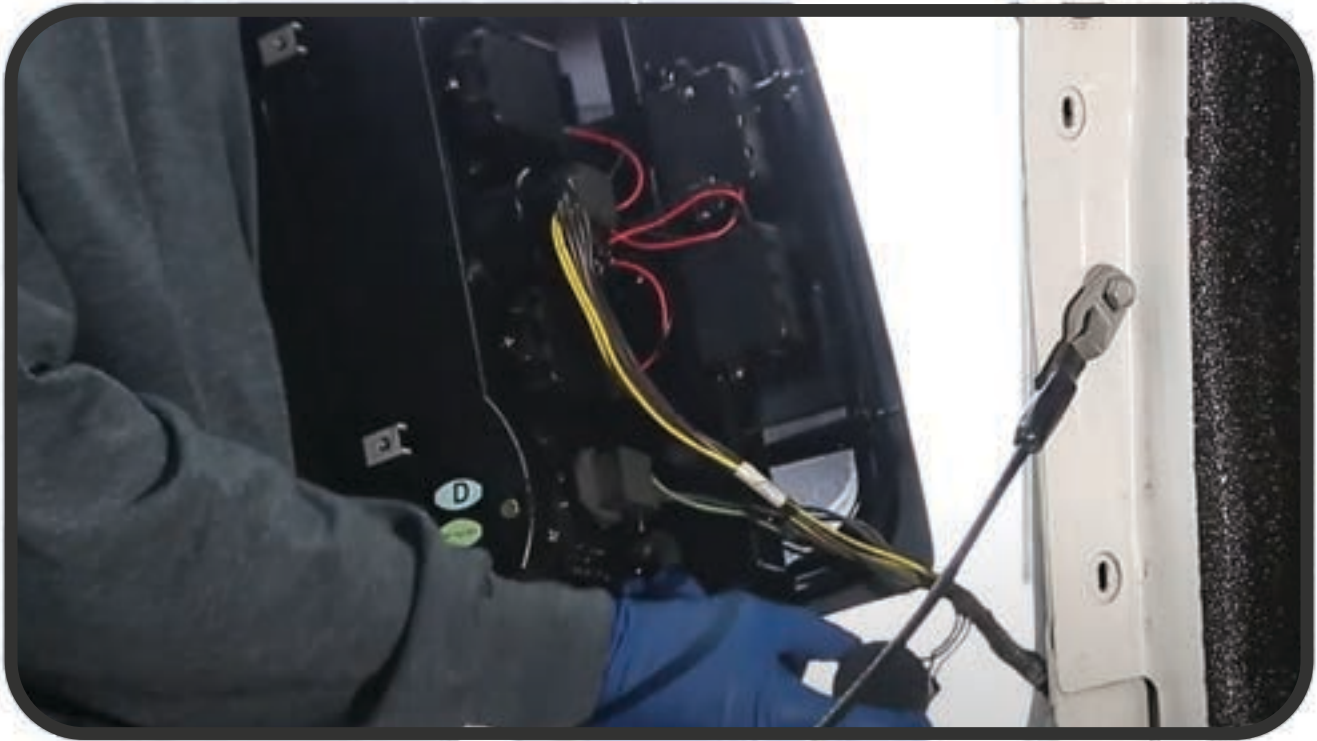
**STEP 6:**  
**INSTALL THE REVERSE LIGHT SOCKET AND THE BRAKE LIGHT SOCKET INTO THE SPYDER TAIL LIGHT**

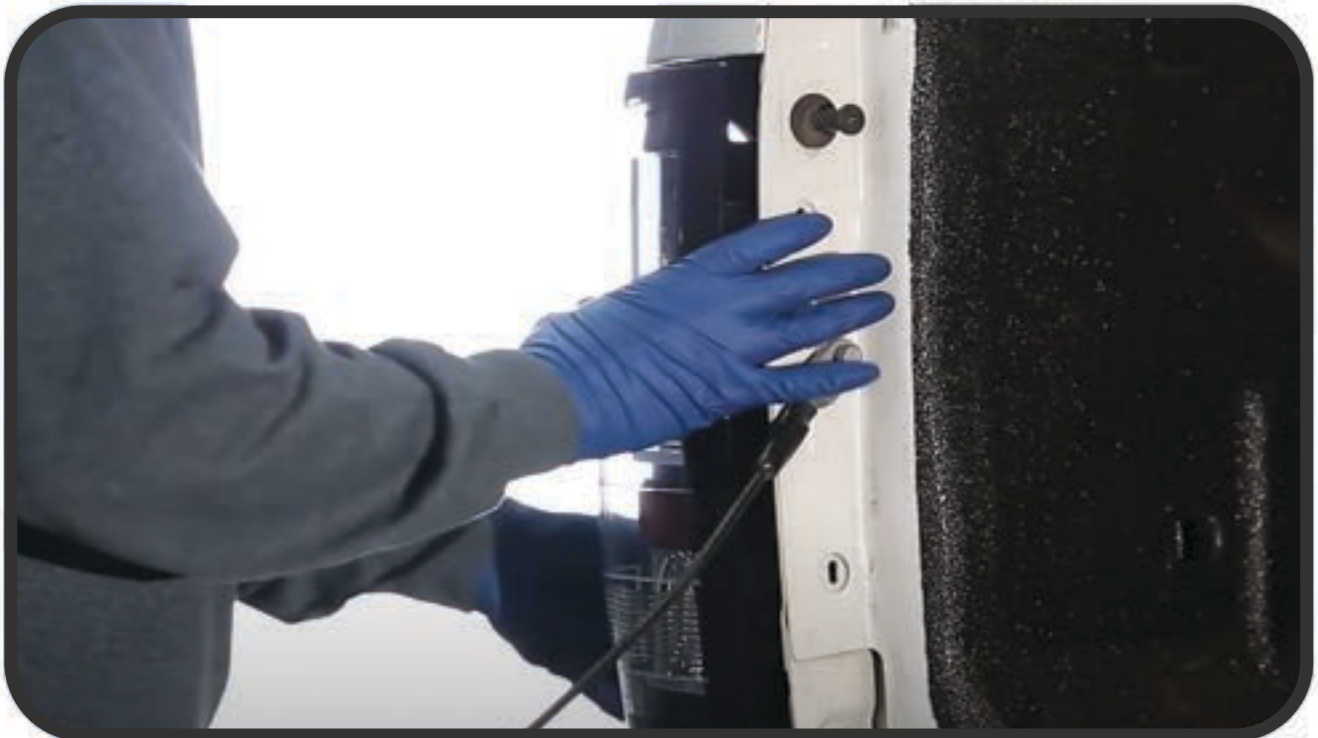
**STEP 7:**  
**SEAT THE SPYDER TAIL LIGHT**

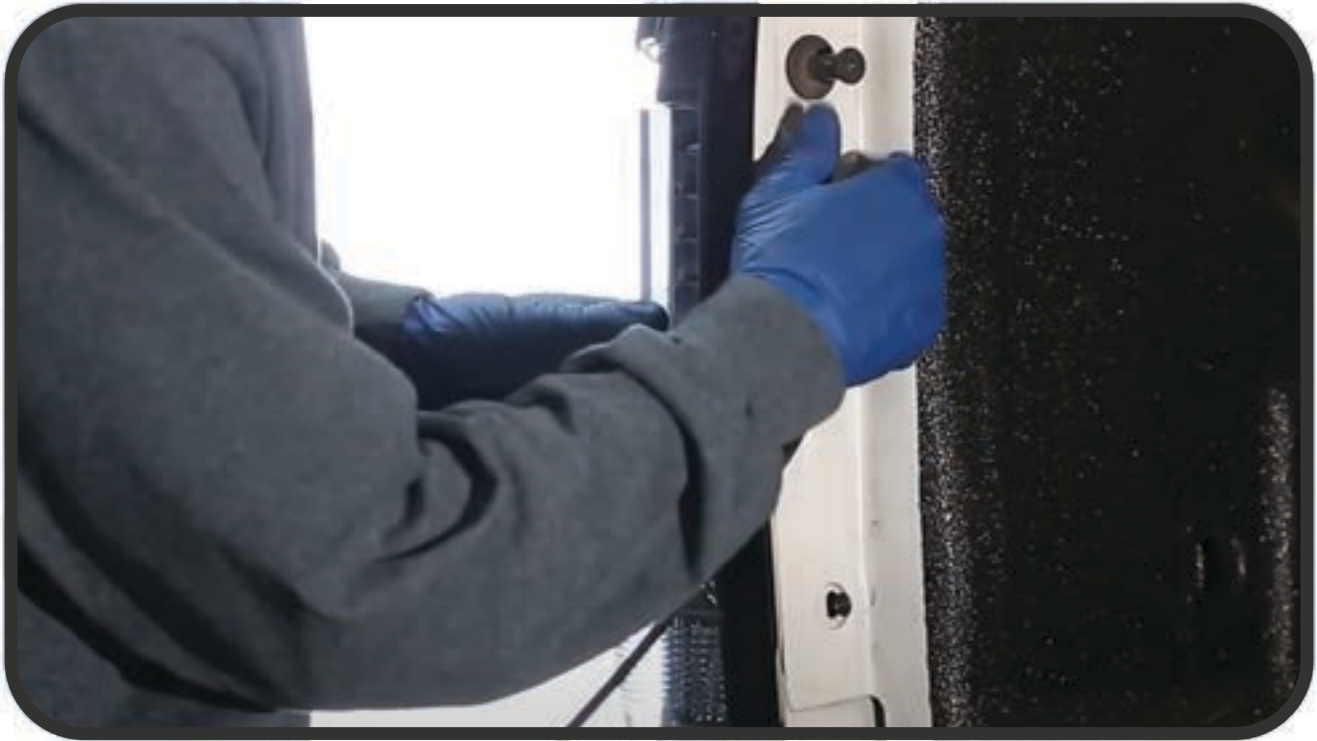
**STEP 8:**

**REINSTALL THE (2) PHILLIPS SCREWS TO SECURE THE TAIL LIGHT**

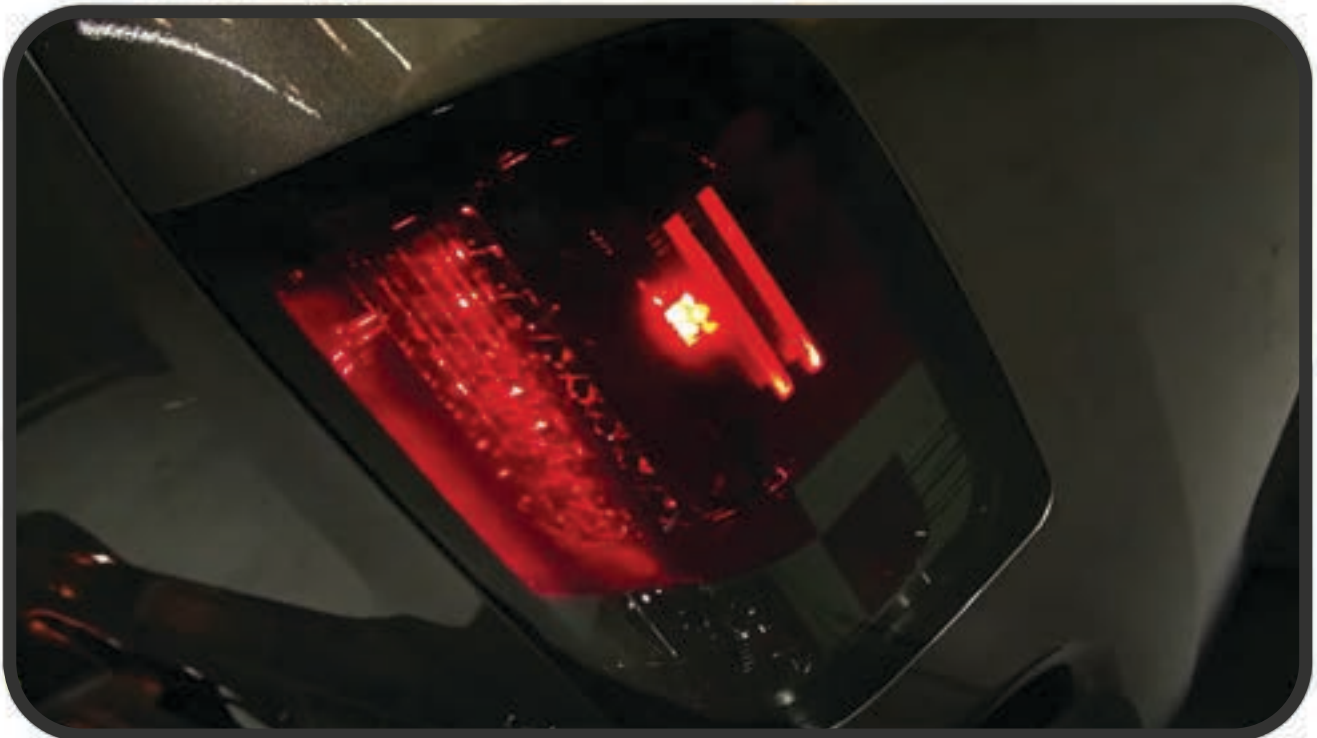
**STEP 9:**

**RECONNECT THE BATTERY AND TEST THE FUNCTIONS TO ENSURE THEY FUNCTION PROPERLY**
