SPYDER™

SKU# 5001986

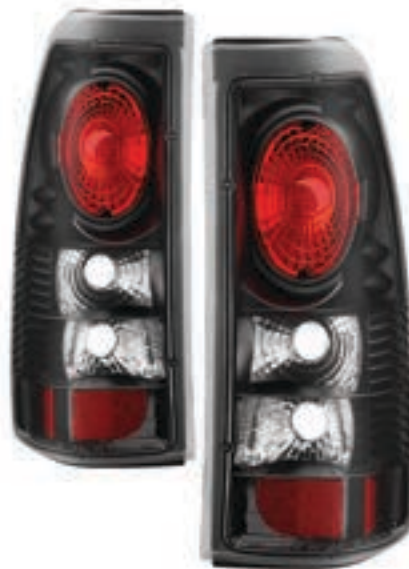
• 2X TAIL LIGHT ASSEMBLIES

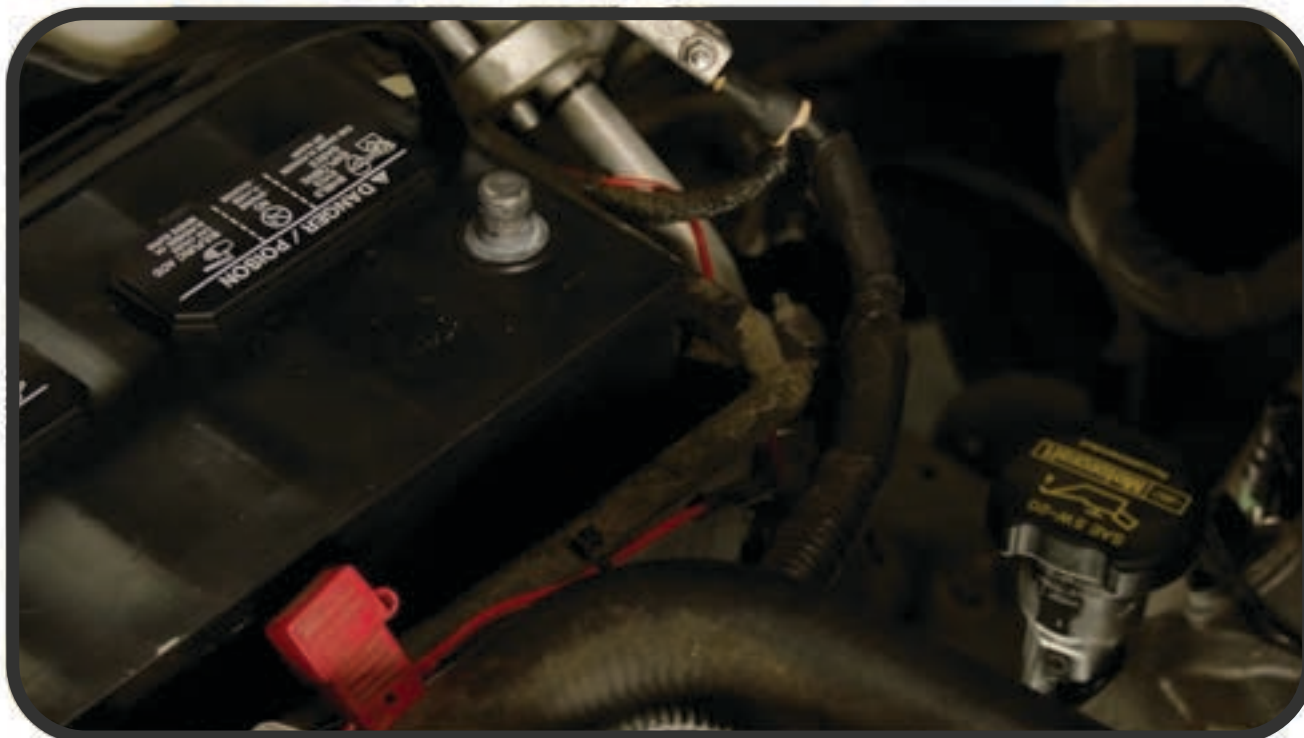
STEP 1:

DISCONNECT THE NEGATIVE BATTERY TERMINAL

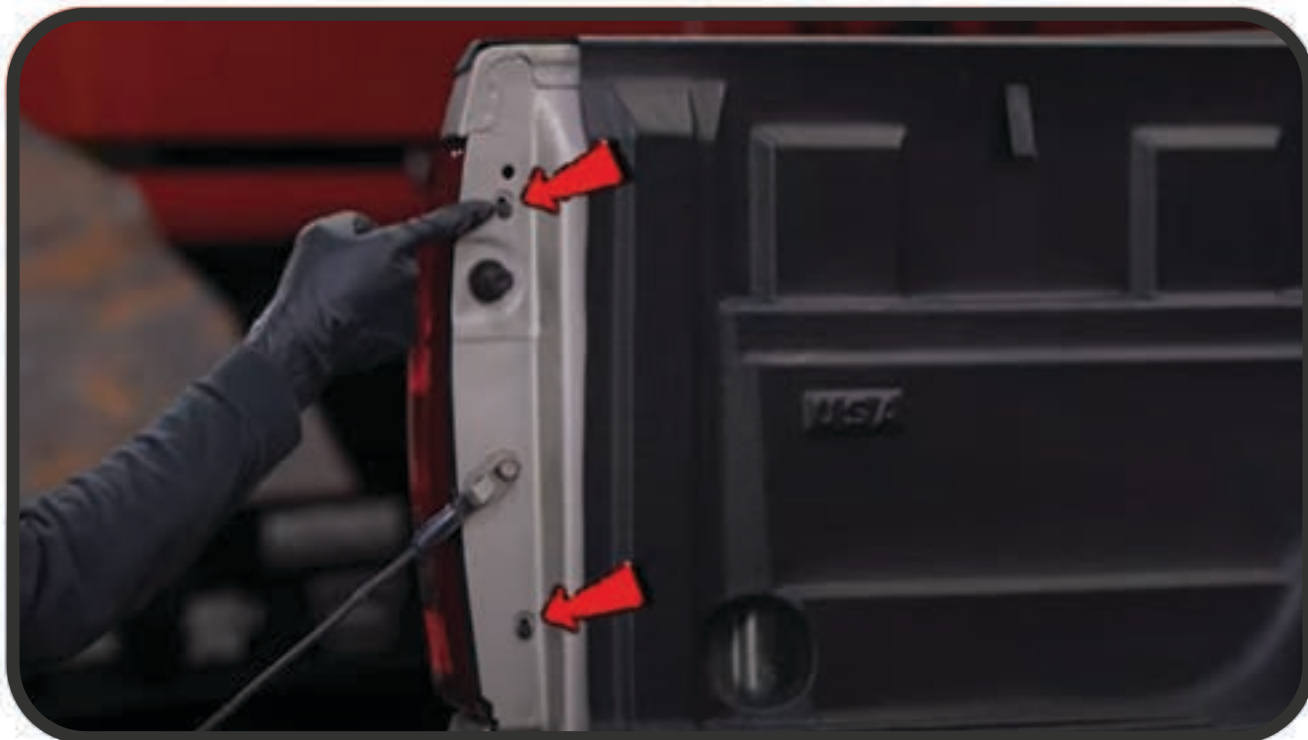
STEP 2:
REMOVE (2X) PHILLIPS SCREWS

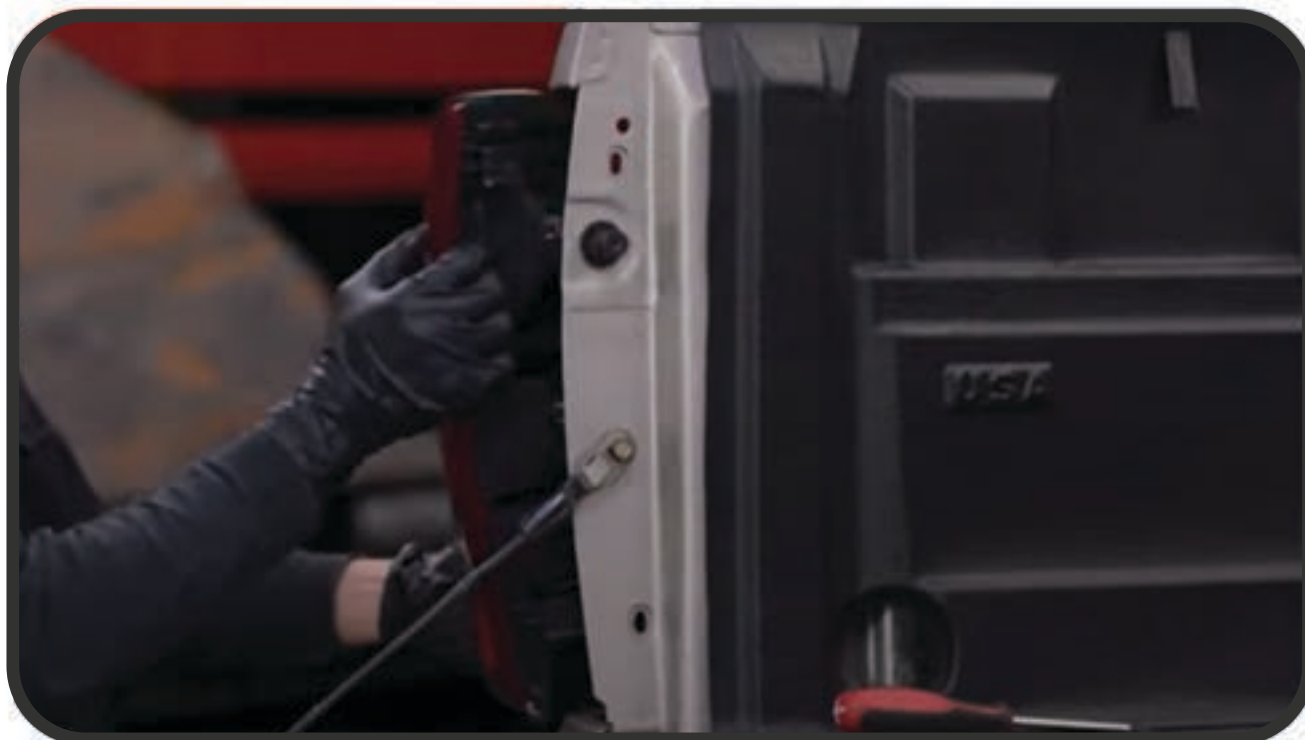
STEP 3:
UNSEAT TAIL LIGHT

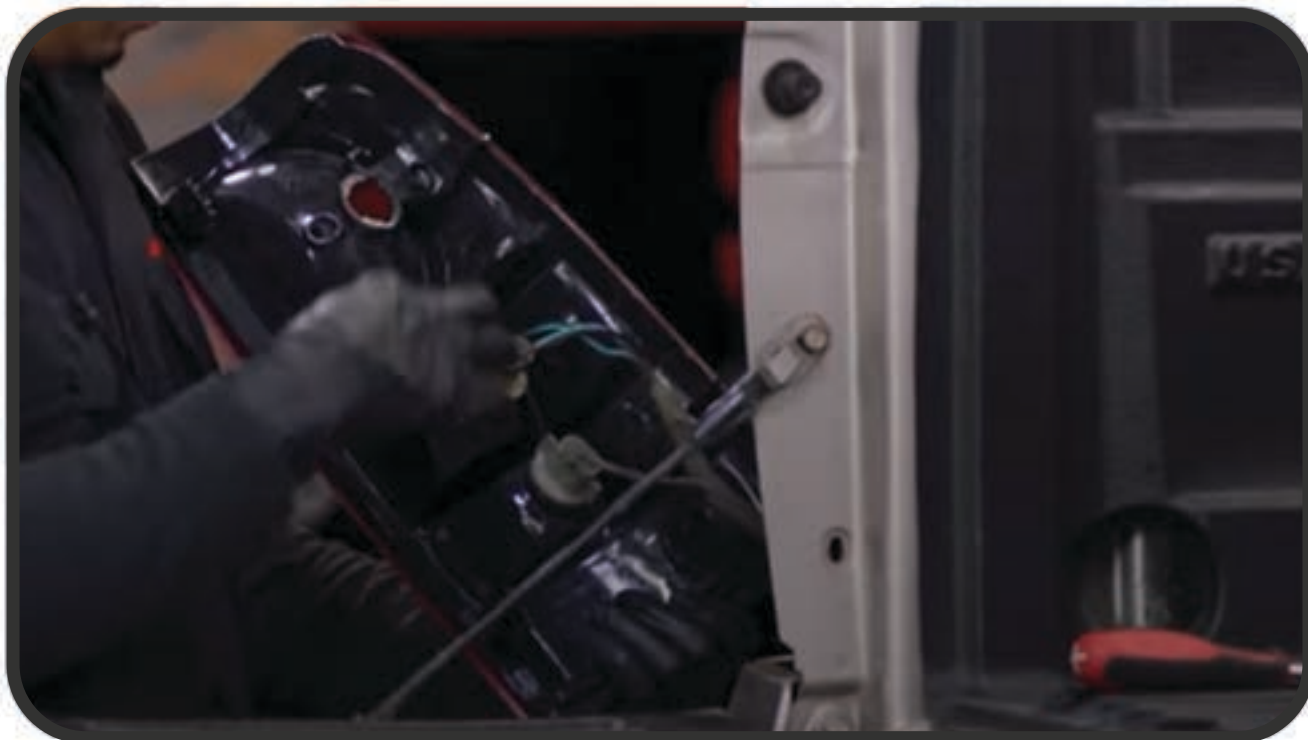
STEP 4:
REMOVE (3X) BULB SOCKETS FROM TAIL LIGHT. (NEVER TOUCH BULBS WITH BARE HANDS)

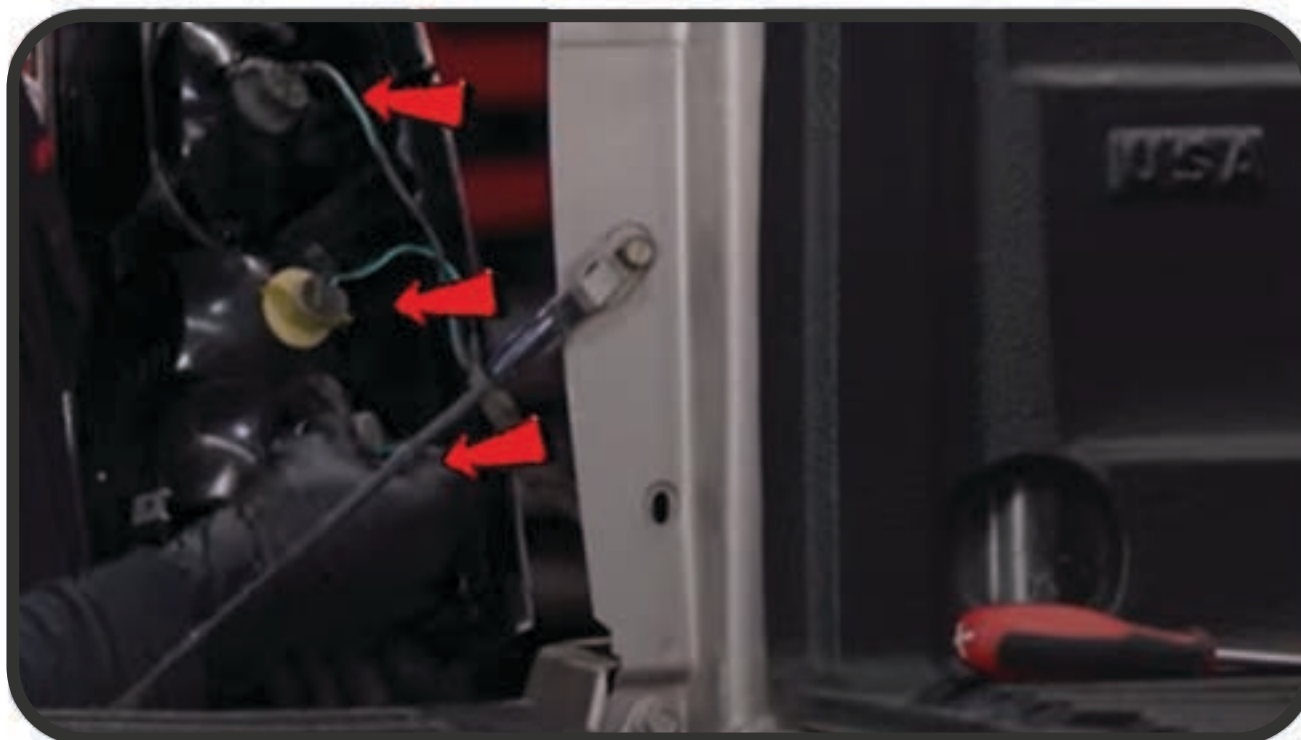
STEP 5:
INSTALL (3X) BULB SOCKETS INTO SPYDER TAIL LIGHT. (MAKING SURE YOU HAVE CANTER AMBER TURN SIGNAL BULB)

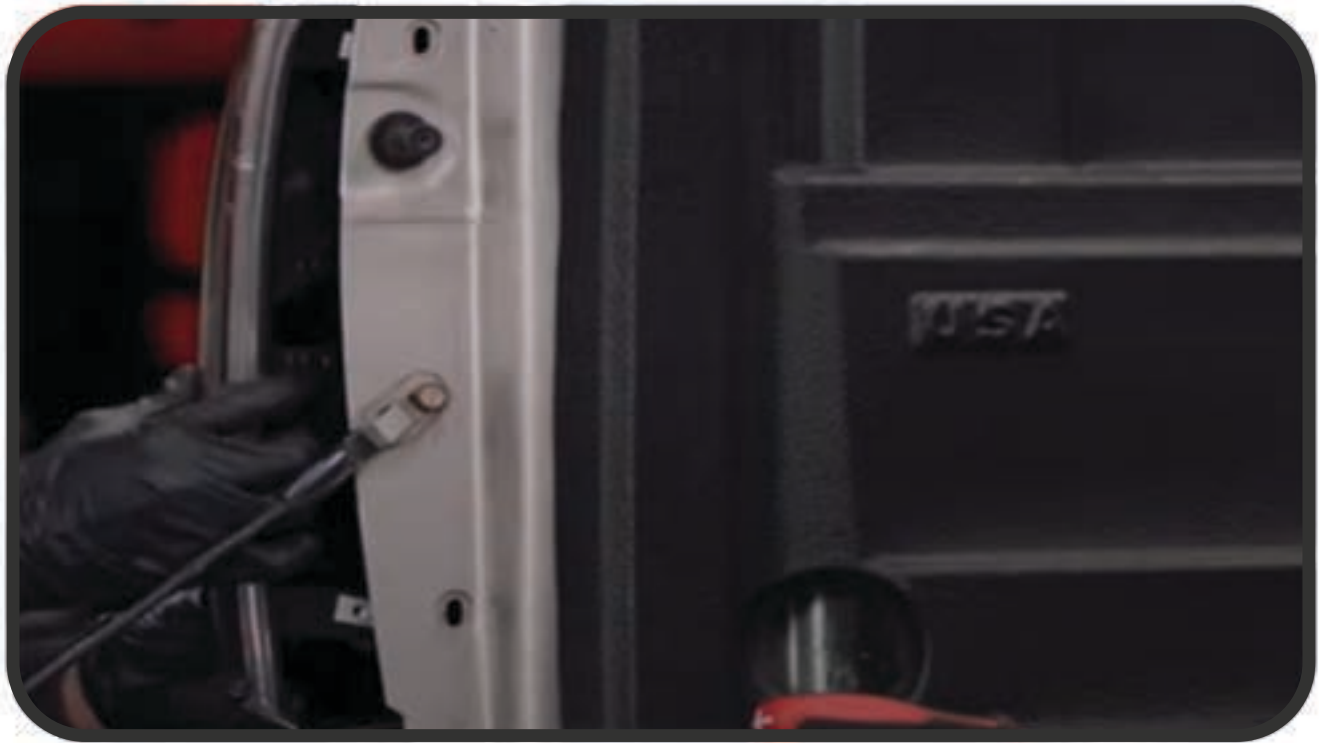
STEP 6:
SEAT SPYDER TAIL LIGHT

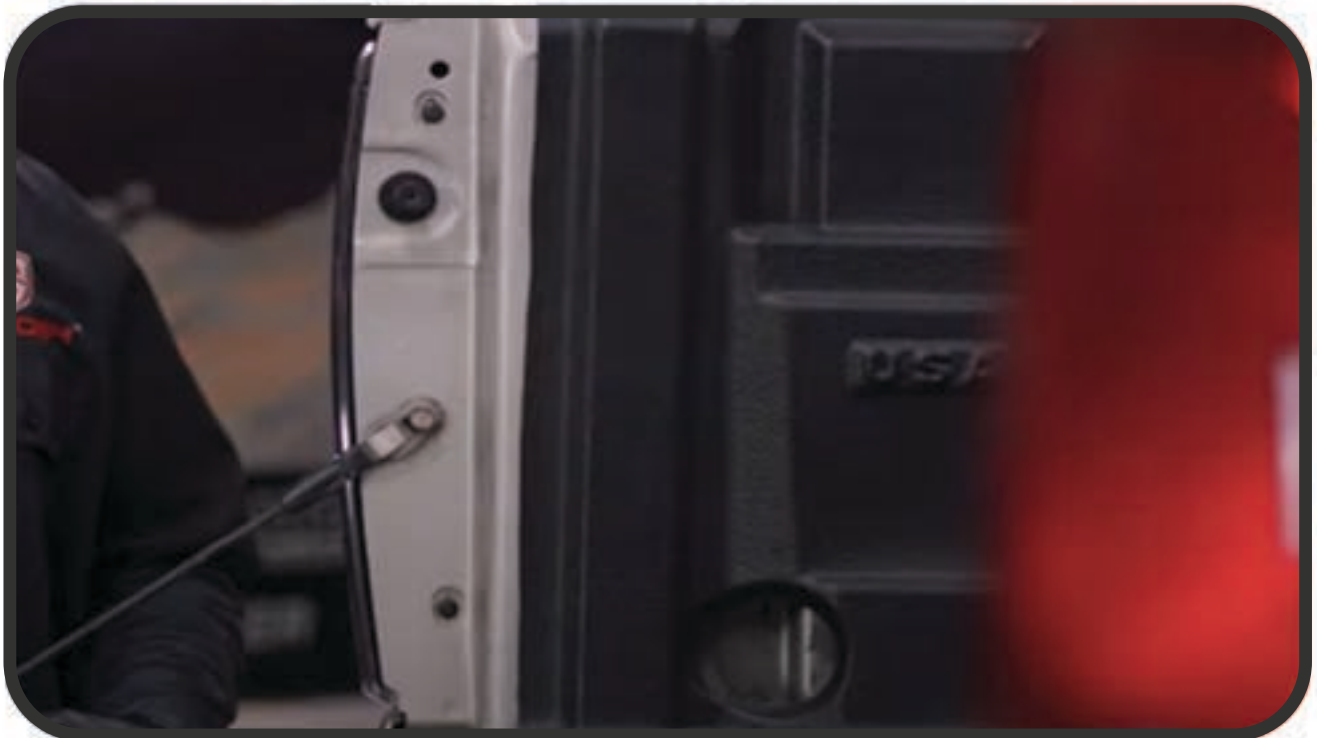
STEP 7:
REINSTALL (2X) PHILLIPS SCREWS SECURING TAIL LIGHT

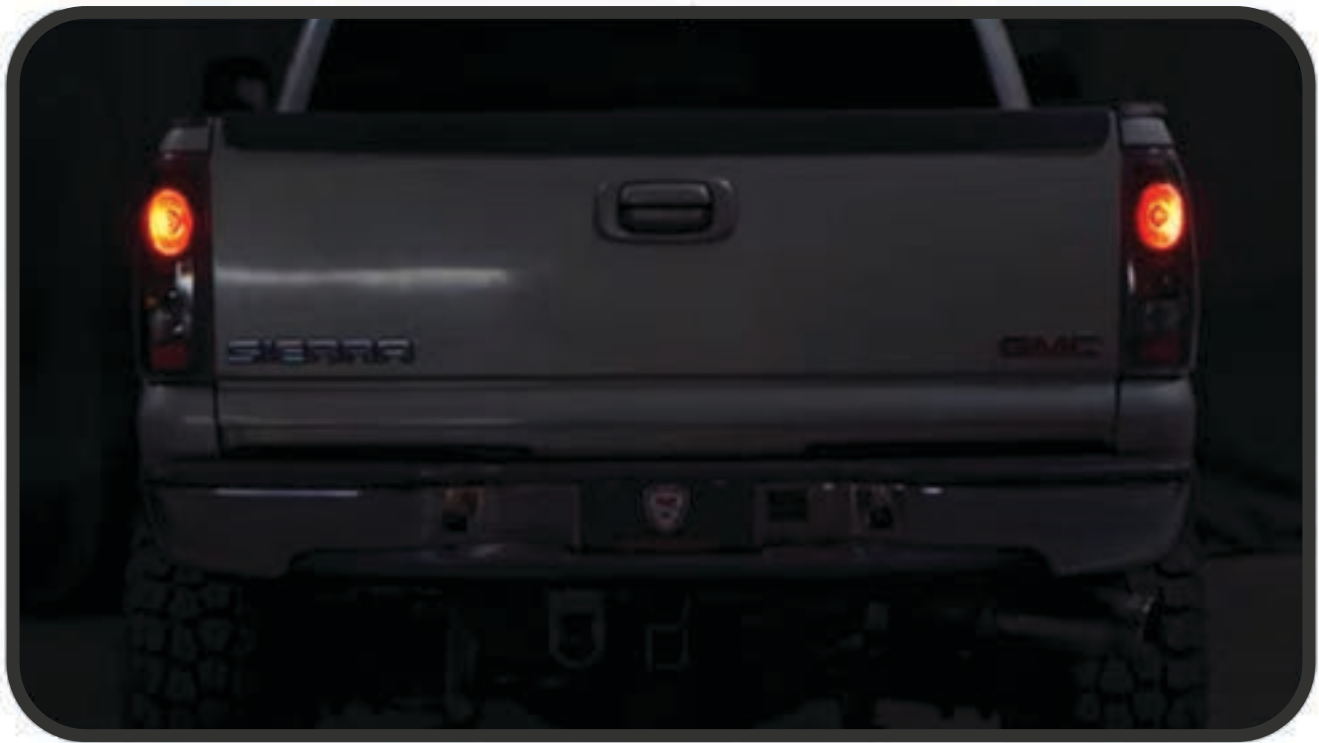
STEP 8:

RECONNECT THE BATTERY AND TEST THE FUNCTIONS TO ENSURE THEY FUNCTION PROPERLY
