SPYDER™

SKU# 5084026

FITMENT:

- 2009-2018 DODGE RAM 1500
- 2010-2018 DODGE RAM 2500/3500

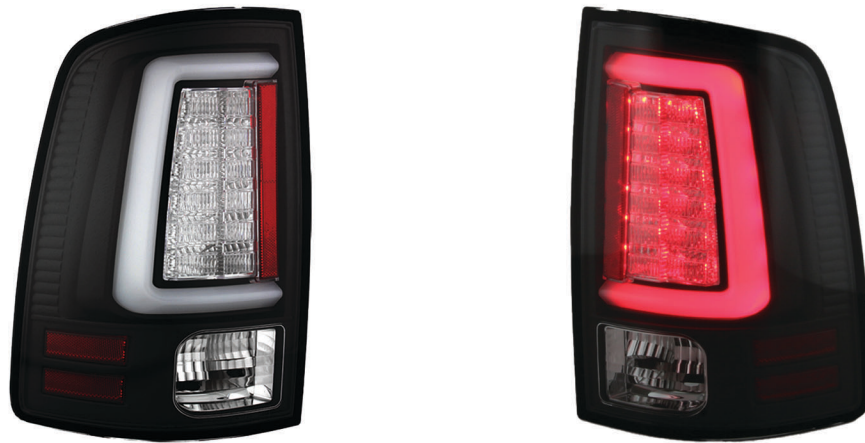
PACKAGE CONTENTS:

• 2X TAIL LIGHT ASSEMBLIES

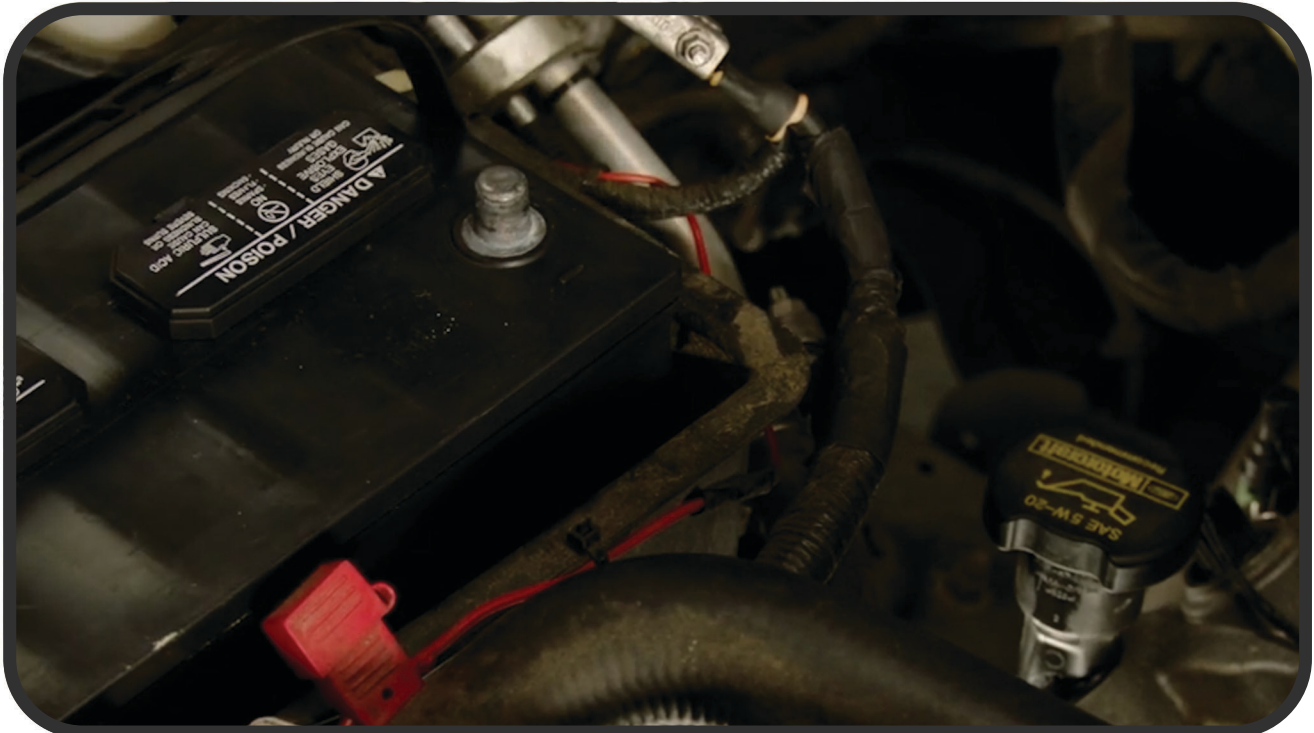
STEP 1:
DISCONNECT THE NEGATIVE BATTERY TERMINAL

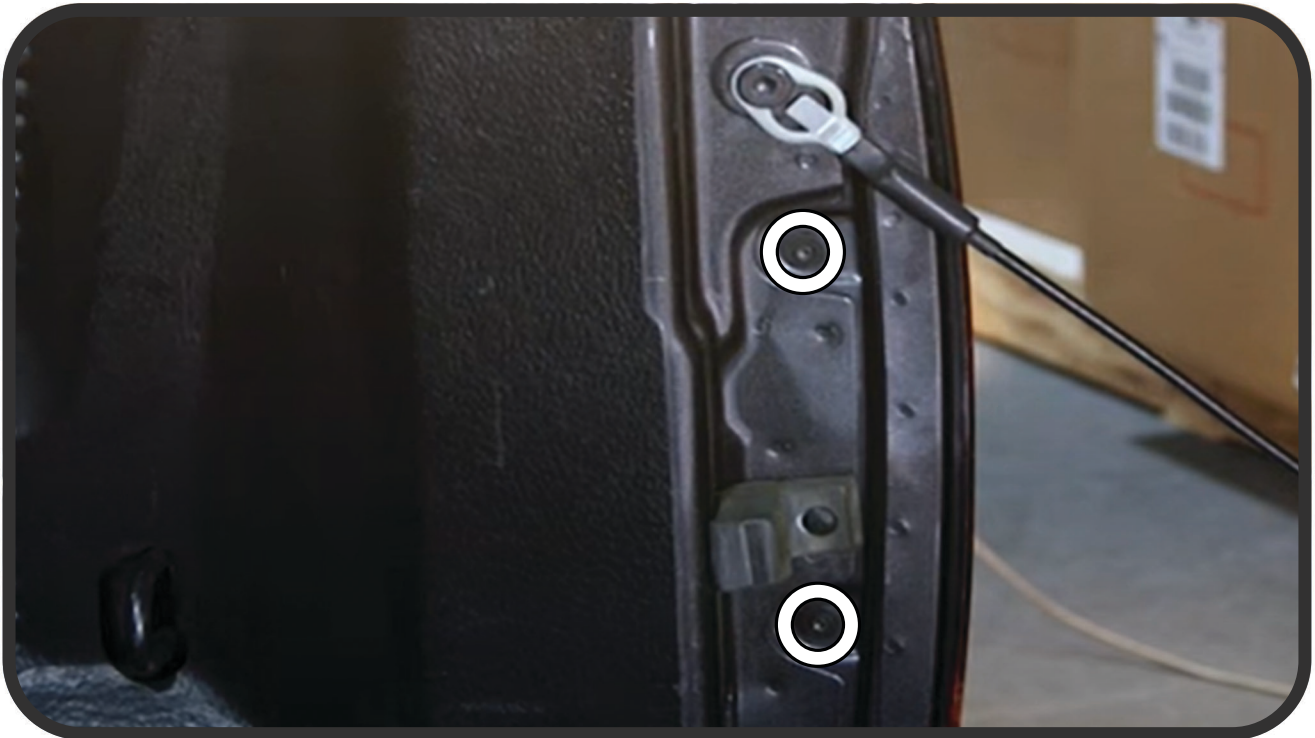
STEP 2:
OPEN THE TAILGATE AND REMOVE (2) T25 TORX SCREWS

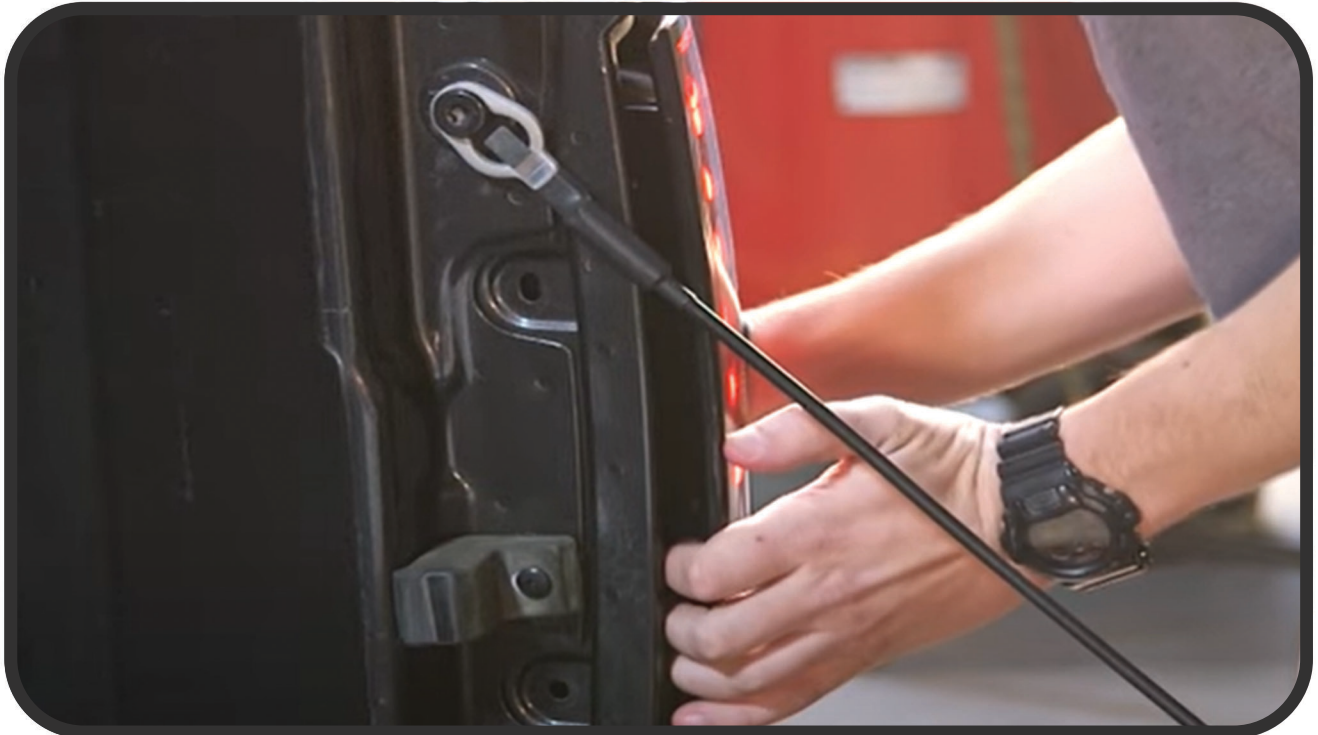
STEP 3:
UNSEAT THE TAIL LIGHT

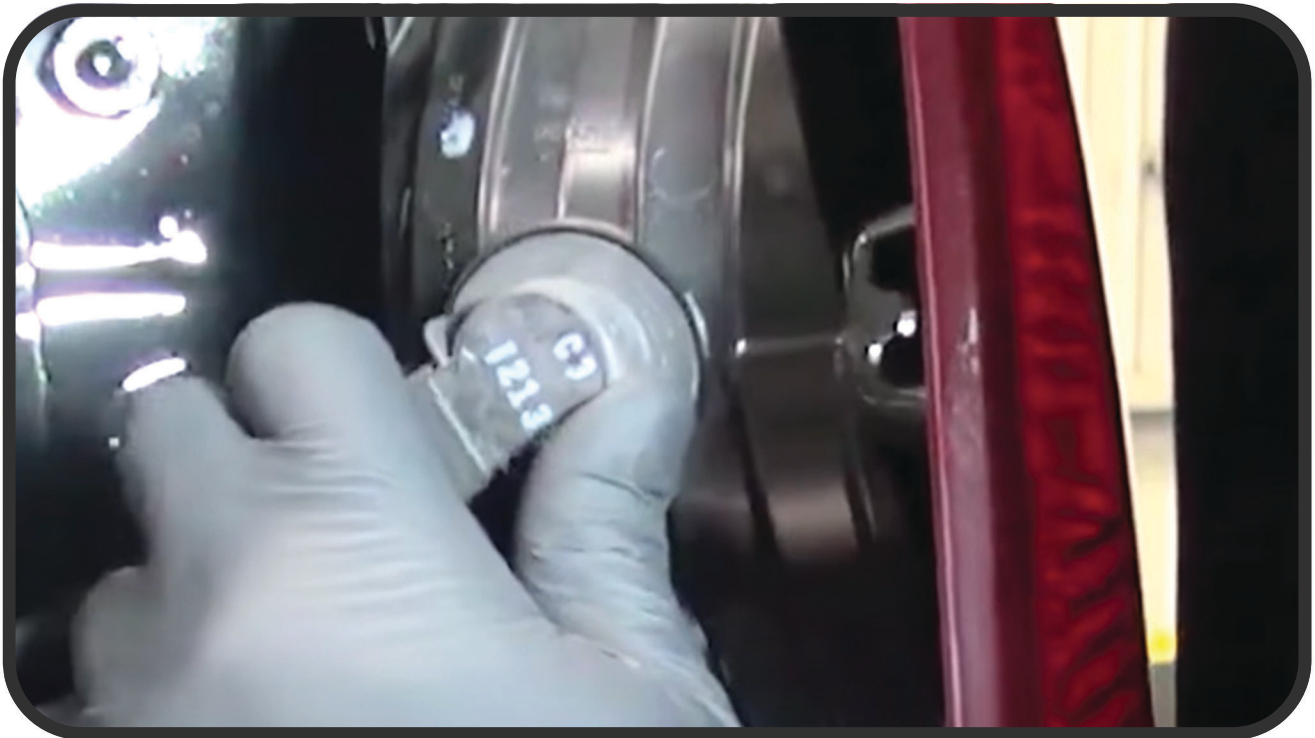
STEP 4:
REMOVE REVERSE SOCKET AND BRAKE LIGHT HARNESS
(NOTE: NEVER TOUCH BULB WITH BARE HANDS)

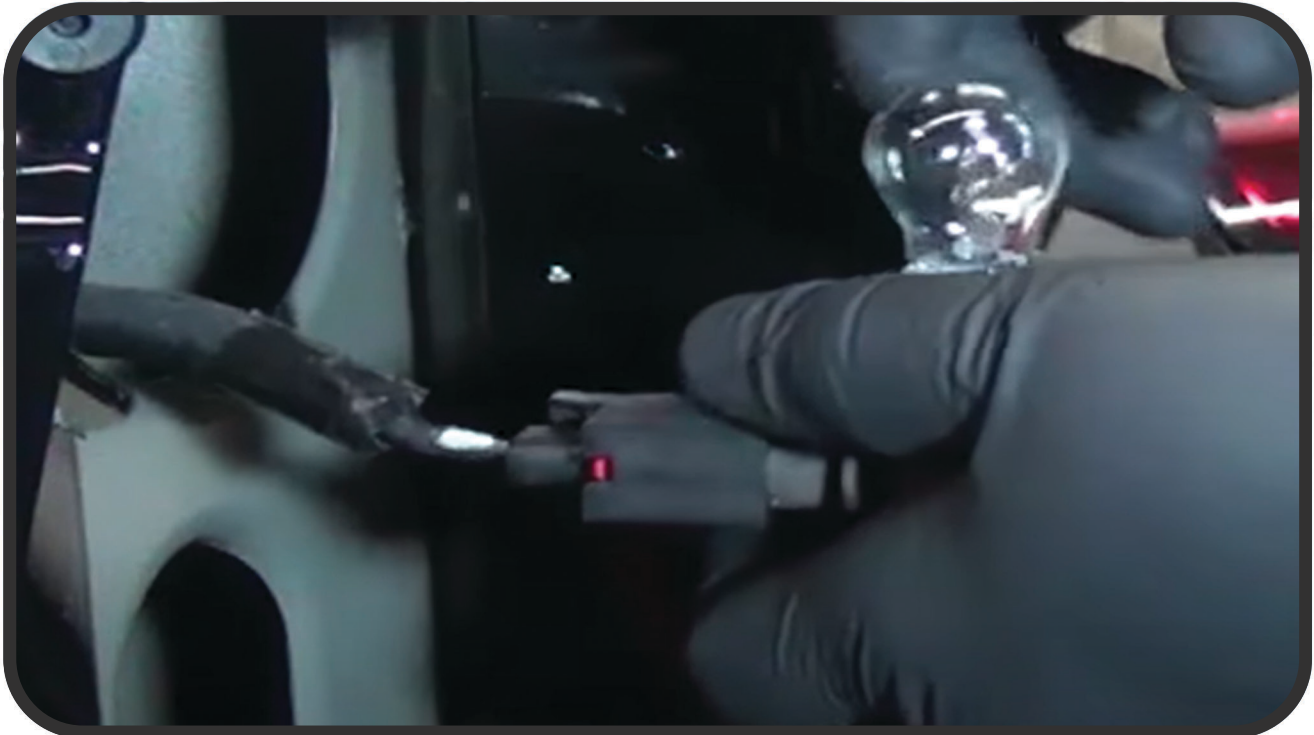
STEP 5:
REMOVE BRAKE BULB FROM SOCKET

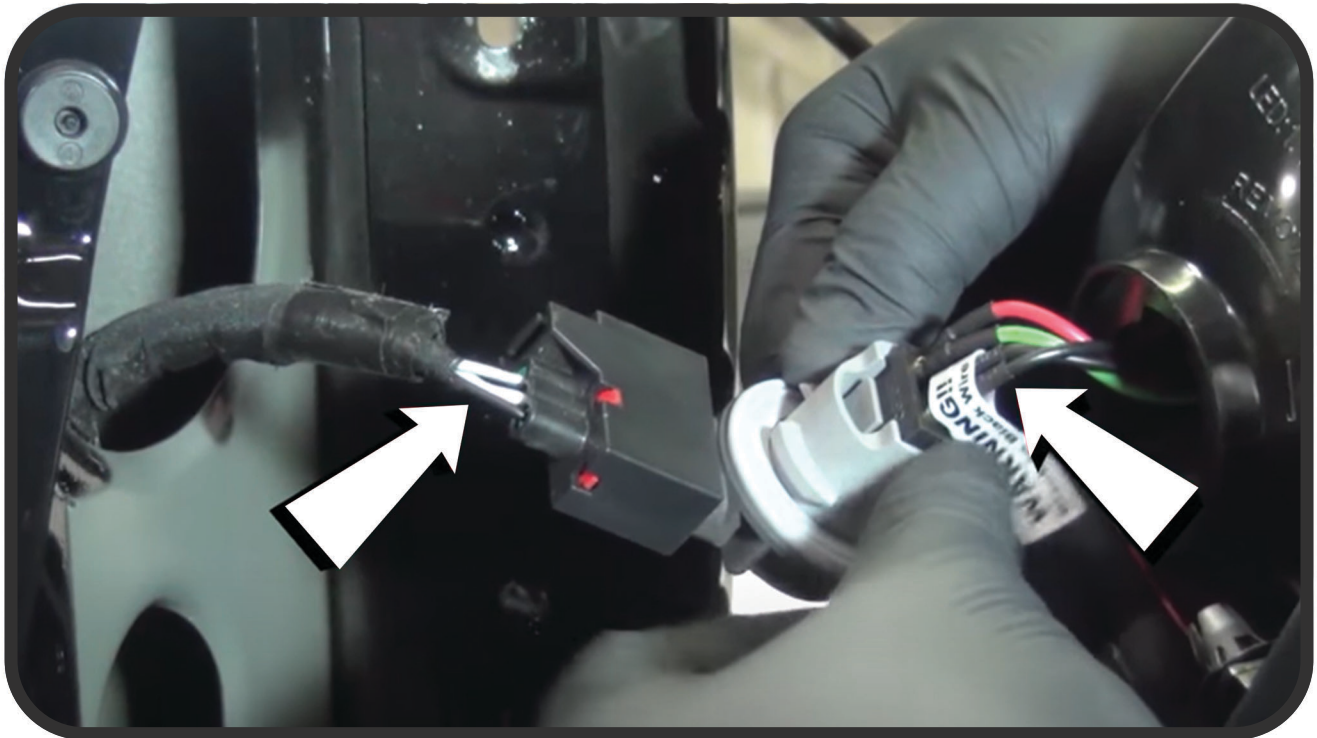
STEP 6:

INSTALL SOCKET INSERT ENSURING THE BLACK WIRE MATCHES THE BLACK WIRE ON THE SOCKET

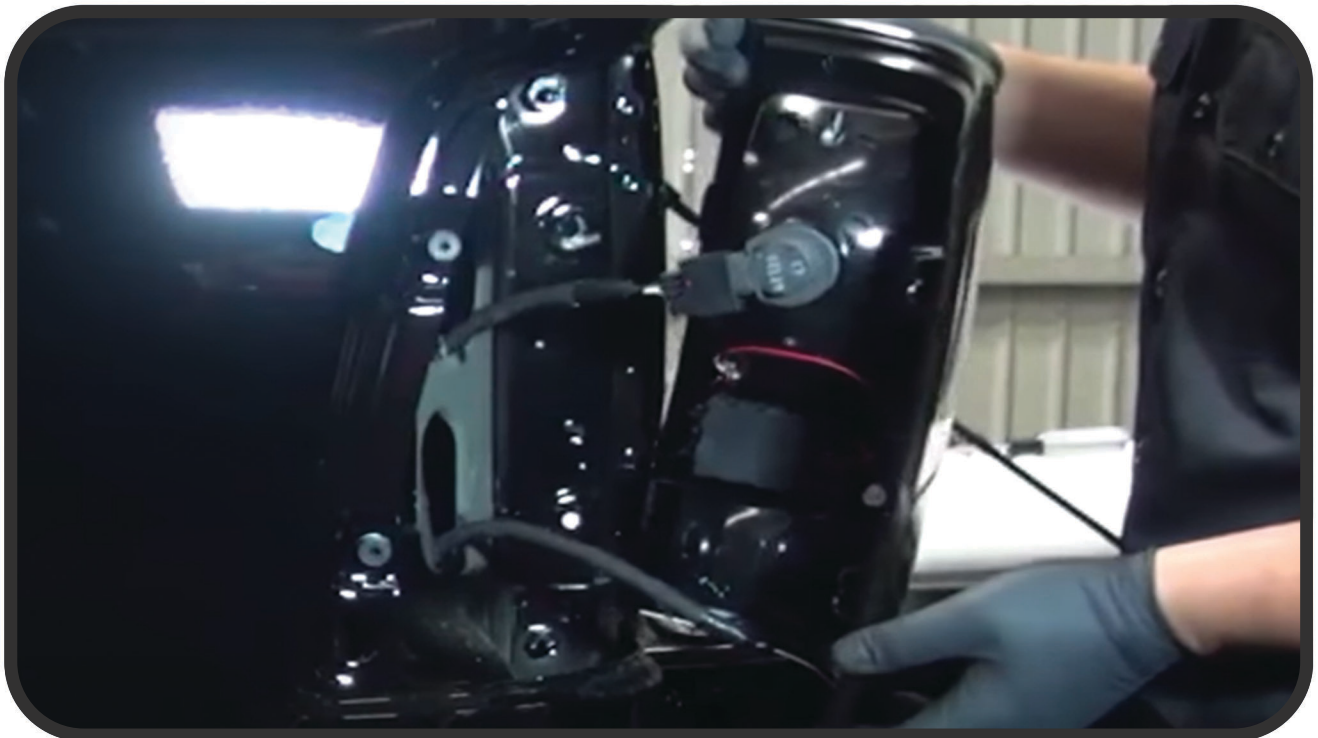
STEP 7:

INSTALL REVERSE SOCKET AND BRAKE LIGHT HARNESS ONTO THE SPYDER TAIL LIGHT

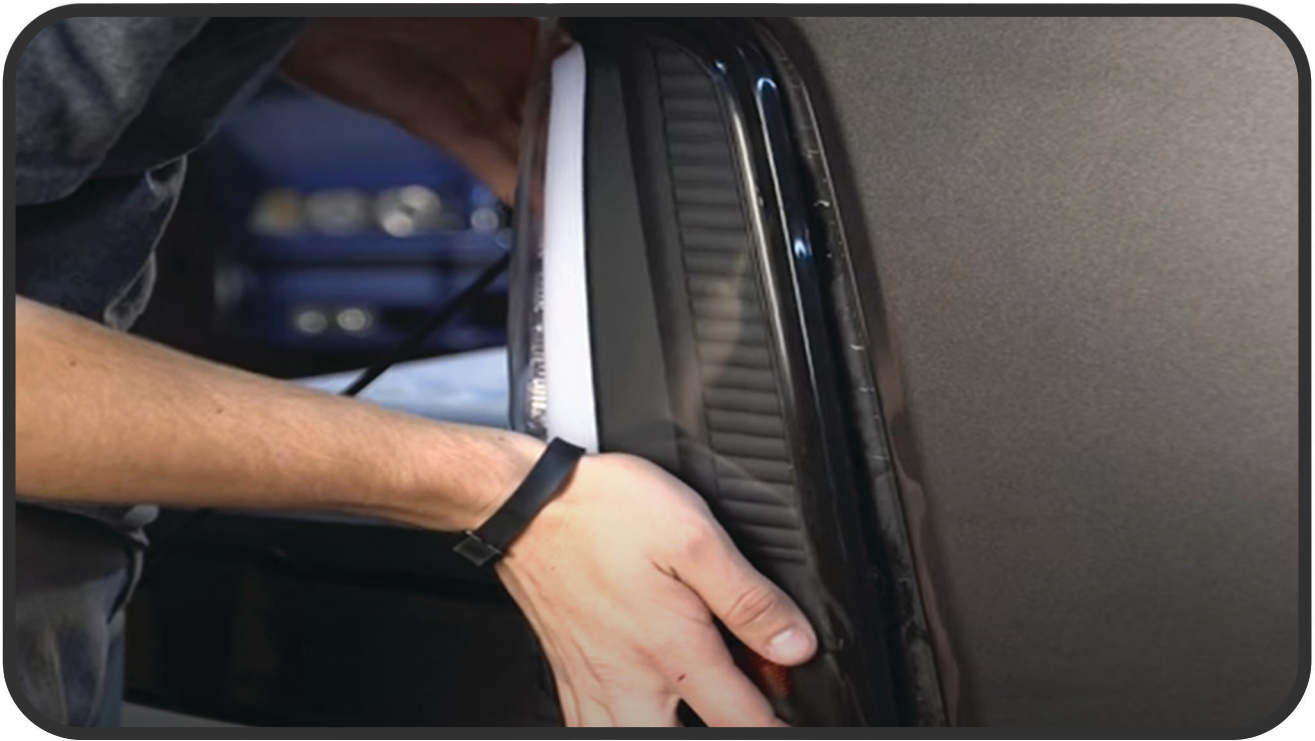
STEP 8:
SEAT THE SPYDER TAIL LIGHT

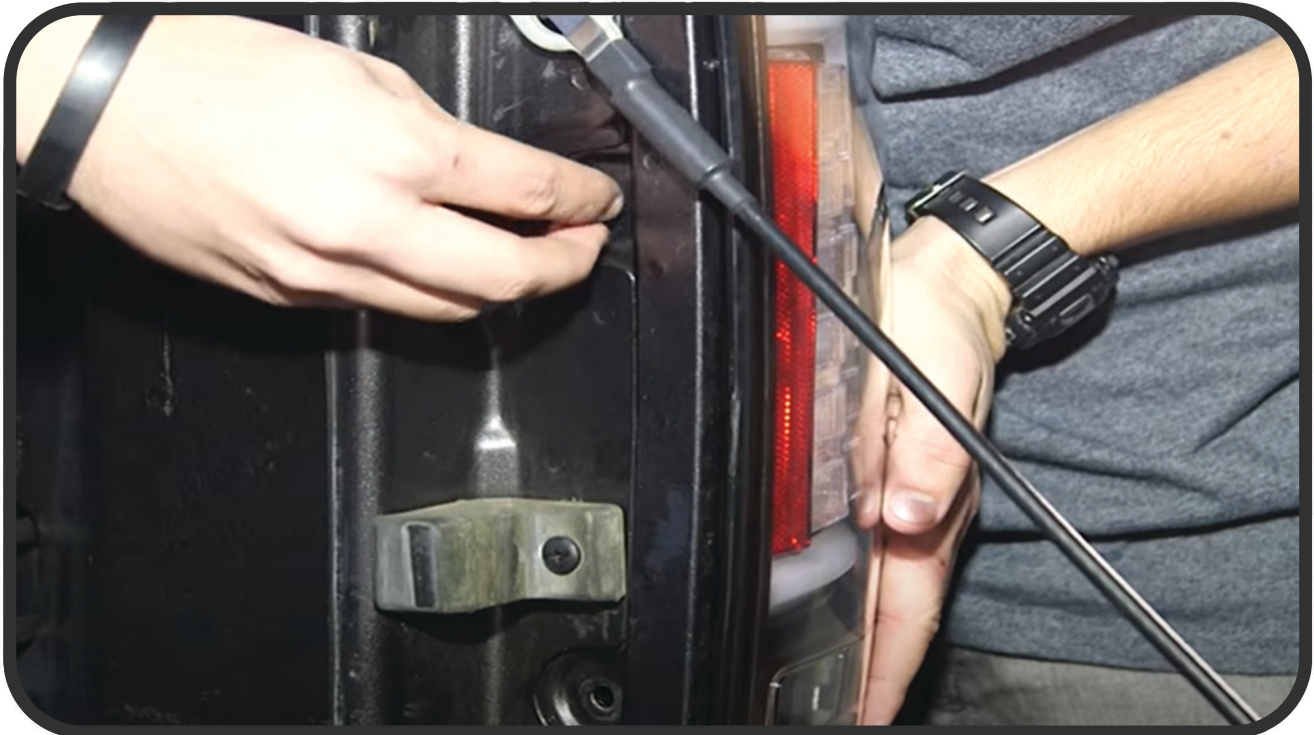
STEP 9:
REINSTALL THE (2) T25 TORX SCREWS AND CLOSE THE TAILGATE

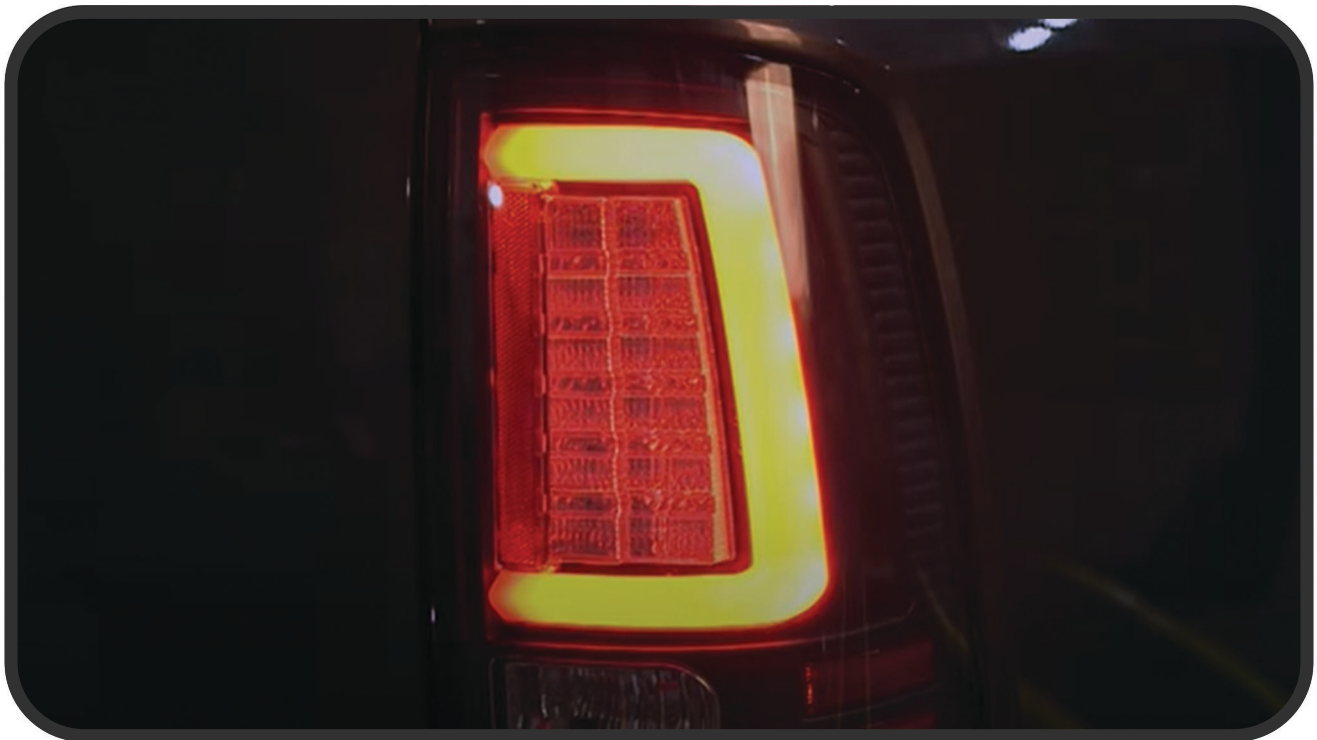
STEP 10:

RECONNECT THE BATTERY AND TEST THE FUNCTIONS TO ENSURE THEY FUNCTION PROPERLY
