SPYDER™

SKU# 5003461

- 1997-2003 FORD F-150 STYLESIDE
- 1999-2007 FORD F-250/350/450/550 SUPERDUTY

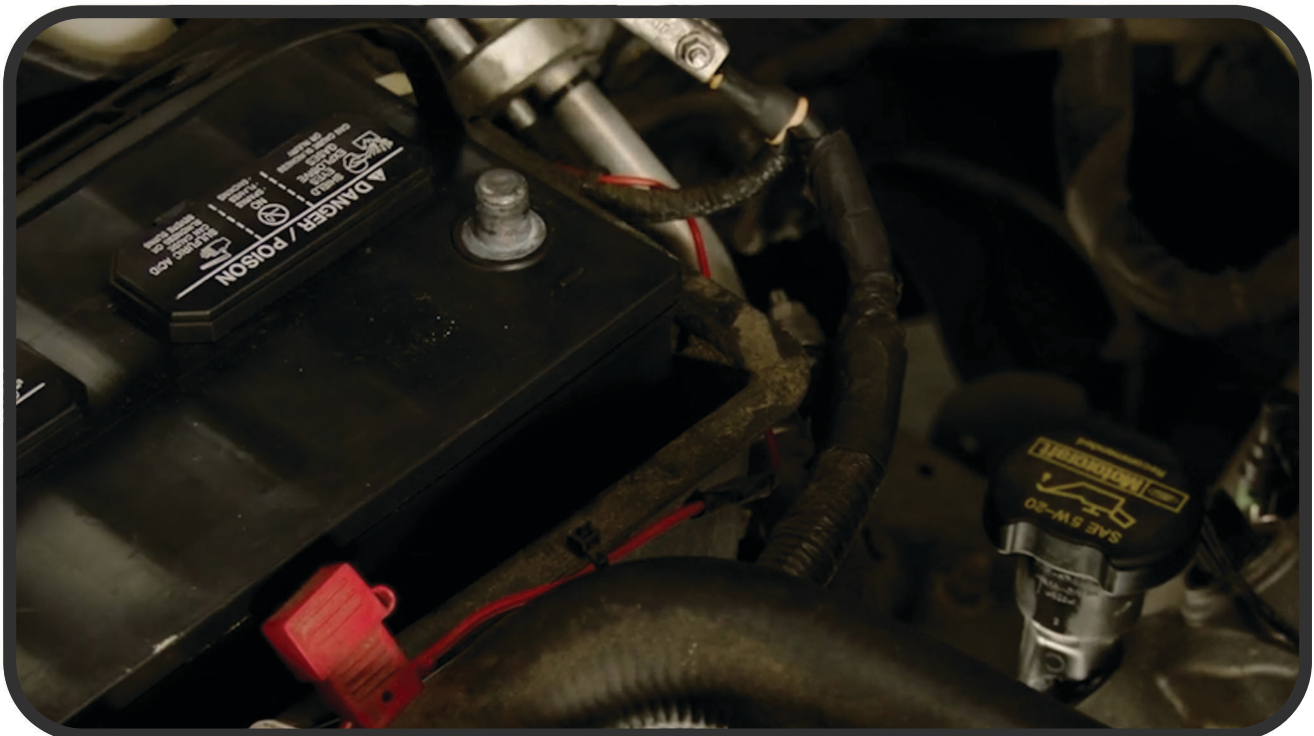
STEP 1:
DISCONNECT THE NEGATIVE BATTERY TERMINAL

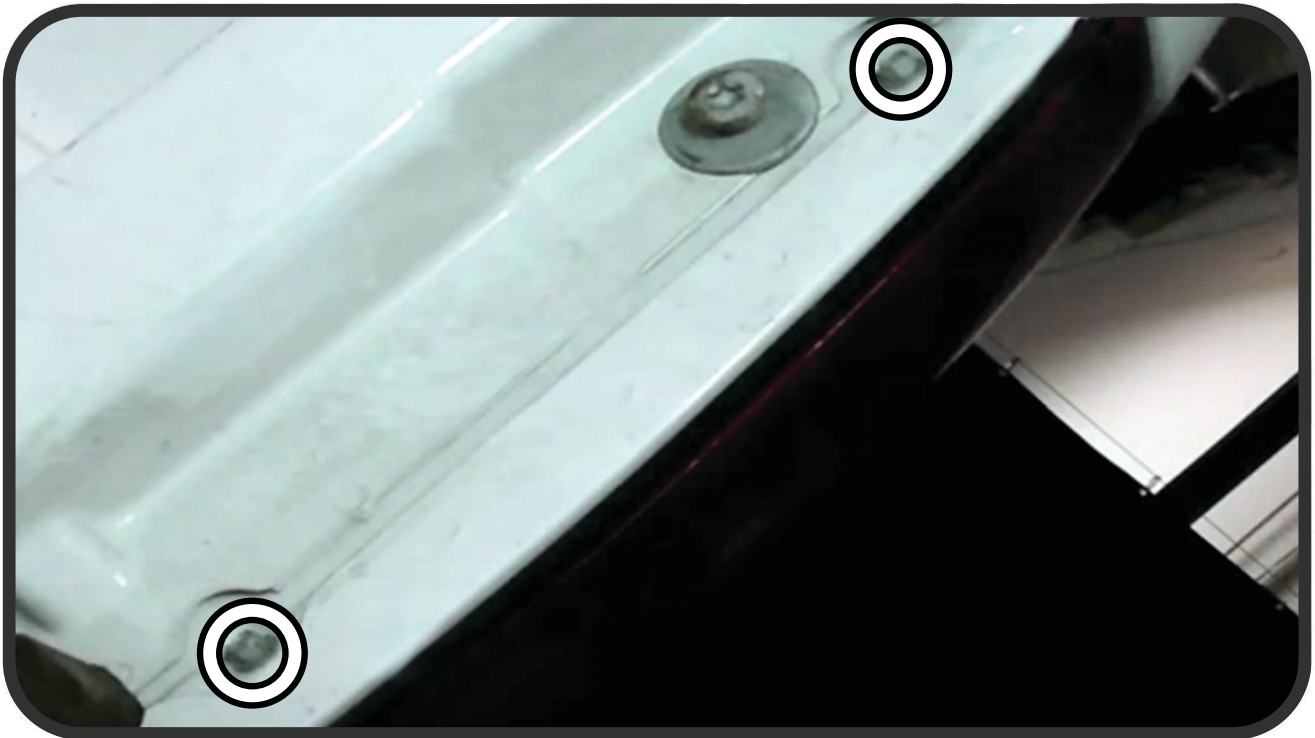
STEP 2:
REMOVE (2) 10MM BOLTS SECURING THE TAIL LIGHT

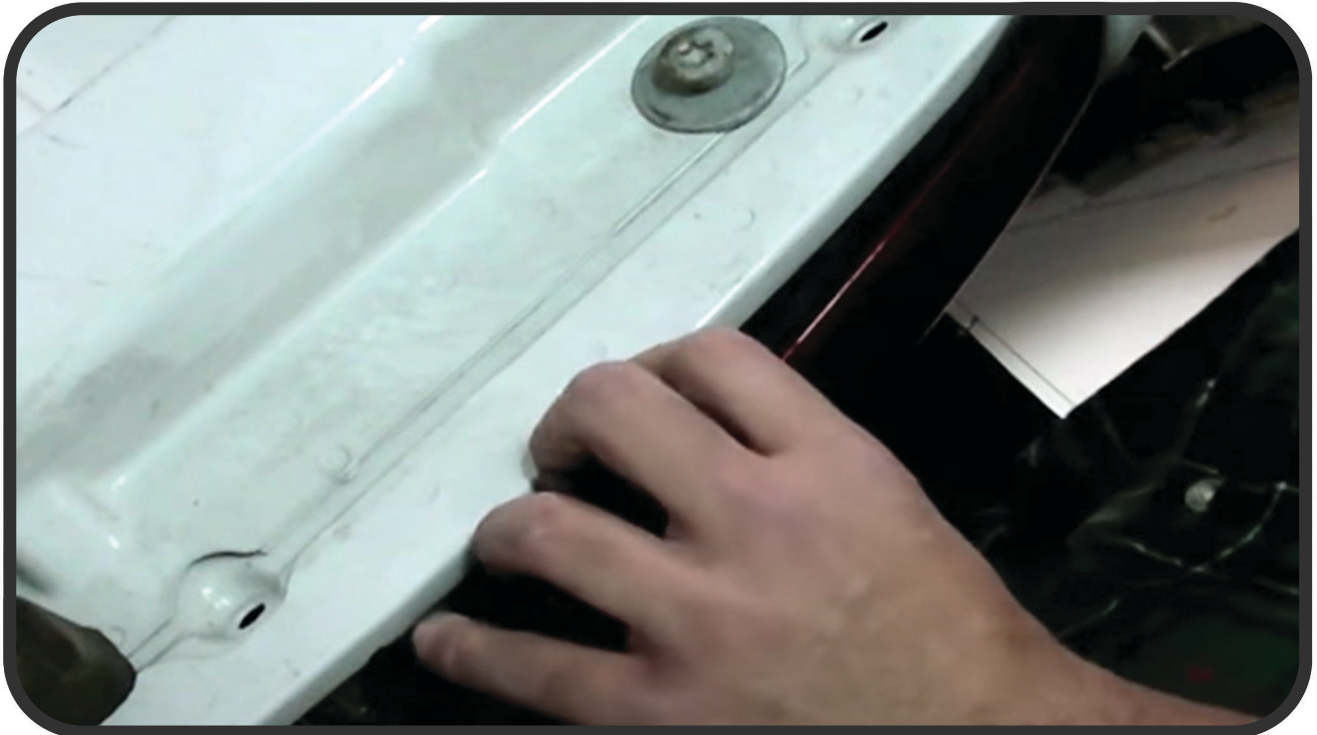
STEP 3:
UNSEAT THE TAIL LIGHT

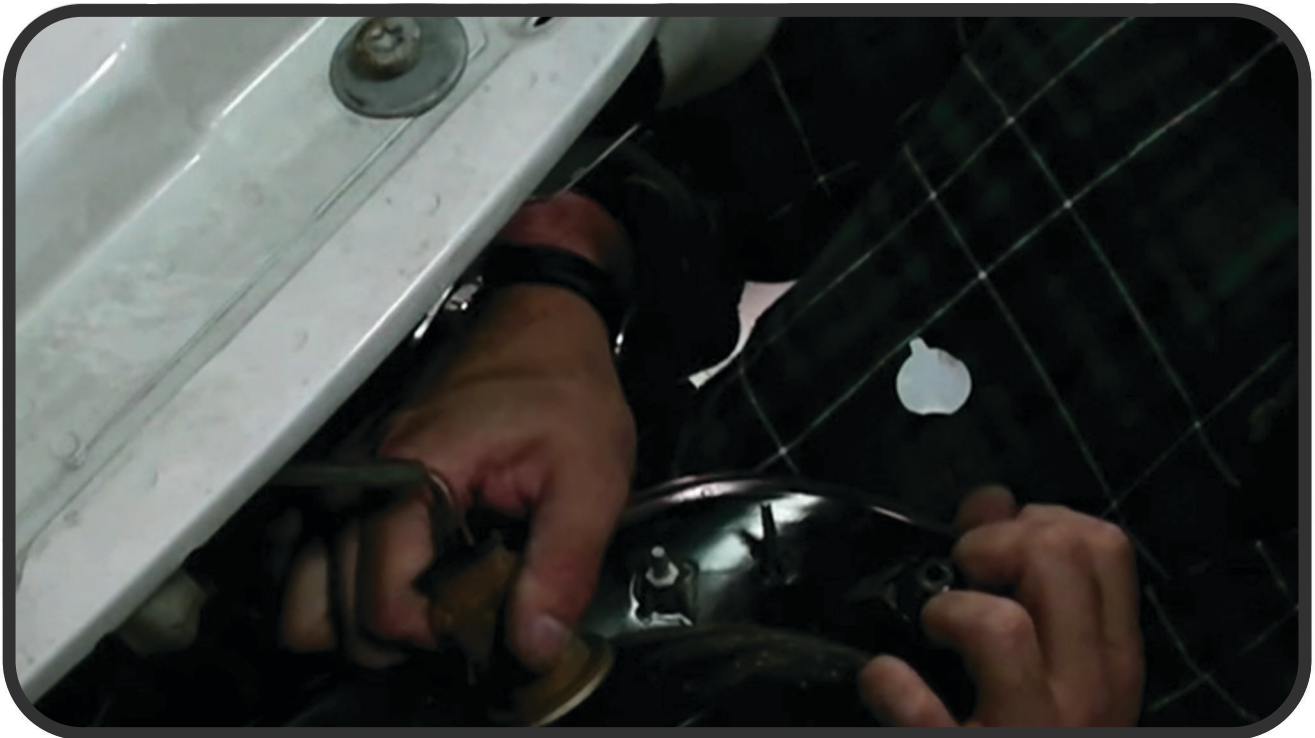
STEP 4:
REMOVE THE BRAKE AND REVERSE LIGHT SOCKETS
(NOTE: MAKE SURE NOT TO TOUCH BULB WITH BARE HANDS)

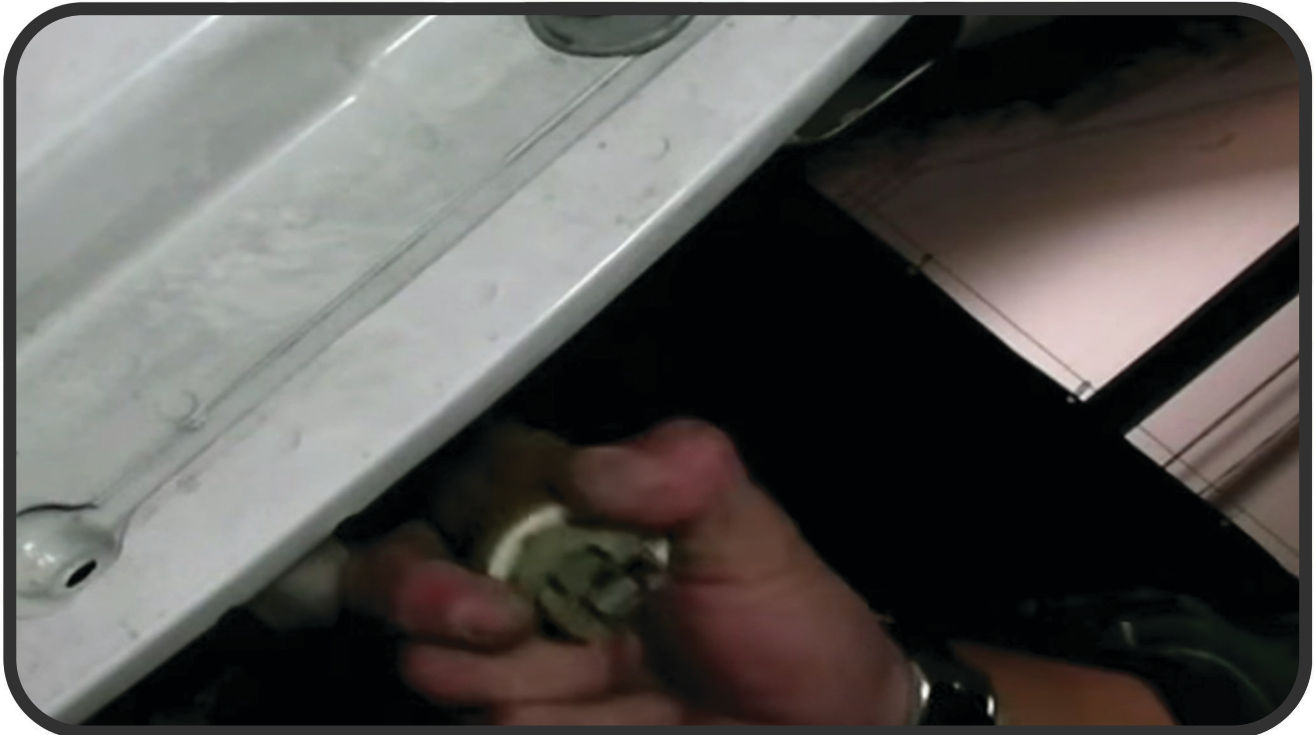
STEP 5:
REMOVE THE BRAKE BULB FROM SOCKET

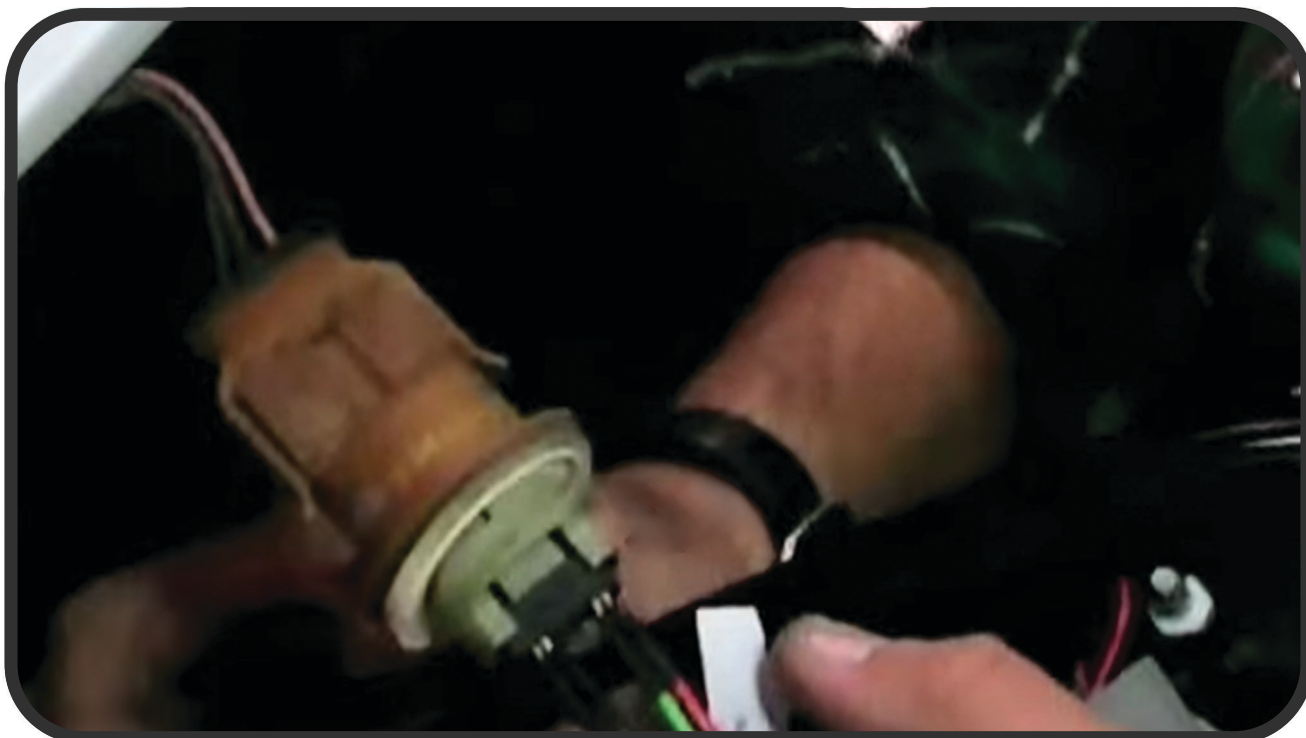
STEP 6:

CONNECT THE BRAKE BULB SOCKET TO THE SPYDER TAIL LIGHT ENSURING THE BLACK WIRE FROM THE SOCKET MATCHES THE BLACK WIRE FROM THE SPYDER TAIL LIGHT

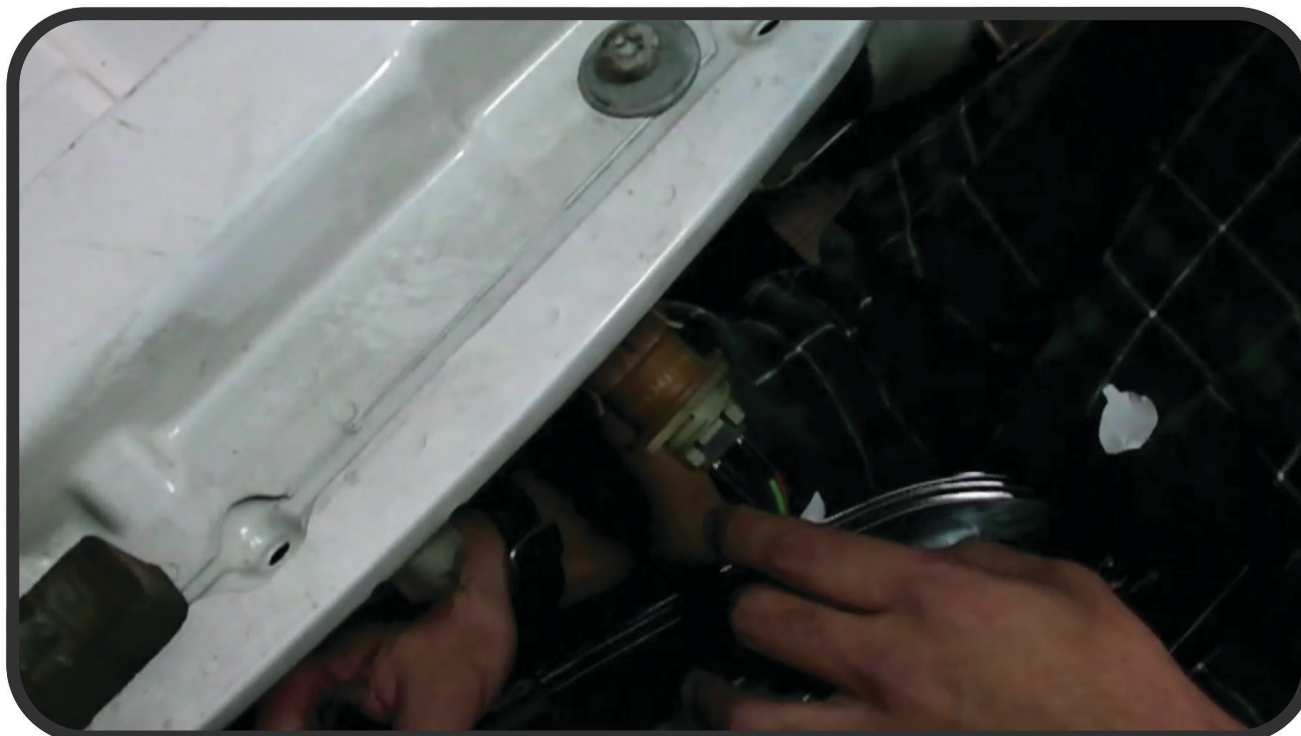
STEP 7:

REINSTALL THE REVERSE SOCKET AND BRAKE SOCKET

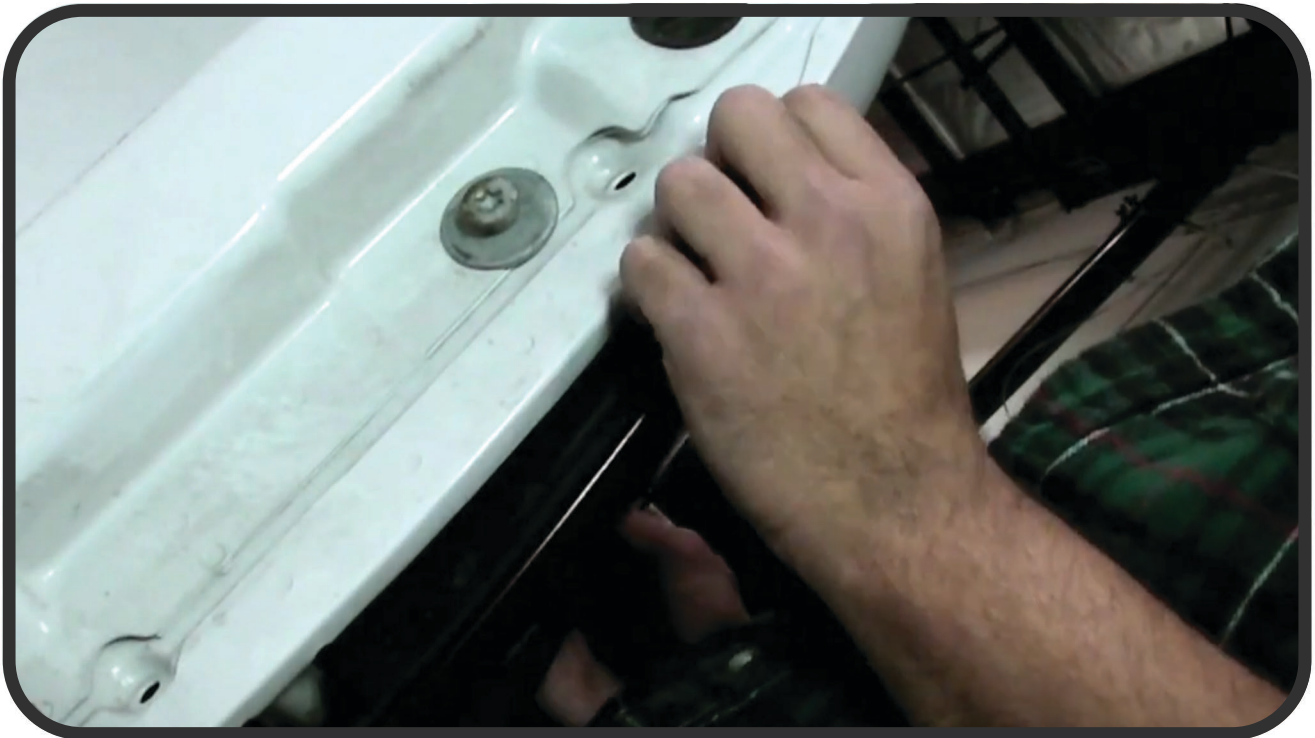
STEP 8:
SEAT THE SPYDER TAIL LIGHT

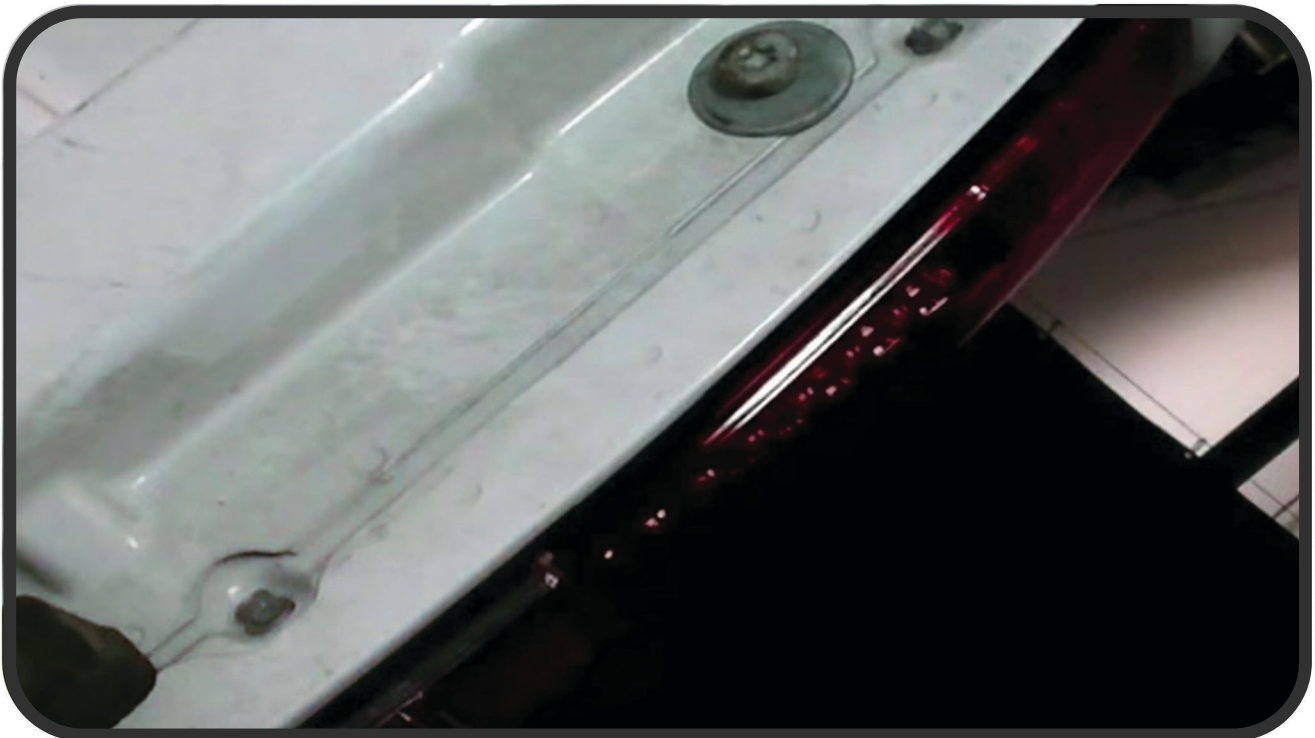
STEP 9:
REINSTALL THE (2) 10MM BOLTS TO SECURE THE TAIL LIGHT

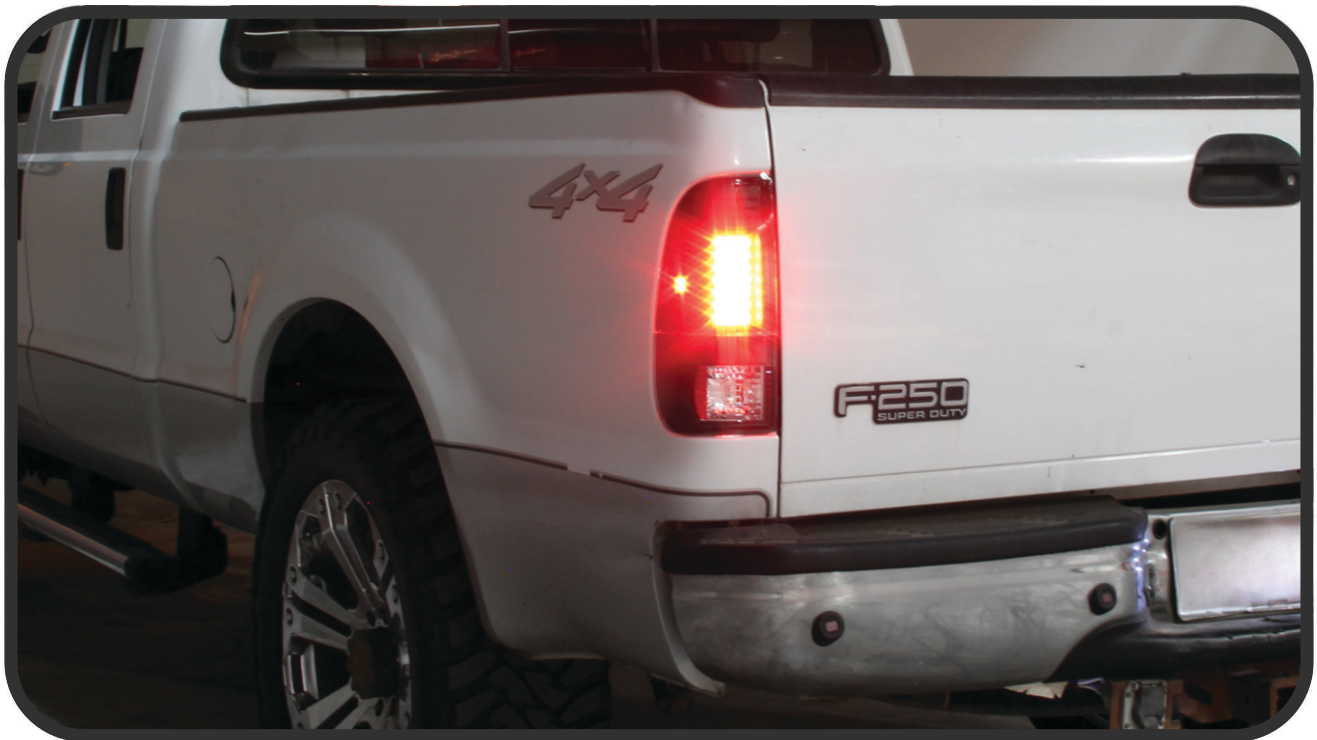
STEP 10:

RECONNECT THE BATTERY AND TEST THE FUNCTIONS TO ENSURE THEY FUNCTION PROPERLY
