# SPYDER<sup>TM</sup>

## SKU# 5085580

### FITMENT:

• 2017-2018 FORD F250 SUPERDUTY

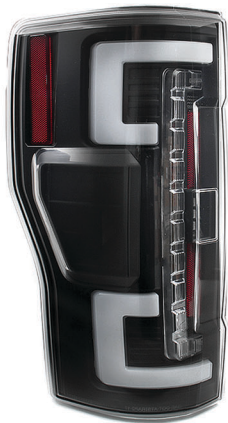
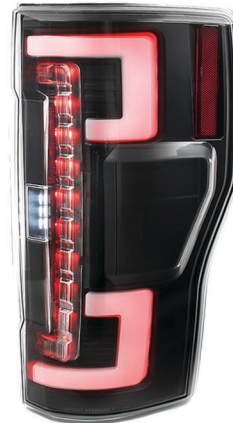
### PACKAGE CONTENTS:

• 2X TAIL LIGHT ASSEMBLIES

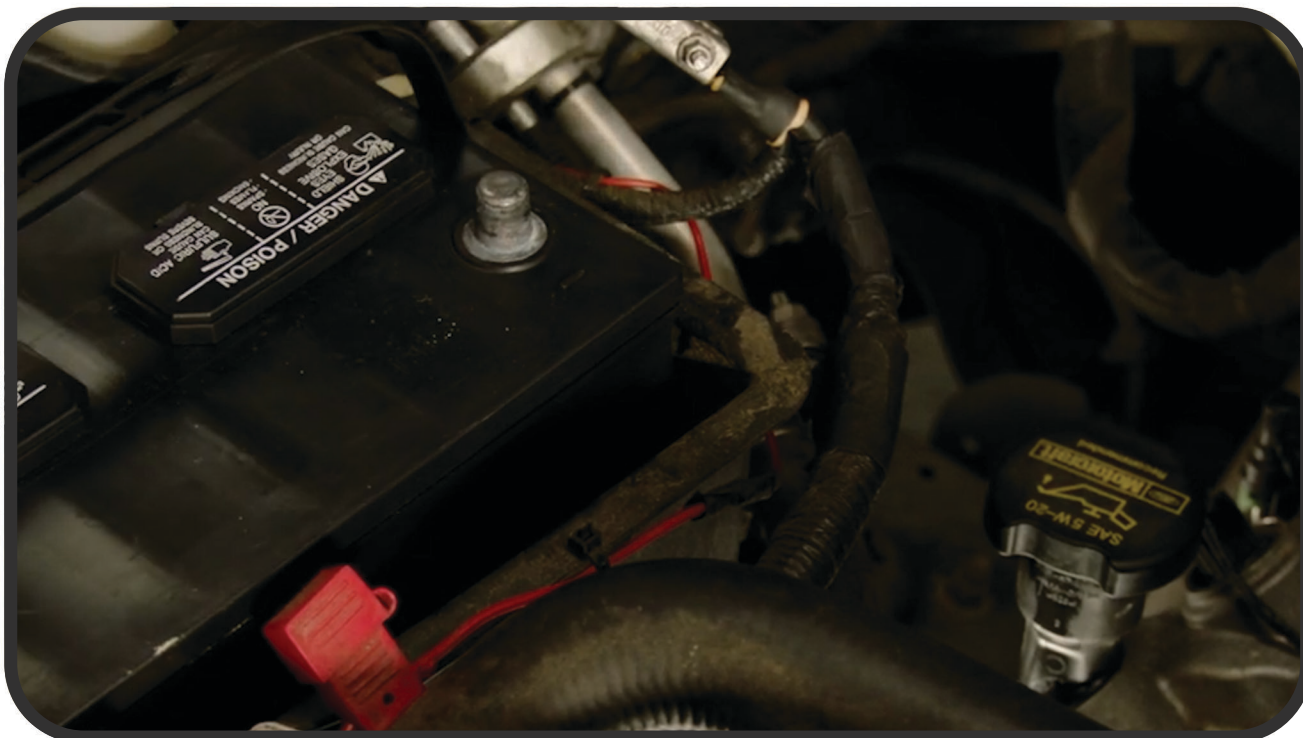
**STEP 1:**

**DISCONNECT THE NEGATIVE BATTERY TERMINAL**

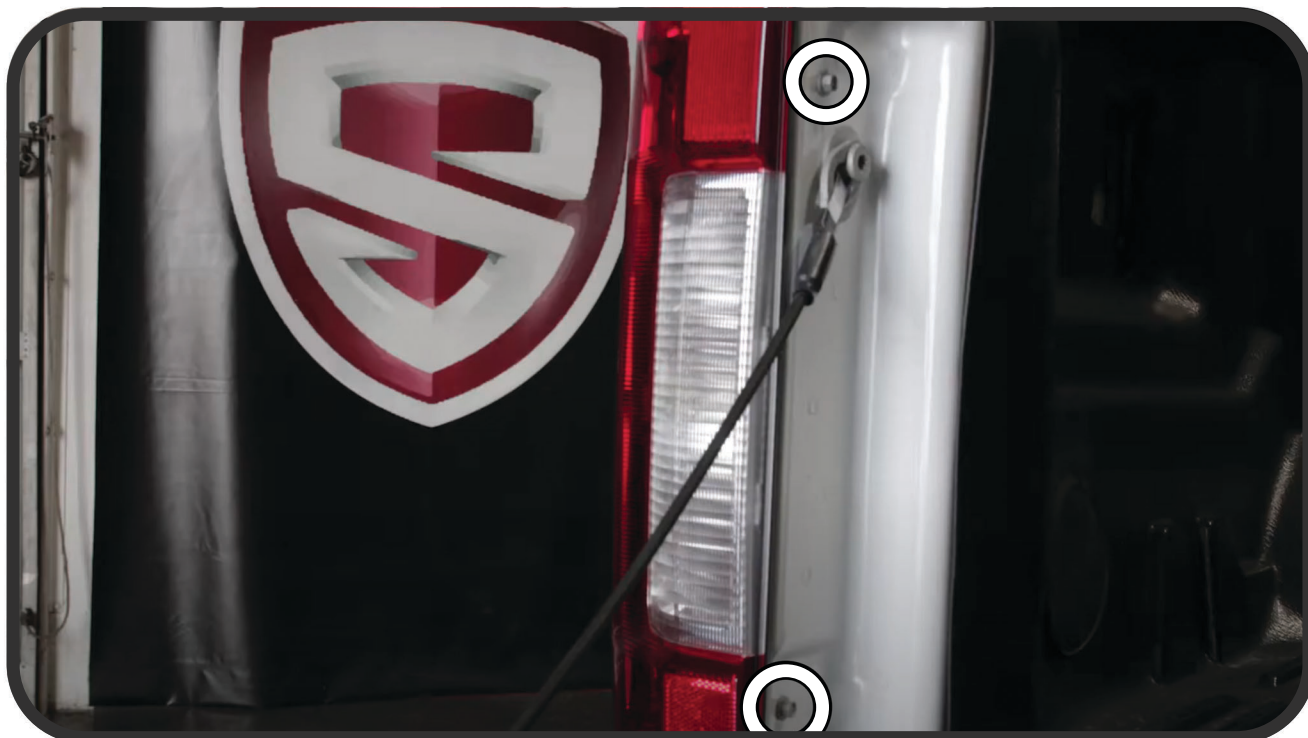
**STEP 2:**

**REMOVE (2) 8MM BOLTS SECURING THE TAIL LIGHT**

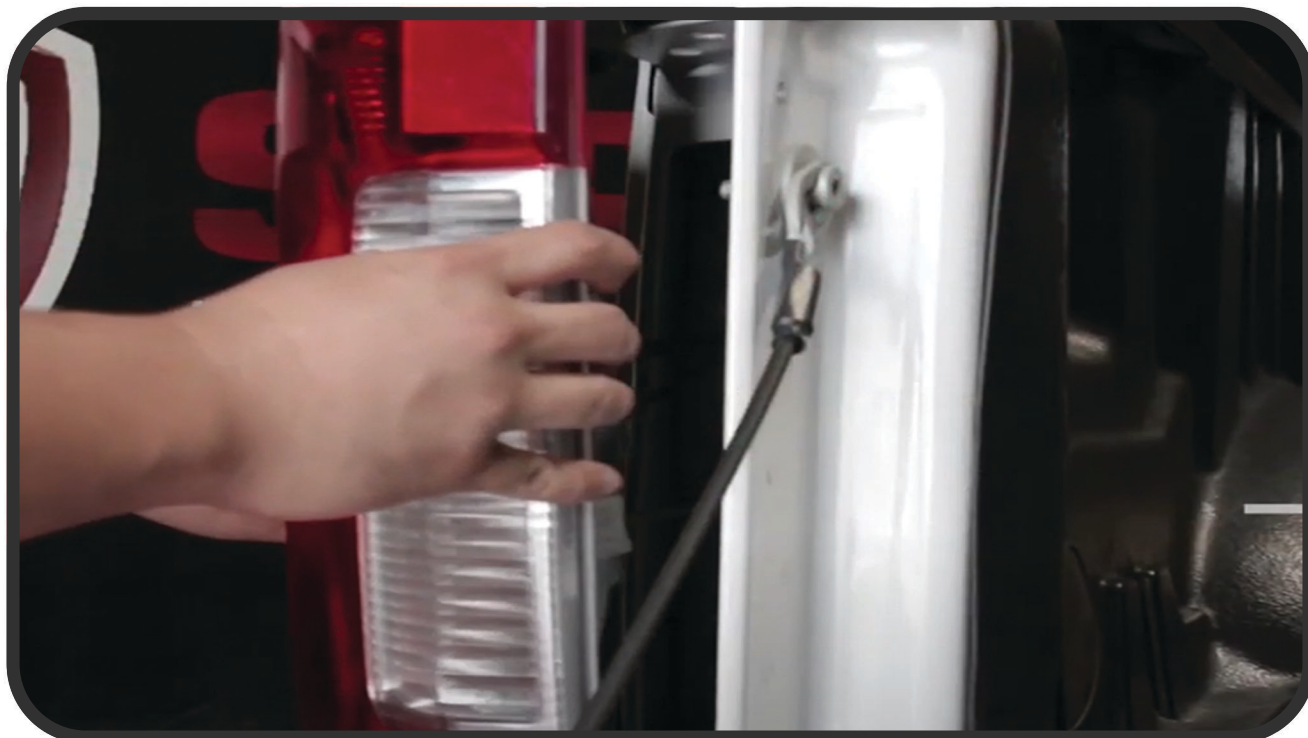
**STEP 3:**

**UNSEAT THE TAIL LIGHT**

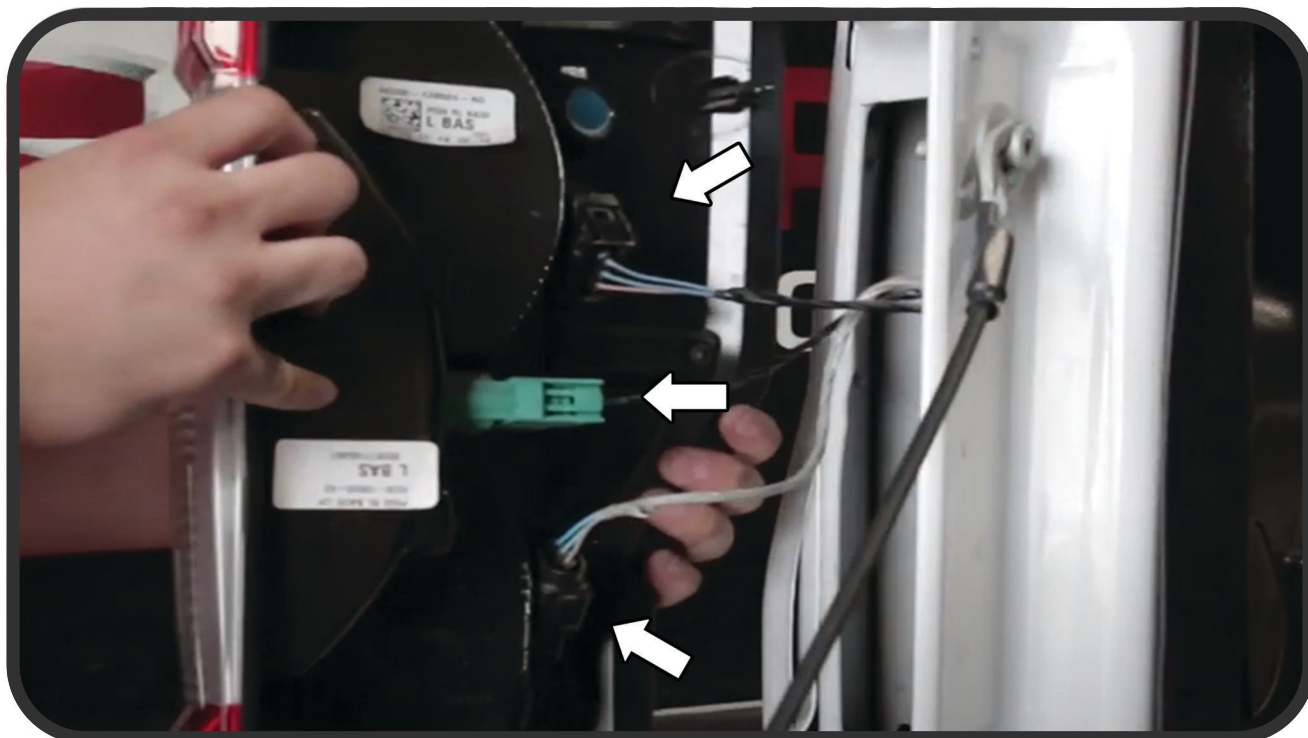
**STEP 4:**

**DISCONNECT THE (3) HARNESSES ATTACHED TO THE TAIL LIGHT**

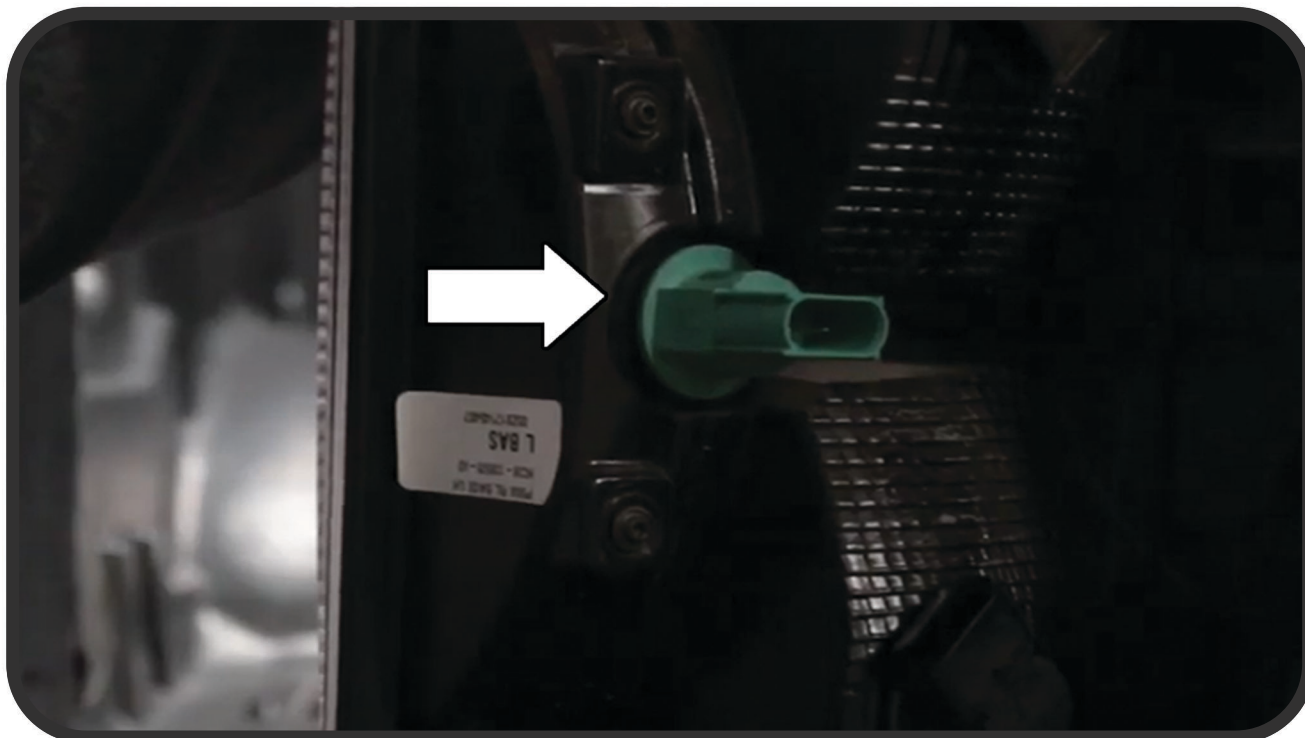
**STEP 5:**

**REMOVE THE REVERSE BULB SOCKET AND DISCONNECT THE BULB  
(NOTE: NEVER TOUCH BULB WITH BARE HANDS)**

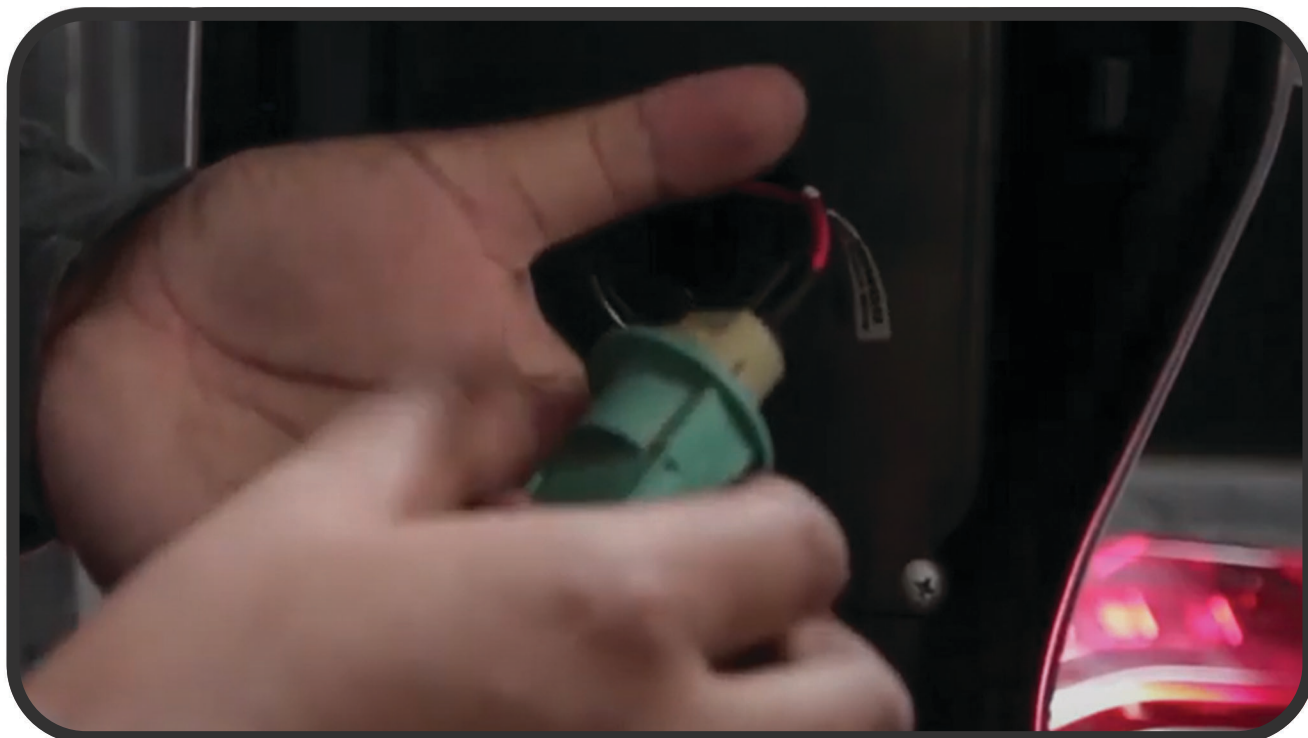
**STEP 6:**

**INSTALL REVERSE SOCKET INSERT INTO THE REVERSE SOCKET AND ENSURE THE BLACK WIRE OF THE SOCKET MATCHES THE BLACK WIRE OF THE SOCKET INSERT**

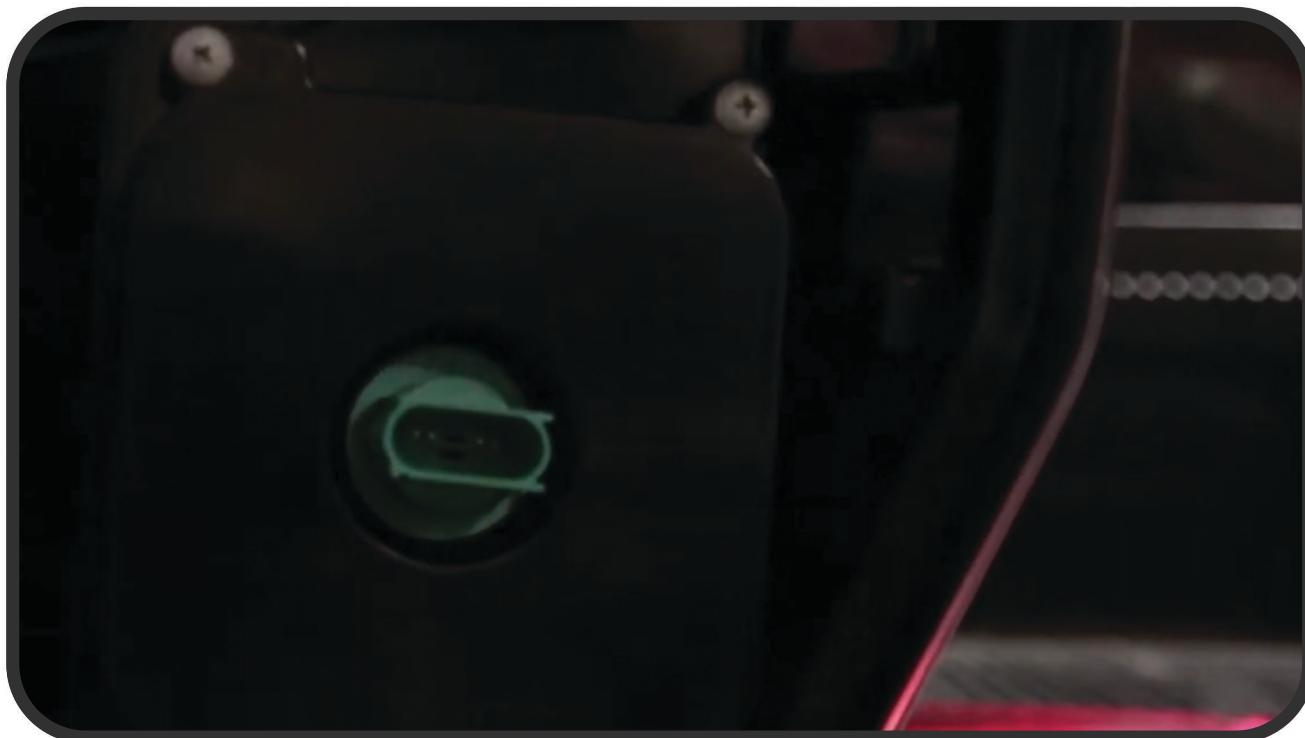
**STEP 7:**

**INSTALL REVERSE SOCKET INTO THE SPYDER TAIL LIGHT**

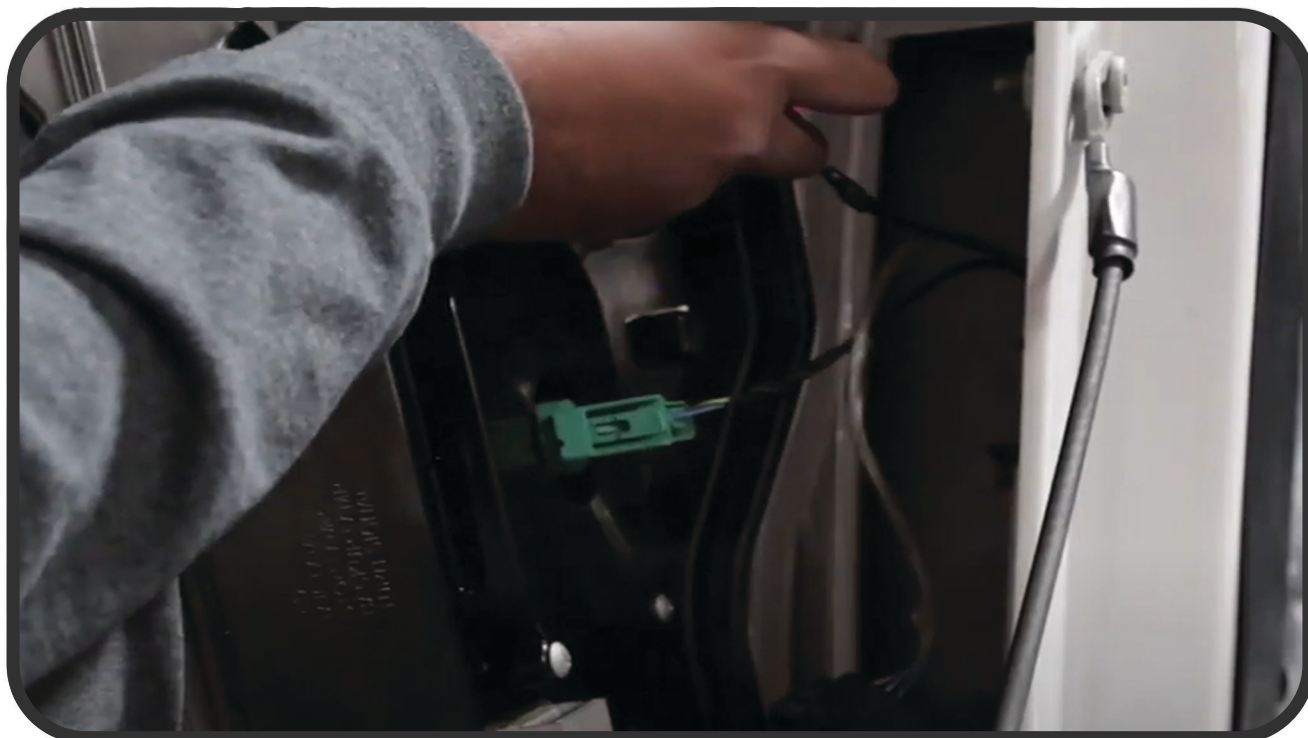
**STEP 8:****CONNECT THE (3) TAIL LIGHT HARNESSES**

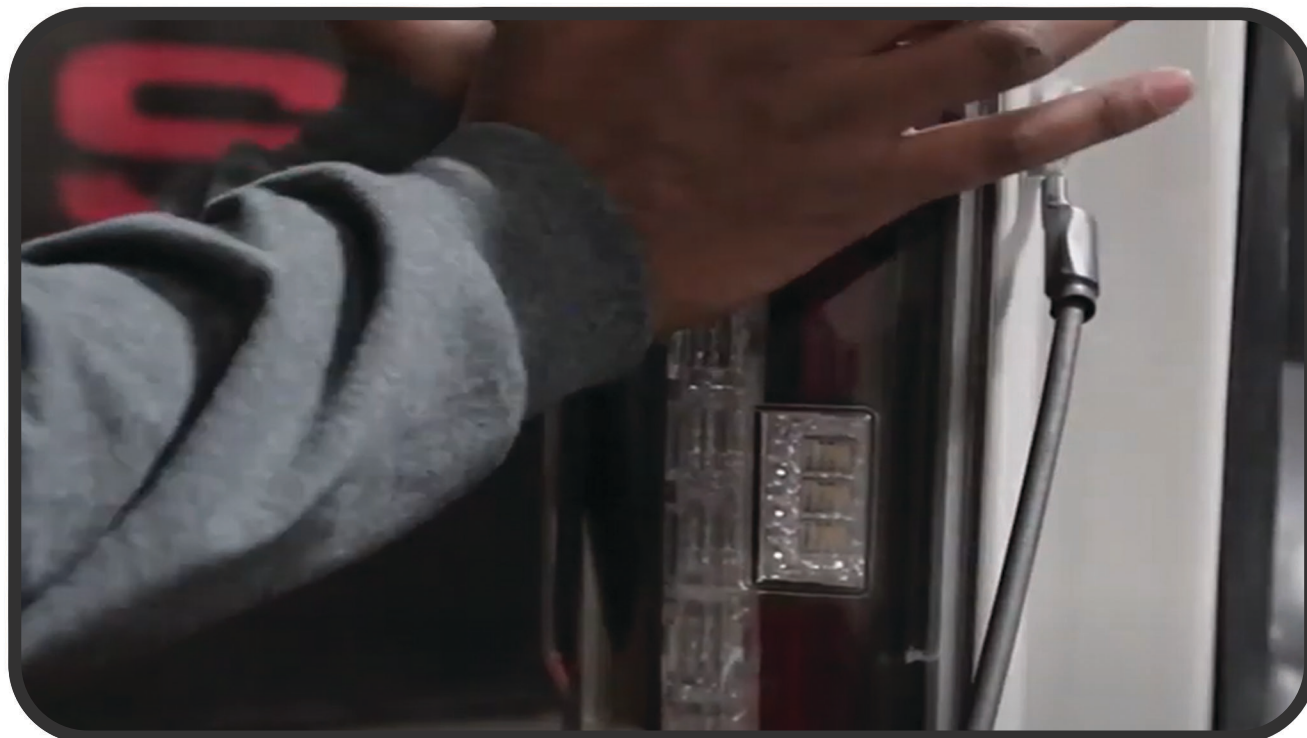
**STEP 9:****SEAT THE TAIL LIGHT**

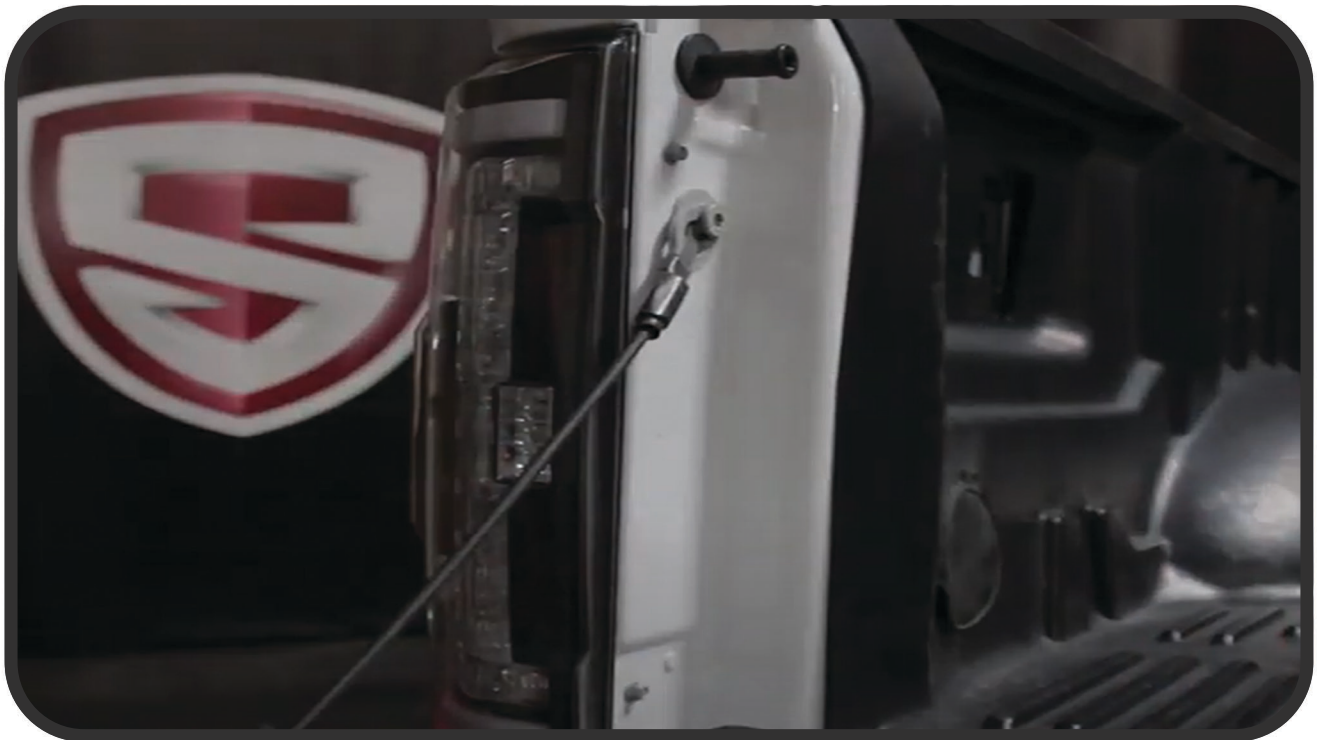
**STEP 10:**  
**REINSTALL THE (2) 8MM BOLTS**

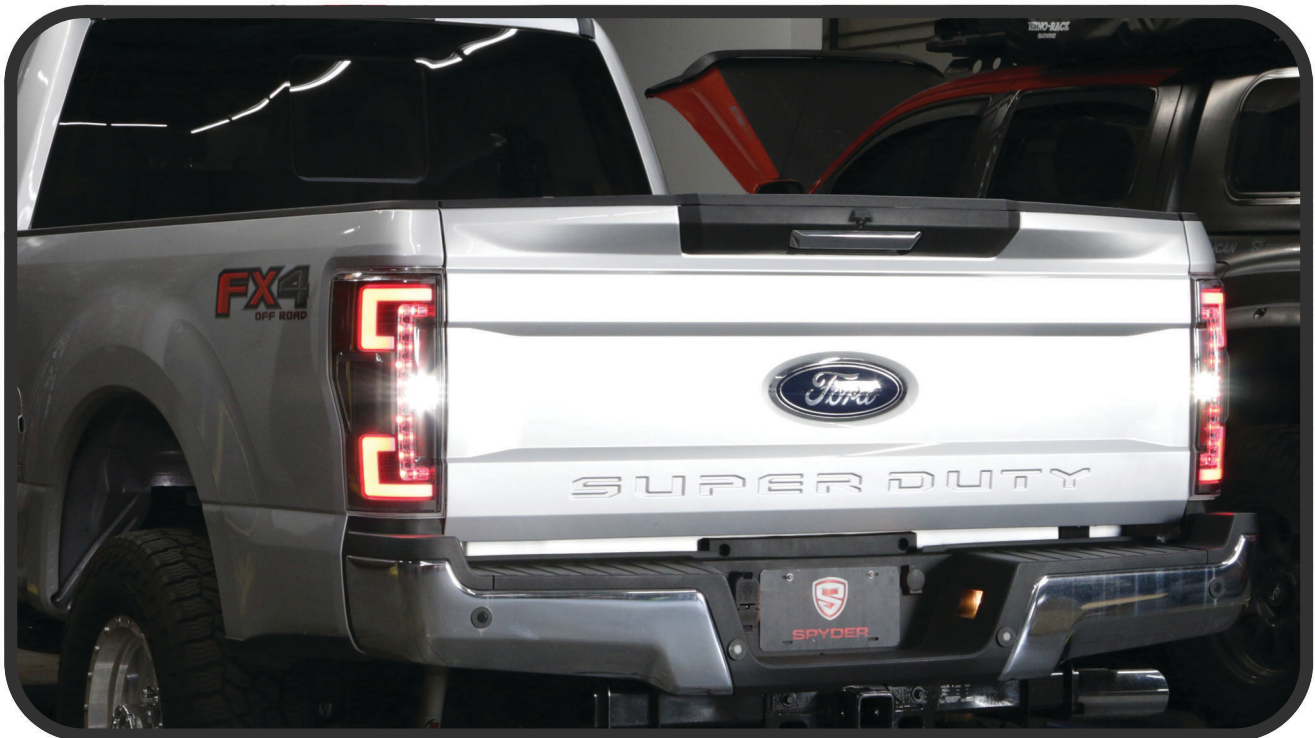
**STEP 11:**  
**RECONNECT THE BATTERY AND TEST THE FUNCTIONS TO ENSURE THEY FUNCTION PROPERLY**
