# SPYDER™

## SKU# 5085702

• 2015-2019 GMC YUKON/YUKON XL

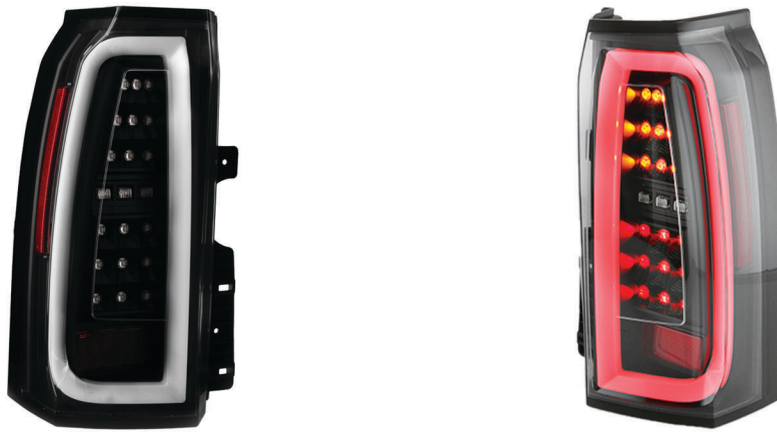
• 2X TAIL LIGHT ASSEMBLIES

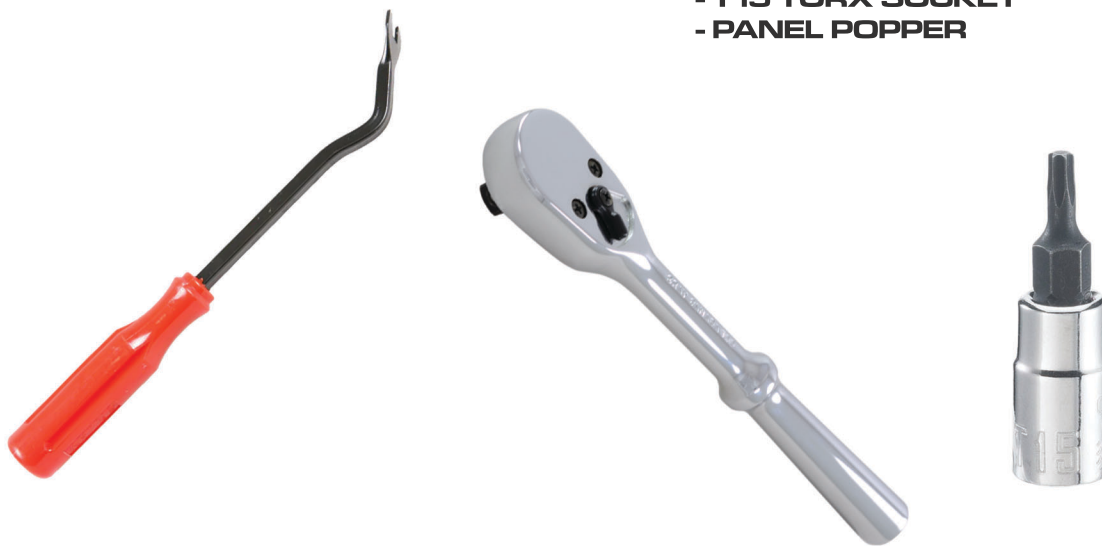
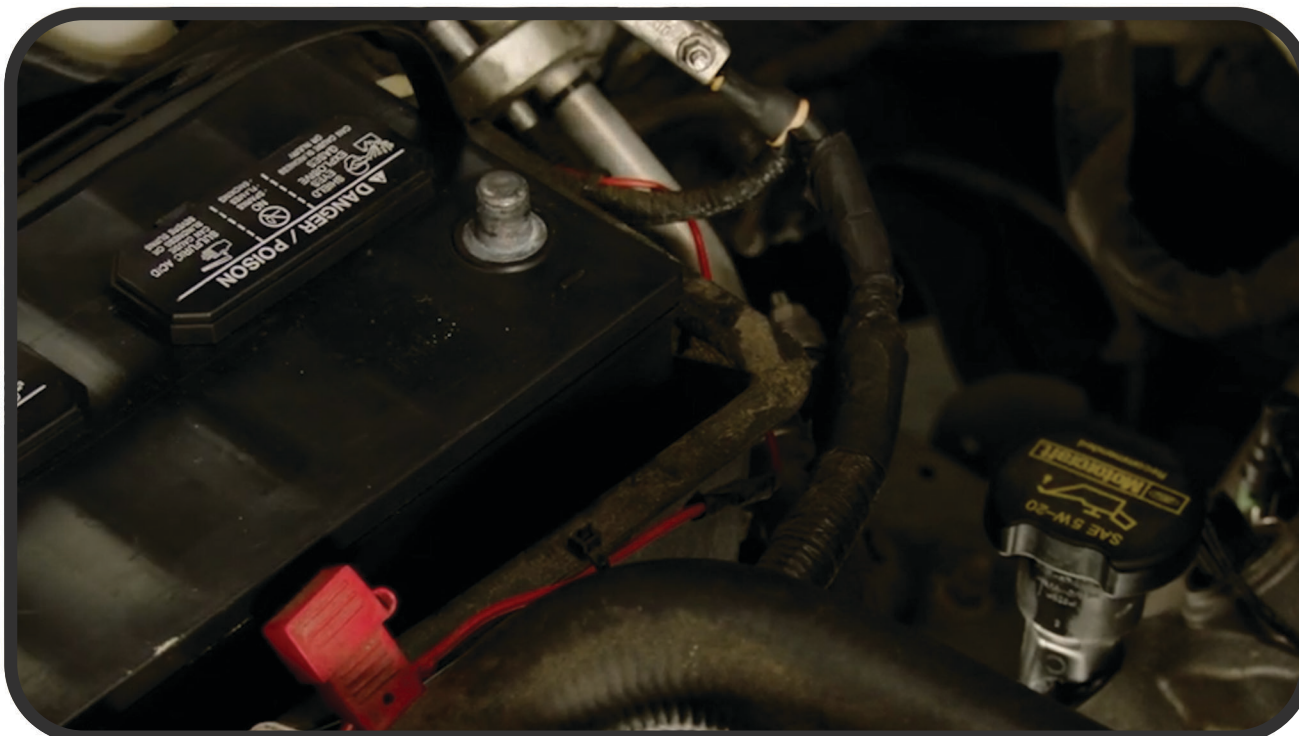
**STEP 1:****DISCONNECT THE NEGATIVE BATTERY TERMINAL**

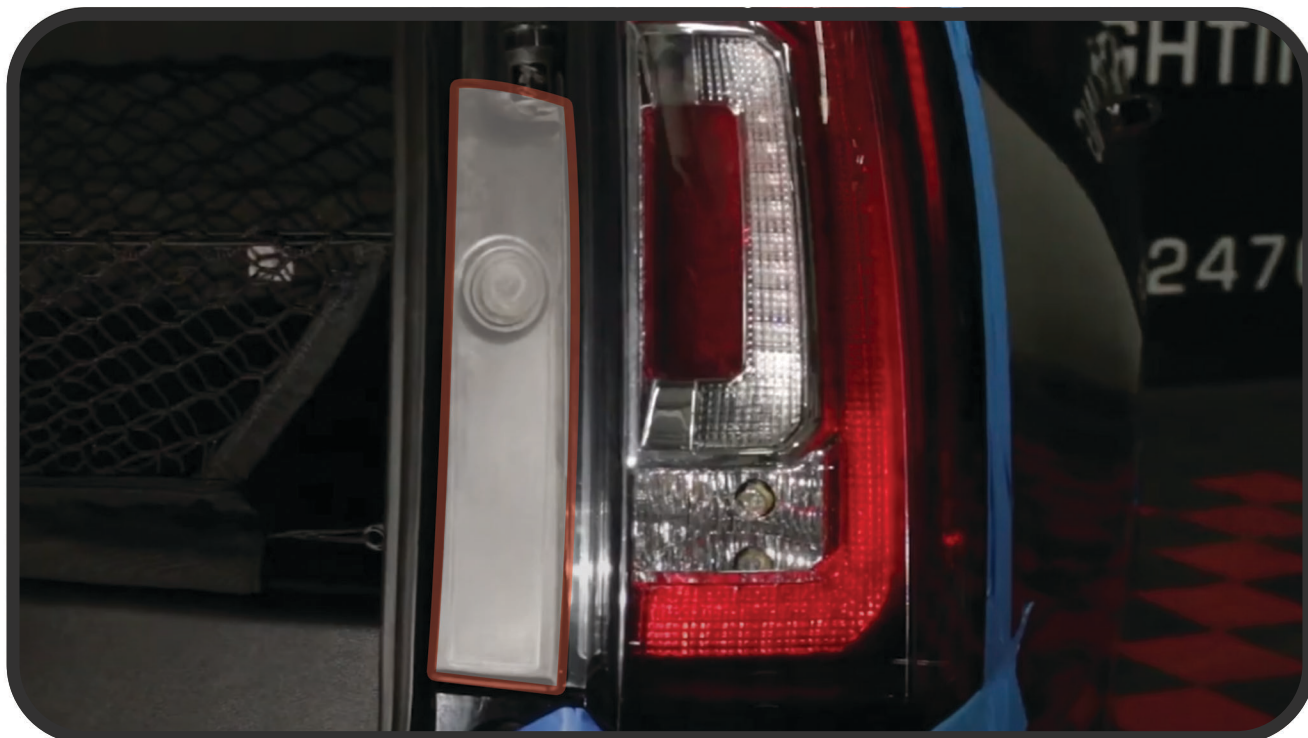
**STEP 2:**

**REMOVE THE TAIL LIGHT TRIM PANEL USING A PANEL POPPER**

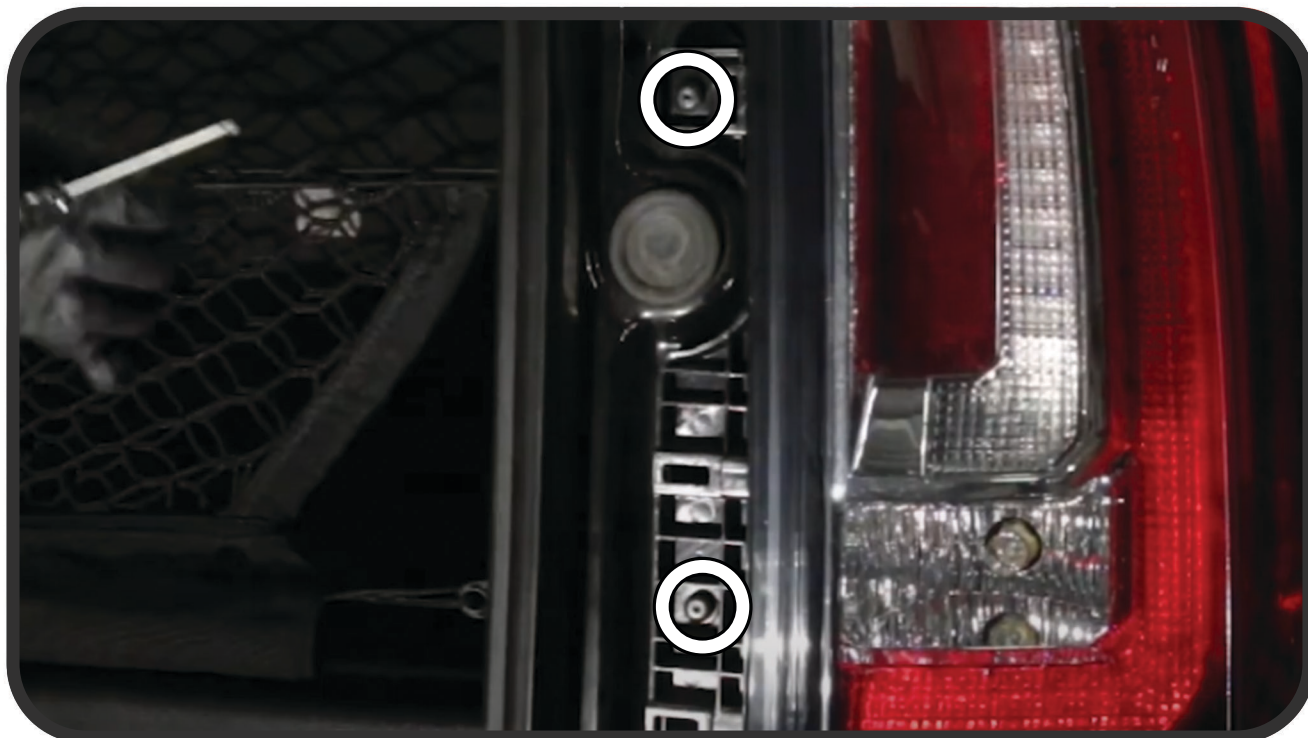
**STEP 3:**

**REMOVE THE (2) T15 TORX BOLTS SECURING THE TAIL LIGHT**

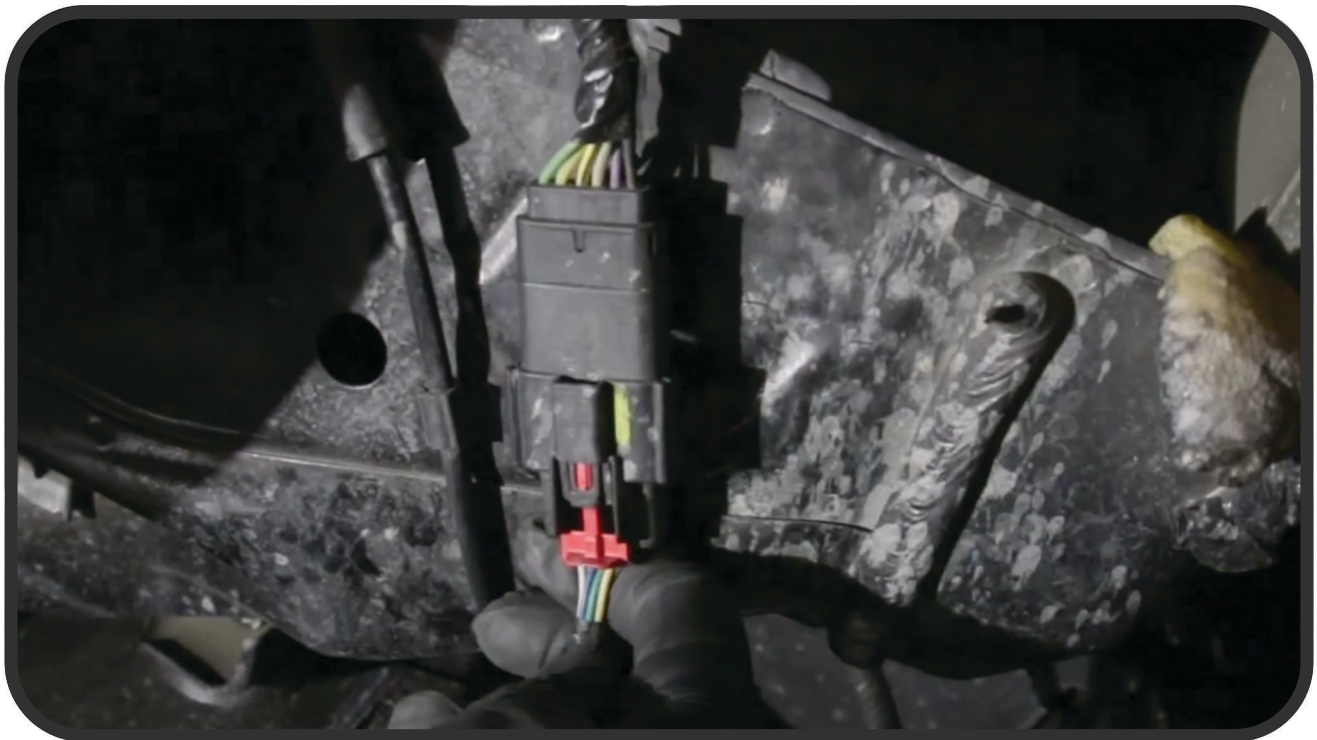
**STEP 4:**

**DISCONNECT THE HARNESS UNDERNEATH THE VEHICLE**

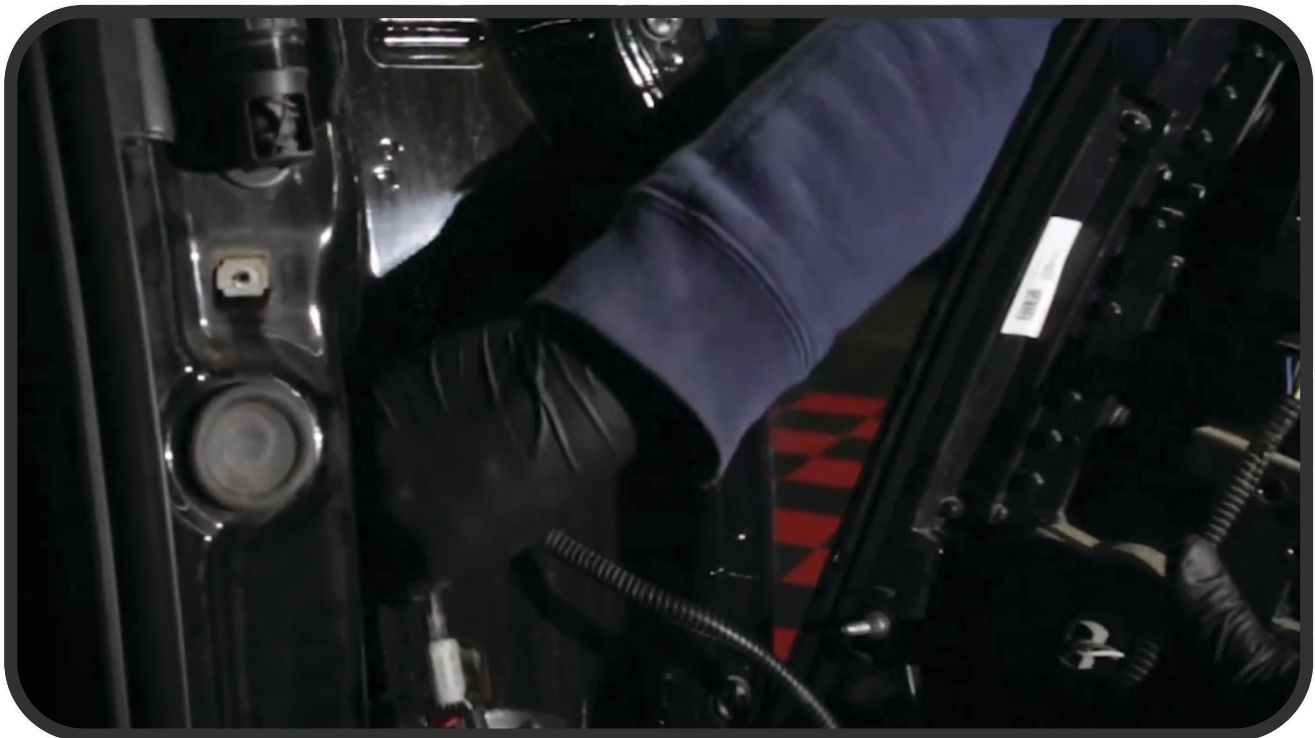
**STEP 5:**

**CAREFULLY UNSEAT THE HEADLIGHT AND THREAD THE TAIL LIGHT HARNESS OUT**

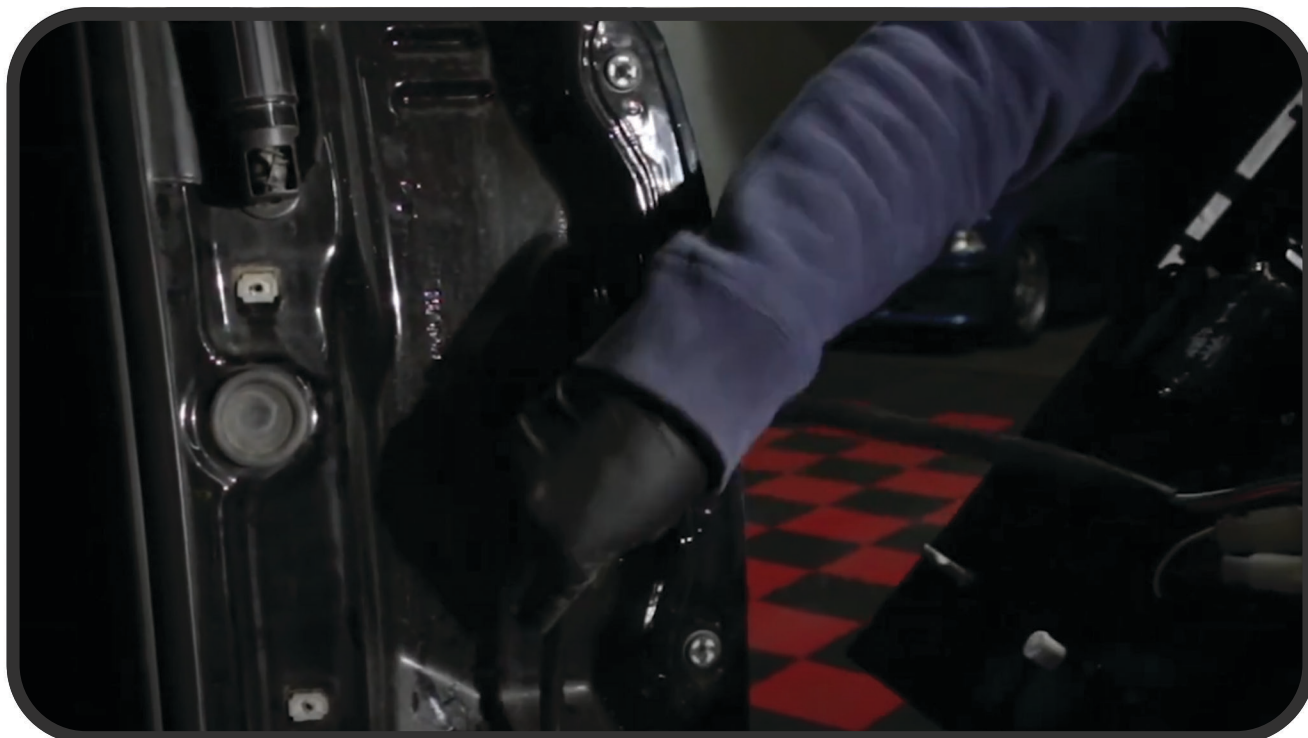
**STEP 6:**  
**FEED SPYDER HARNESS INTO THE VEHICLE**

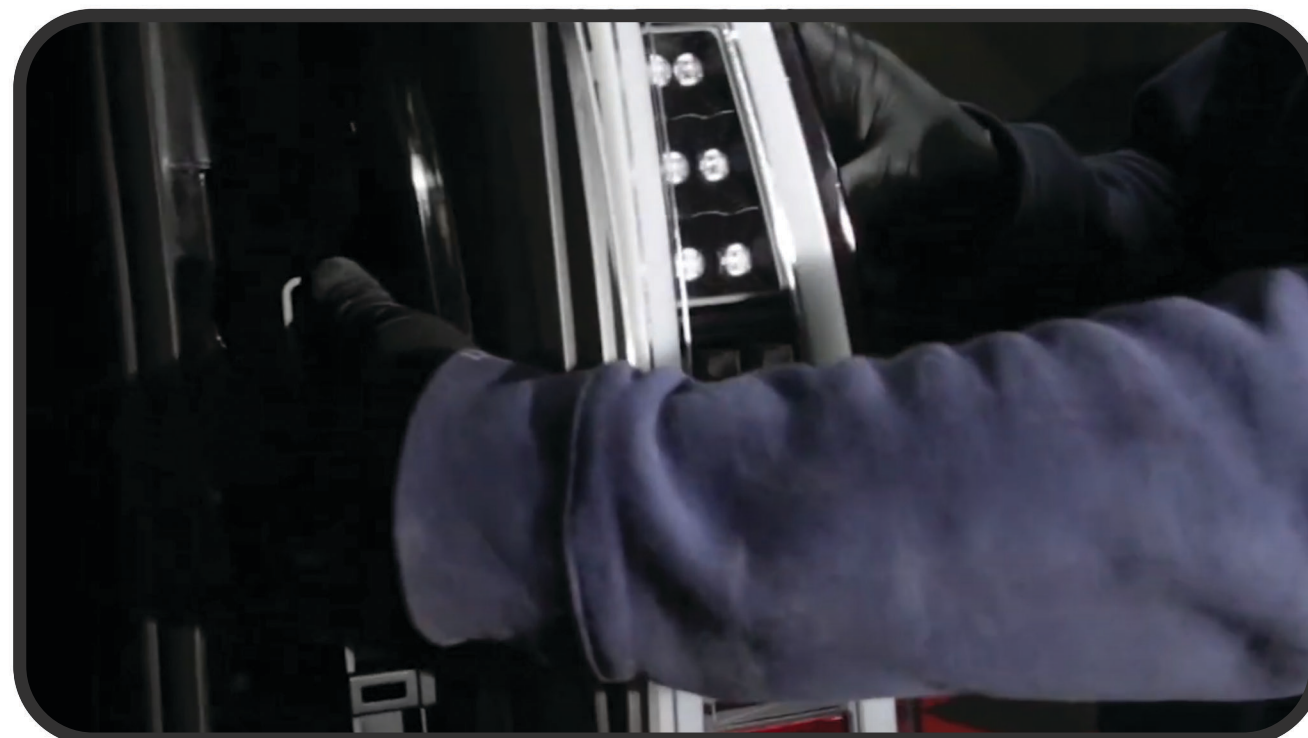
**STEP 7:**  
**SEAT THE SPYDER TAIL LIGHT**

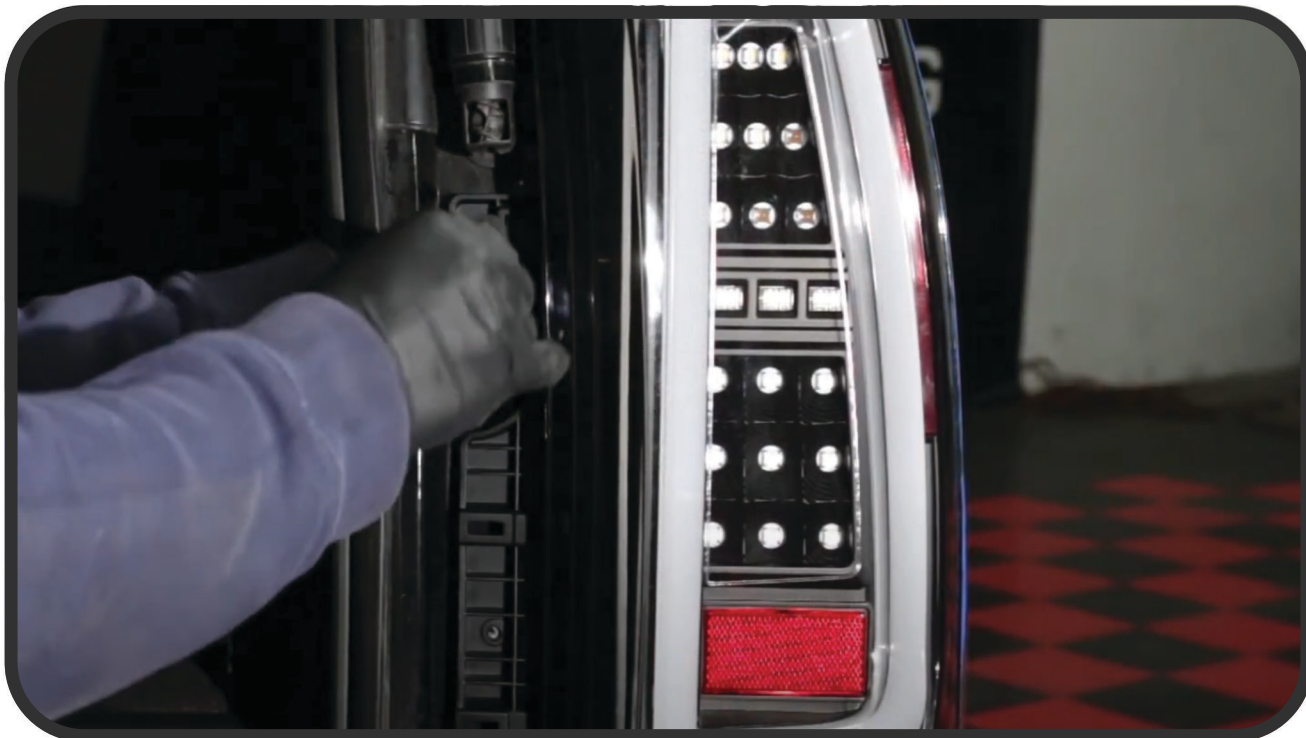
**STEP 8:**

**REINSTALL THE (2) T15 TORX SCREWS TO SECURE THE TAIL LIGHT**

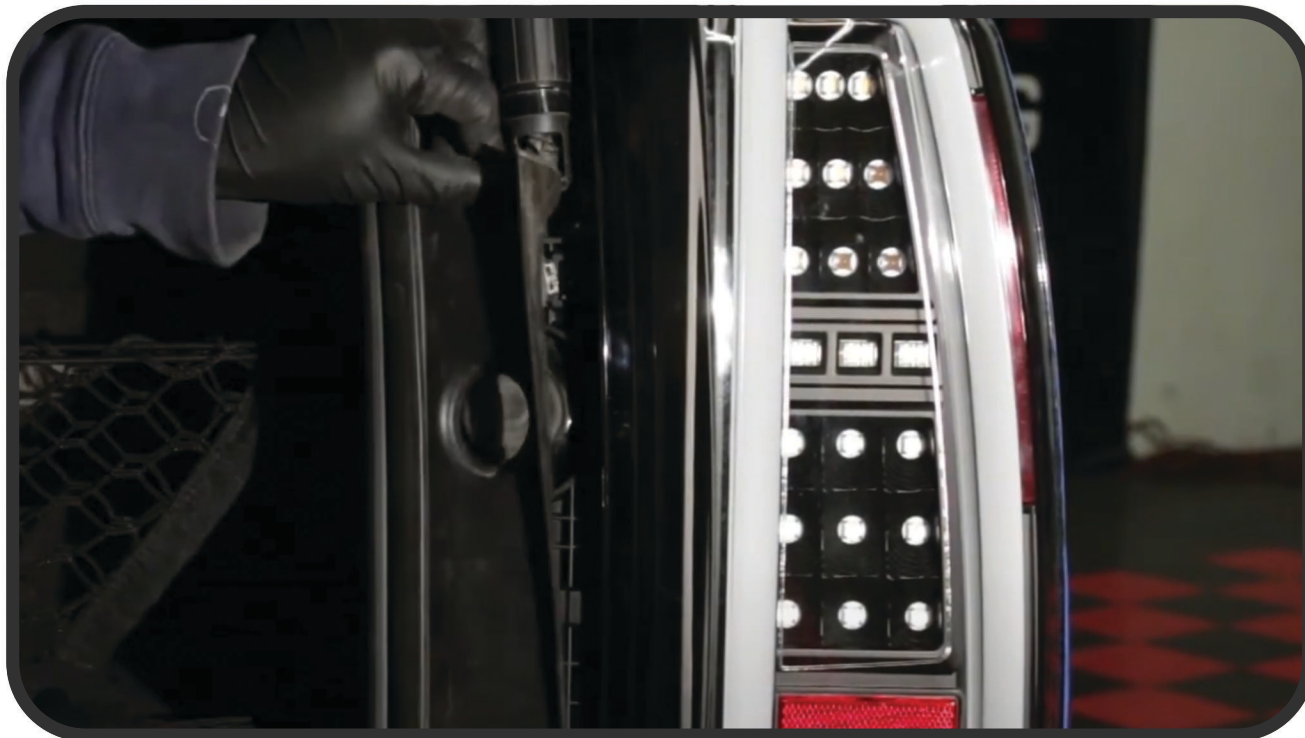
**STEP 9:**

**REINSTALL THE TRIM PANEL**

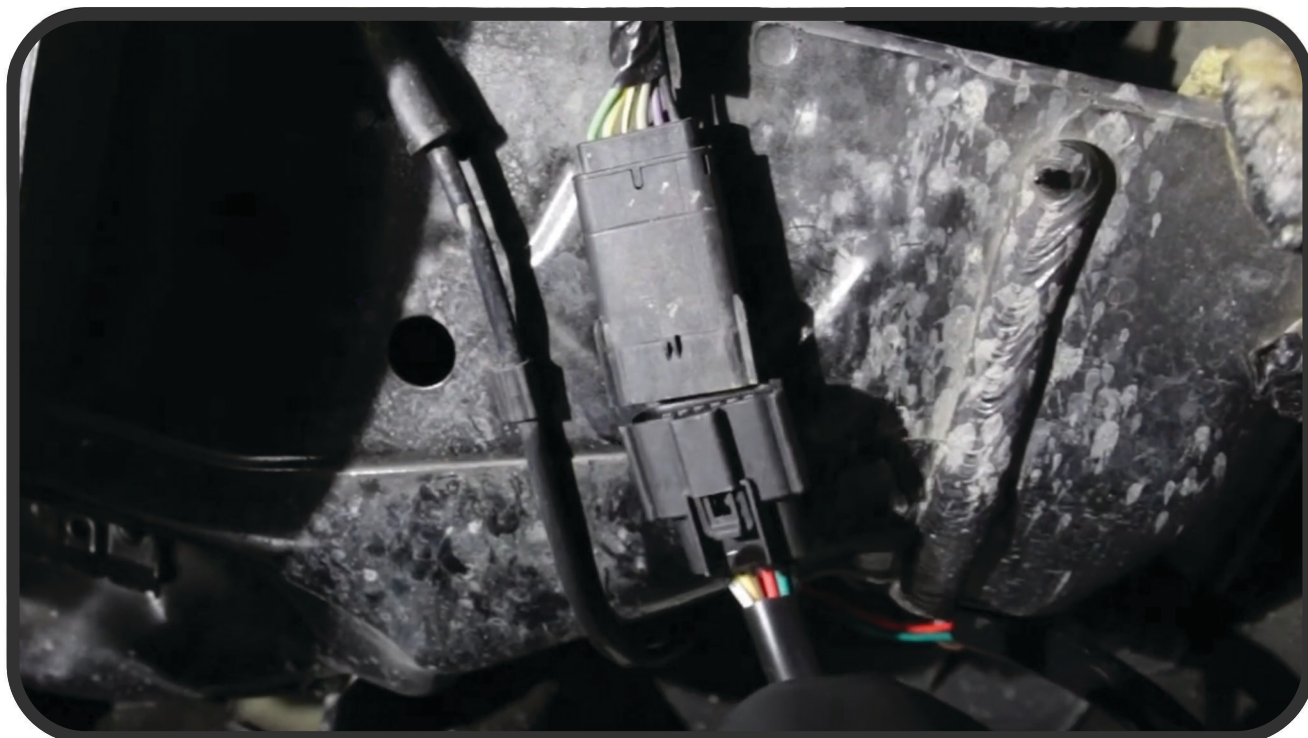
**STEP 10:**  
**CONNECT THE TAIL LIGHT HARNESS**

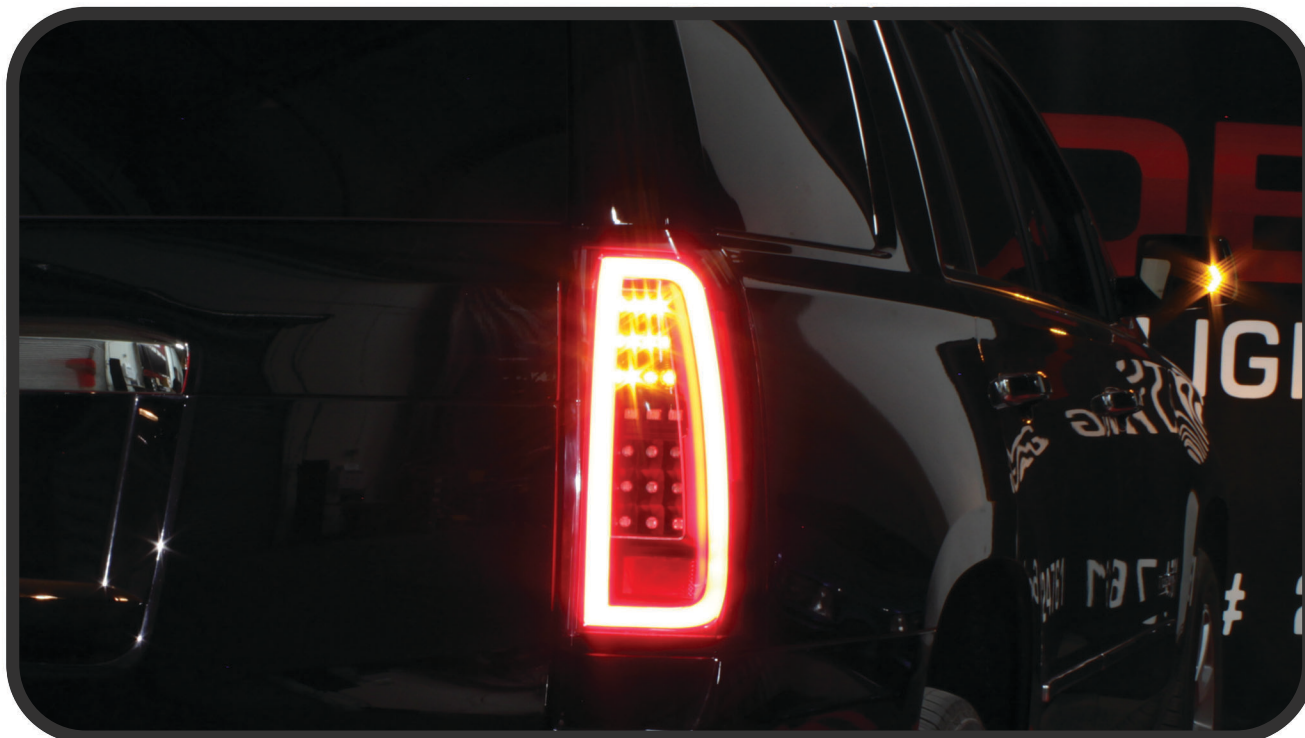
**STEP 11:**  
**RECONNECT THE BATTERY AND TEST THE FUNCTIONS TO ENSURE  
THEY FUNCTION PROPERLY**
