SPYDER™

SKU# 5085733

• 2016-2019 TOYOTA TACOMA

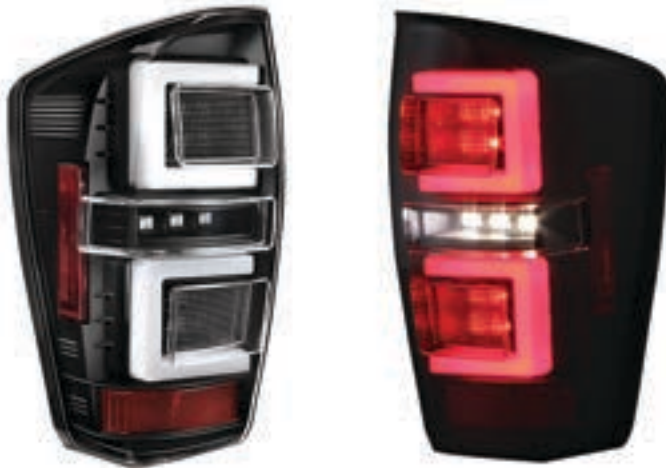
• 2X TAIL LIGHT ASSEMBLIES

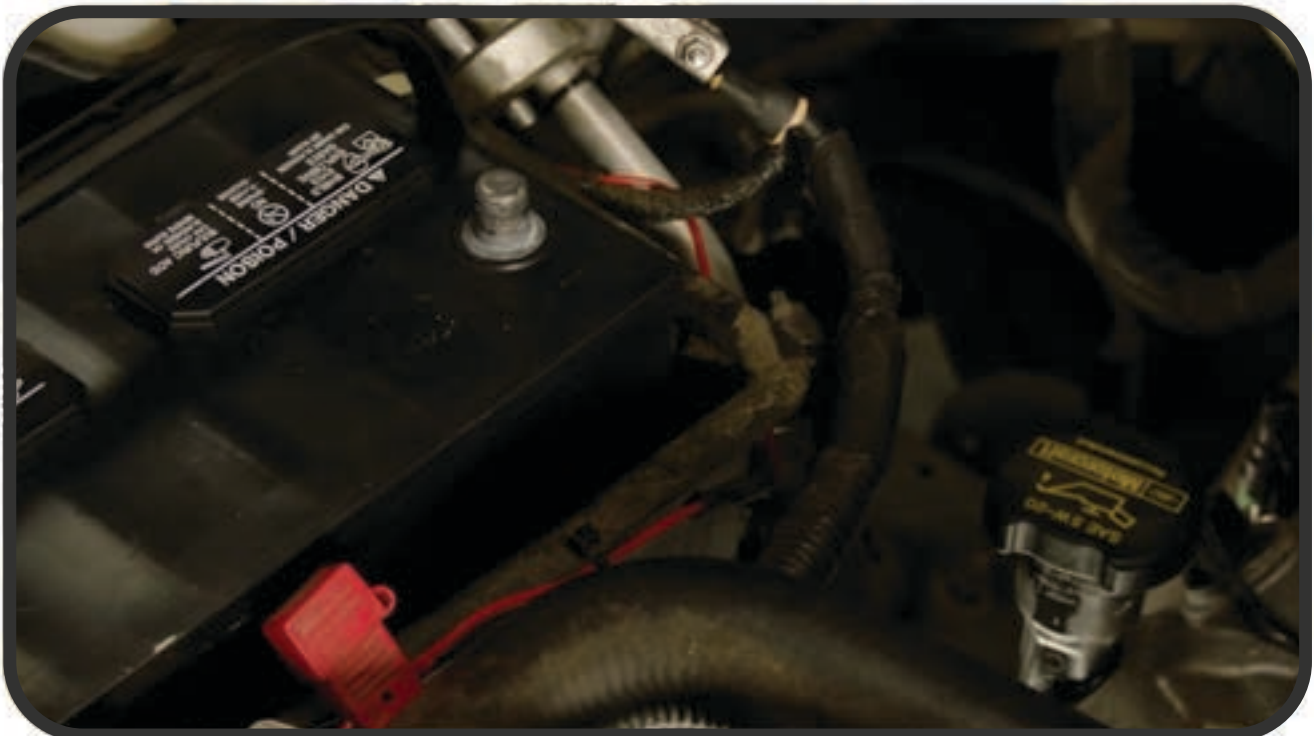
STEP 1:
DISCONNECT THE NEGATIVE BATTERY TERMINAL

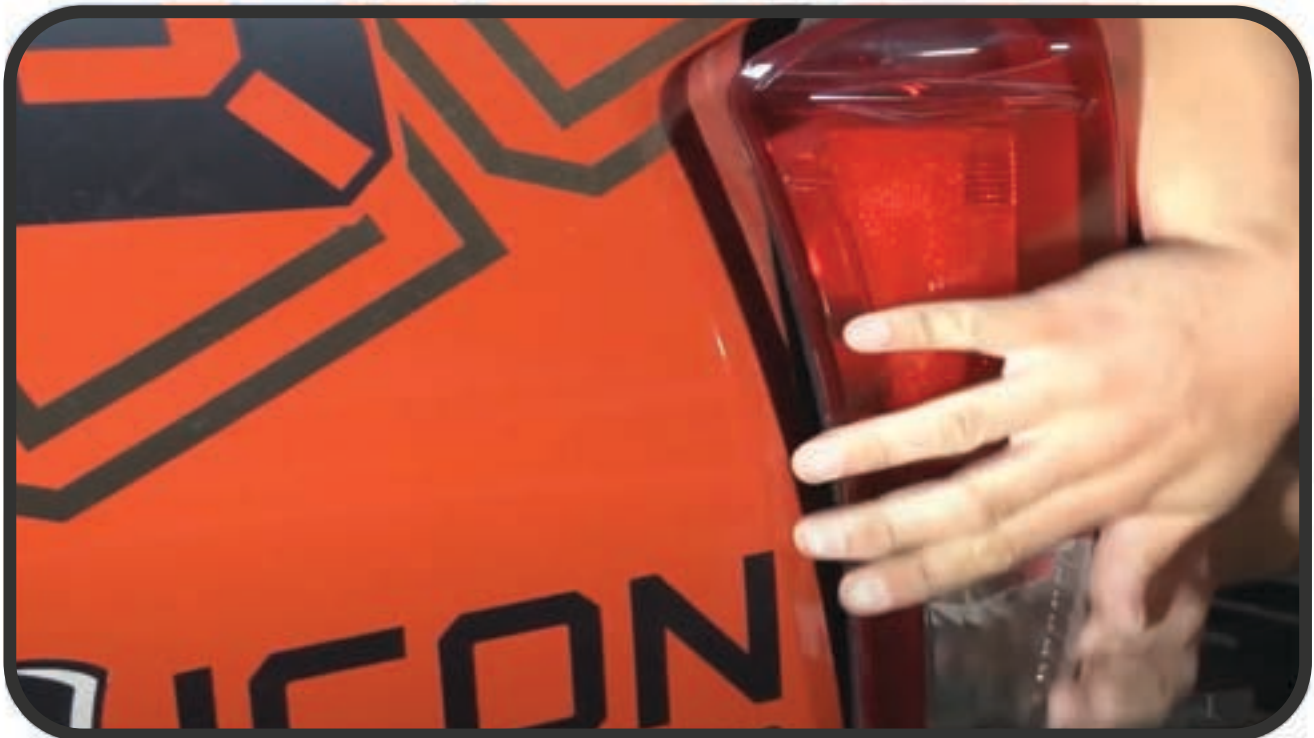
STEP 3:
UNSEAT TAIL LIGHT

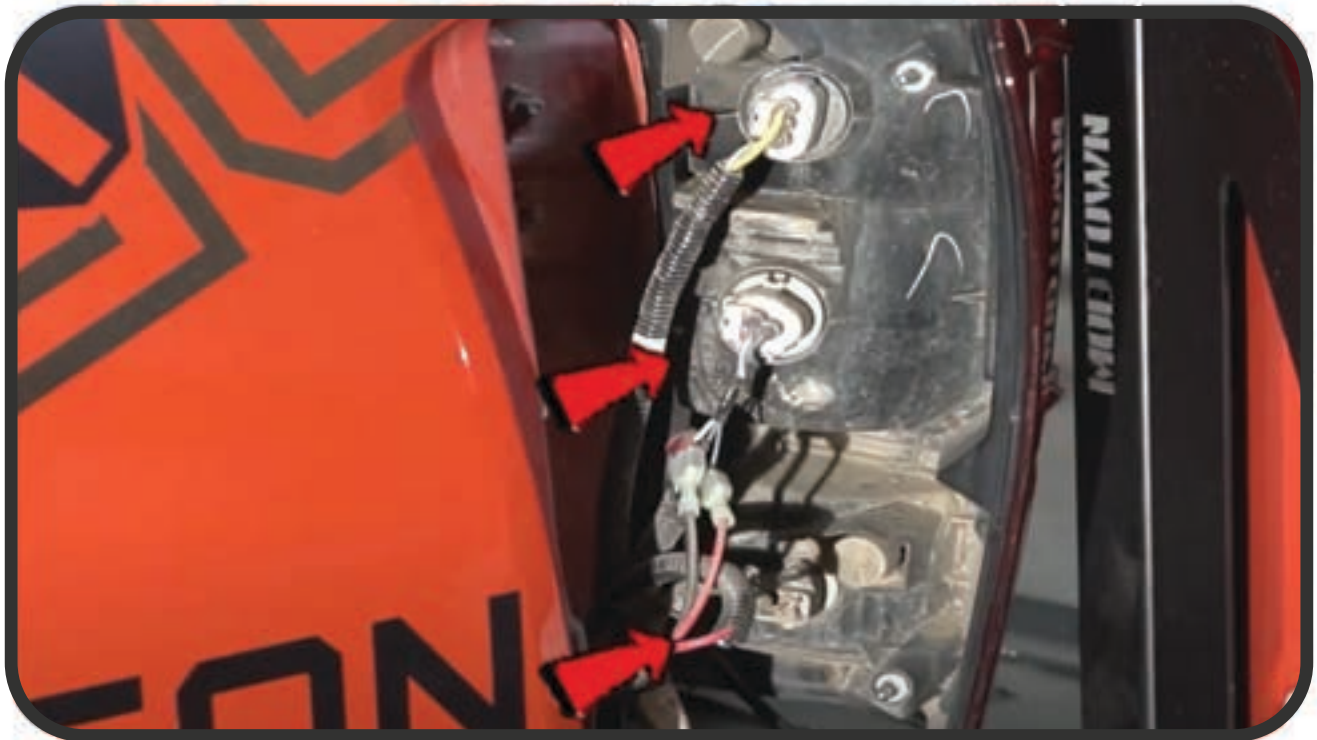
STEP 4:
REMOVE (3) BULB SOCKETS

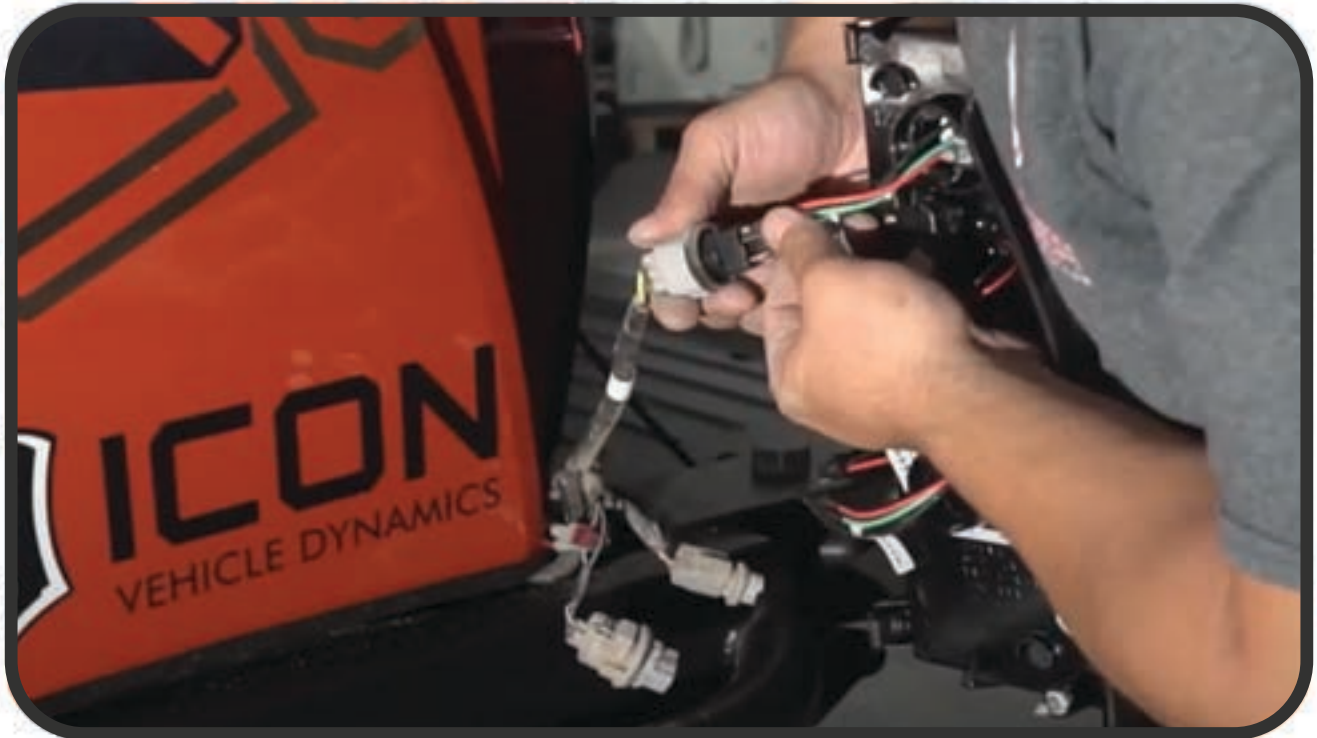
STEP 6:

INSTALL TOP SOCKET INSERTS. (ALIGN YELLOW WIRE FROM SOCKET TO RED WIRE OF SOCKET INSERT) REINSTALL SOCKET

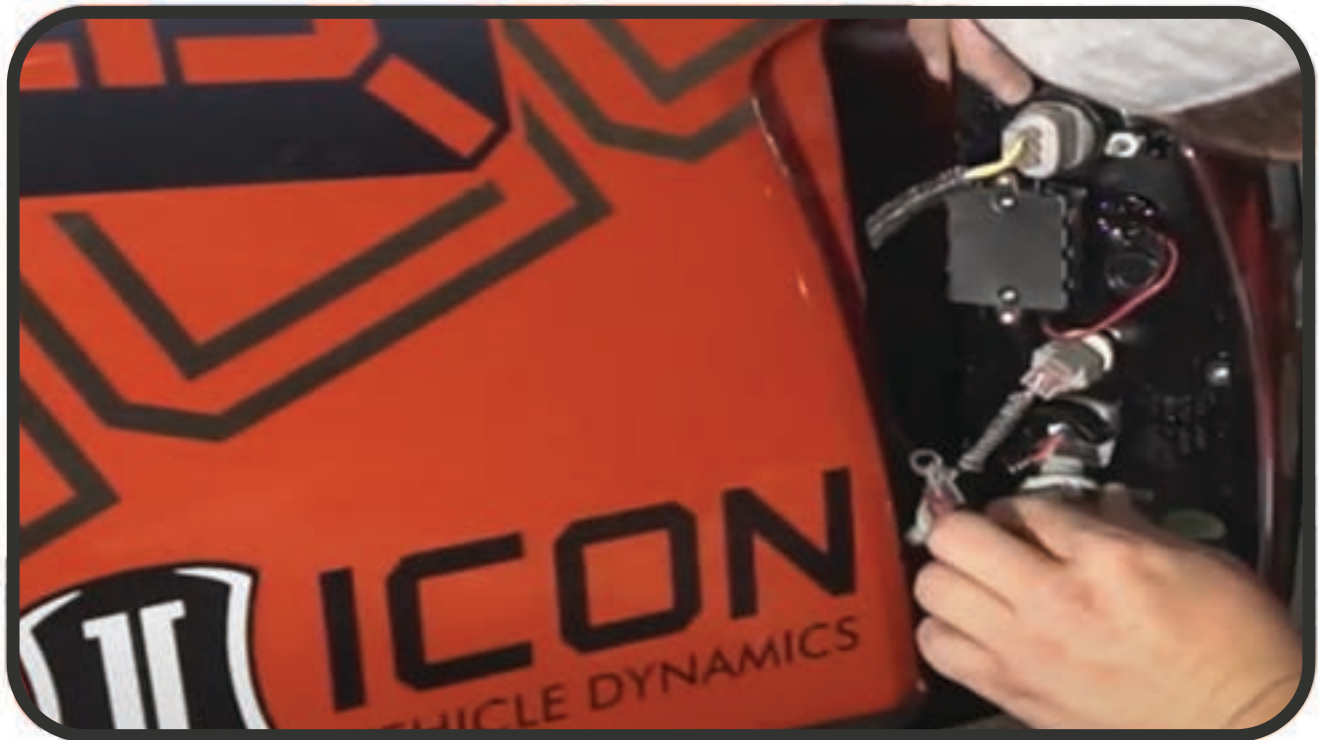
STEP 8:

INSTALL BOTTOM SOCKET INSERT. (ALIGN BLUE WIRE FROM SOCKET TO RED WIRE OF SOCKET INSERT) REINSTALL SOCKET

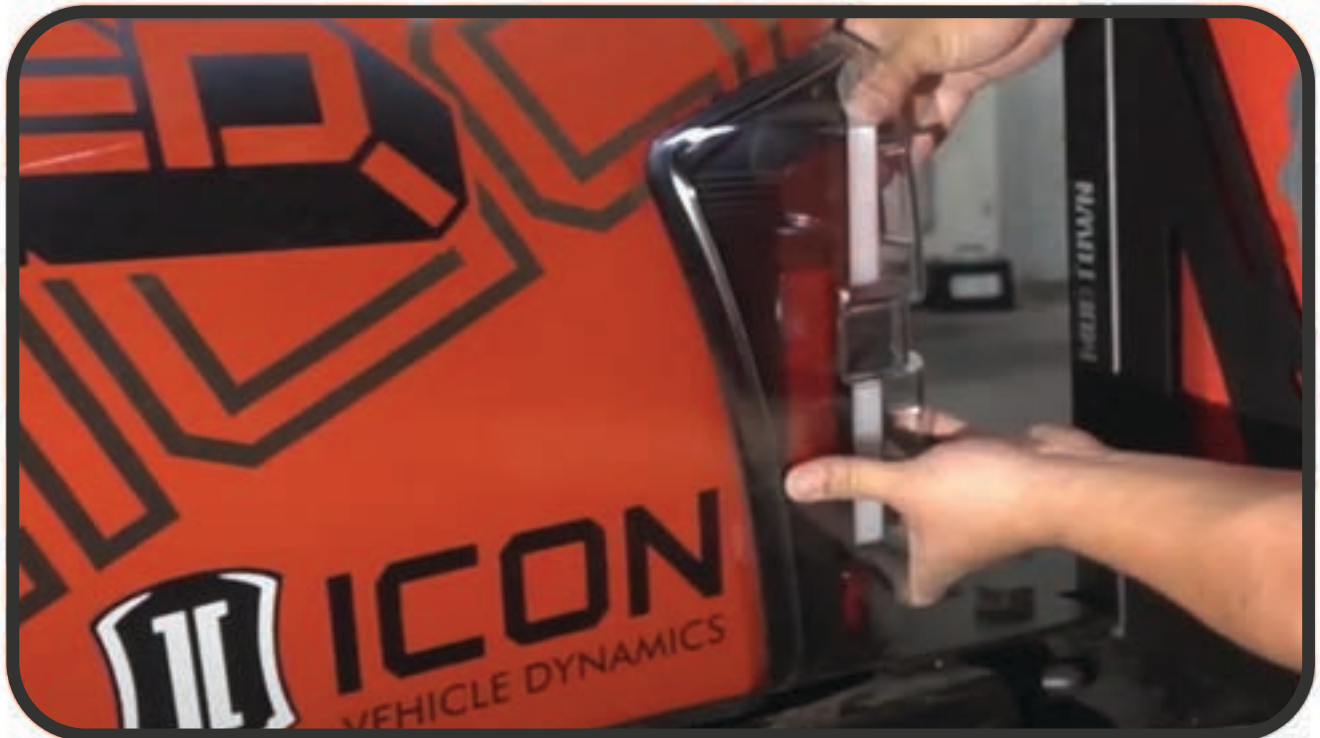
STEP 9:

SEAT SPYDER TAIL LIGHT

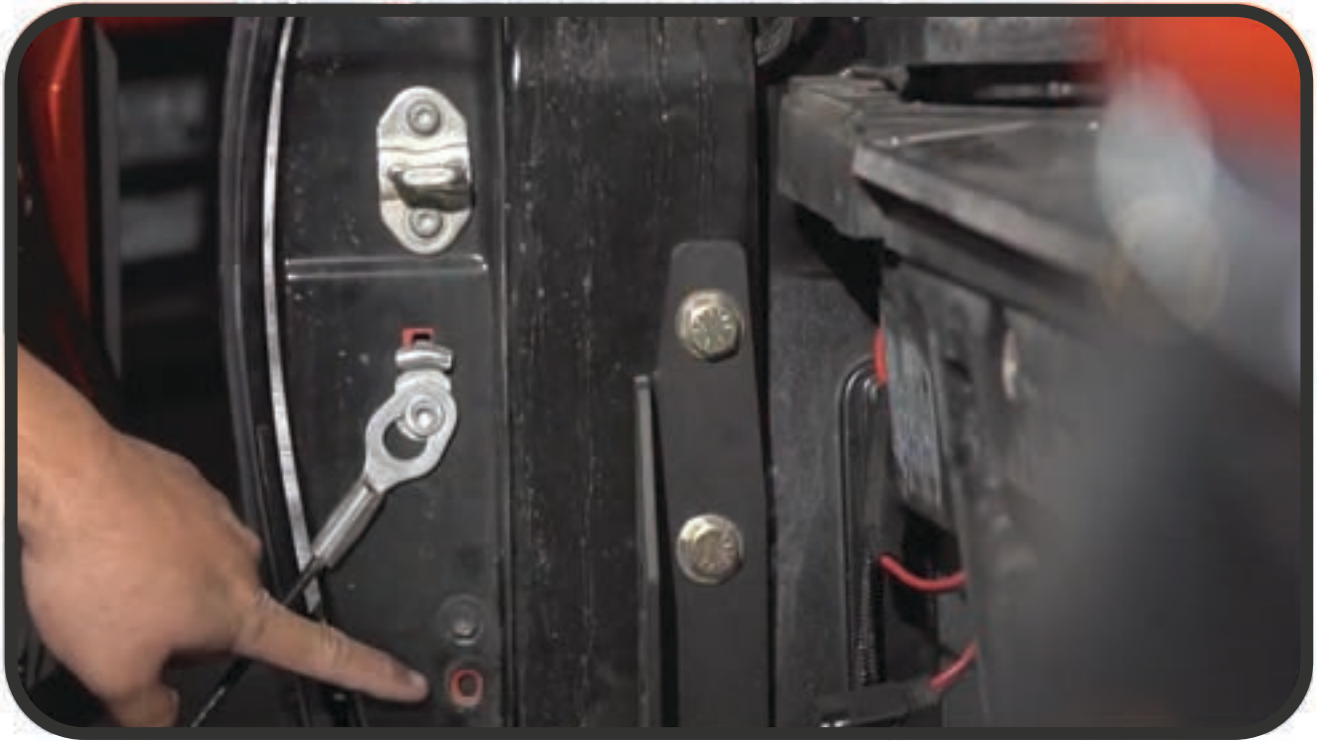
STEP 10:
REINSTALL (2) 10MM BOLTS

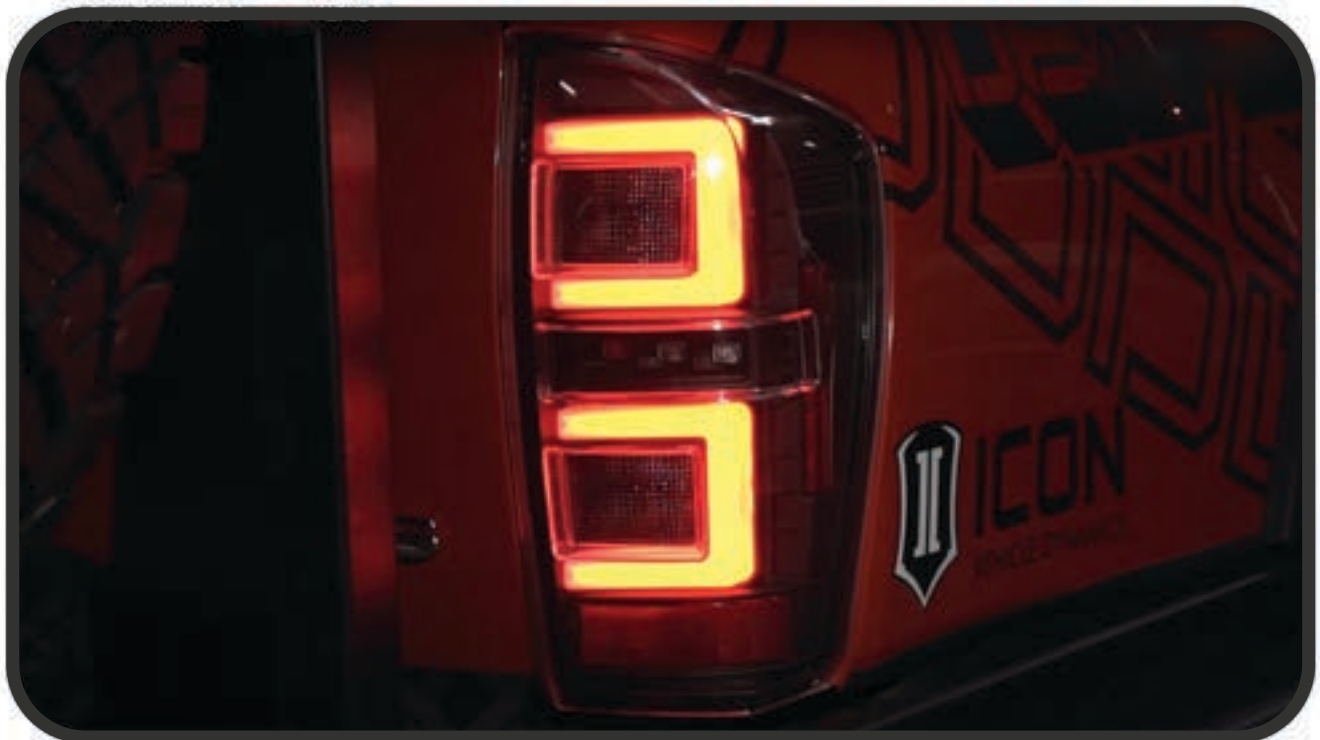
STEP 11:
RECONNECT THE BATTERY AND TEST THE FUNCTIONS TO ENSURE THEY FUNCTION PROPERLY
