## 3" Bull Bar

Part No. B0028S/B

Fits: **2004 - Current**  
**2003 - Current**

**Ford F150 (Excl. Heritage edition)**  
**Ford Expedition**

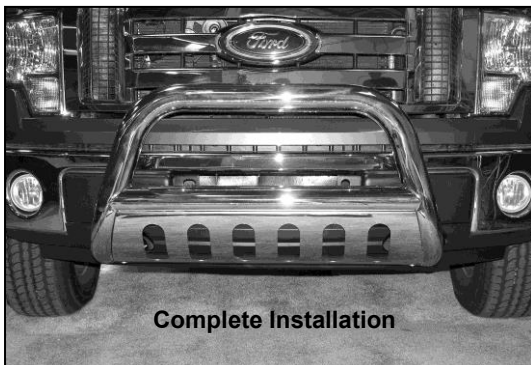
Complete Installation
