REAR TUBULAR DOOR

Part: J051RD

Jeep Wrangler JK

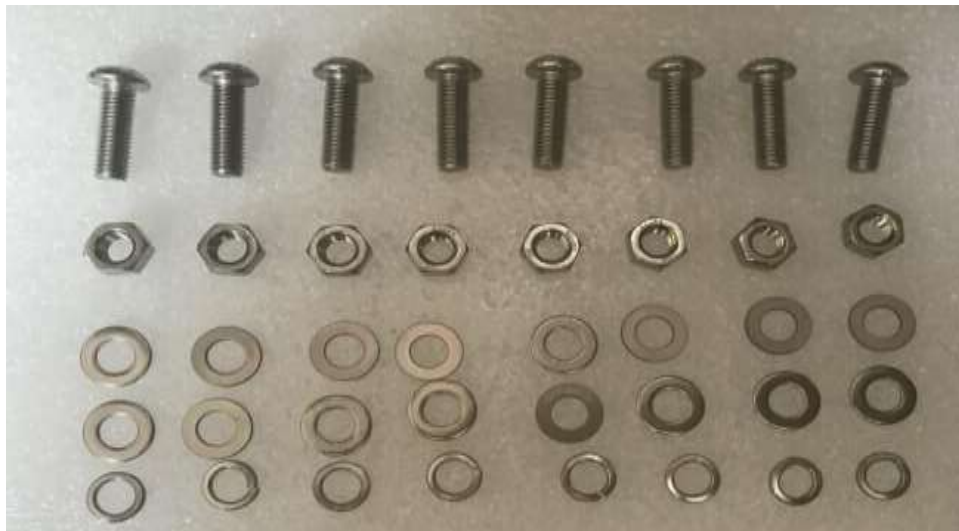
PART LIST IMAGES

Qty	Part Description	Qty	Part Description
8	M8*25 Half Round Head Socket Hexagon Bolt	8	M8 Spring Washer
16	M8*16*1 Flat Washer	8	M8 Nuts

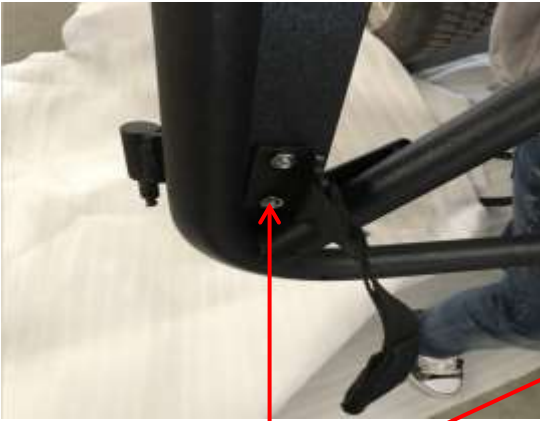
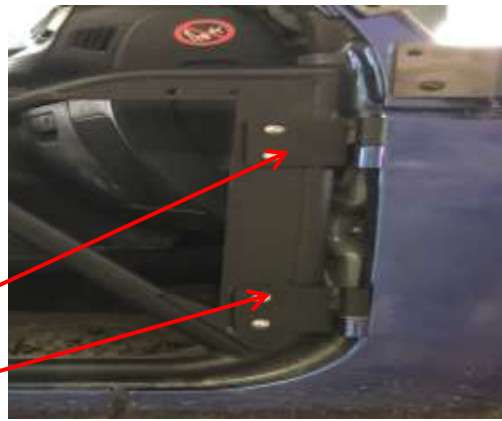
A – Door Assembly

1. Assemble to Doors parts and the safety belt (4xM8*25 bolts,8xM8 Flat washers, 4xM8 Spring washers, 4xM8 Nuts)

Step 1: Assemble the doors as shown below.

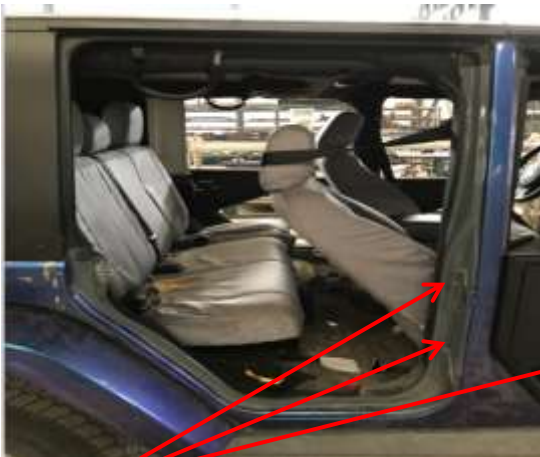
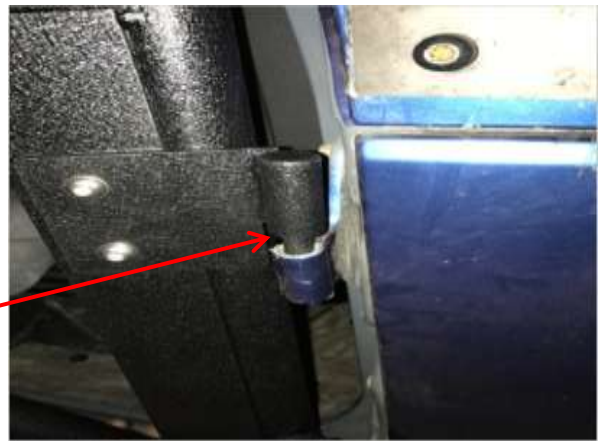
2. Rear Door Installation as Illustrated below

Step 2: Remove the Factory installed Rear door. Raise the TrailFx Rear Tubular Door up into place and align the (2) holes on the frame with the holes on vehicle on the doors..

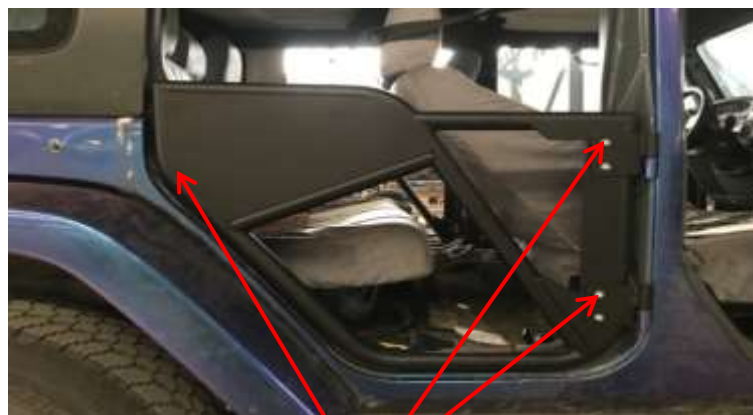
3. Fix the door and Debugging screws.

Step 3: Close the Door and Debugging Screws.

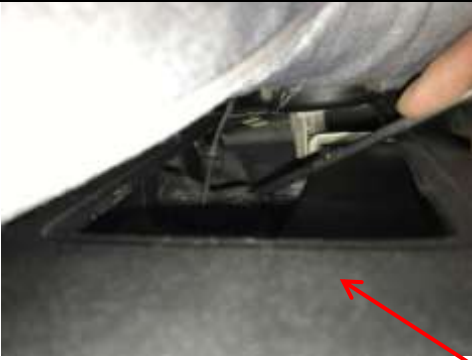
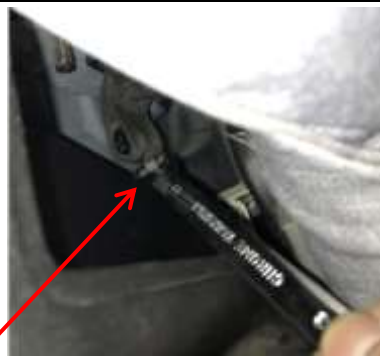
4. Fasten Safety Belt in doors

Step 4: Fasten Safety Belt in Doors.

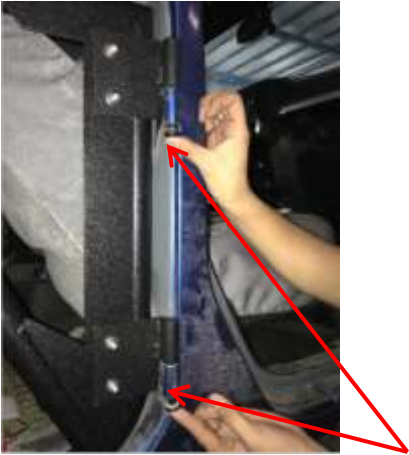
5. Install OEM Vehicle bolts

Step 5: Install the OEM Vehicle bolts.

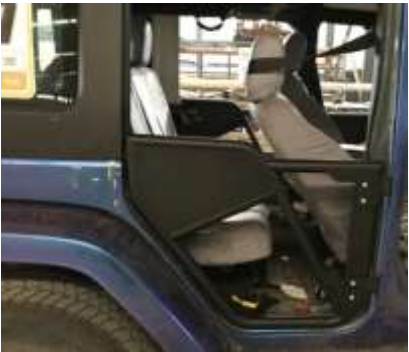
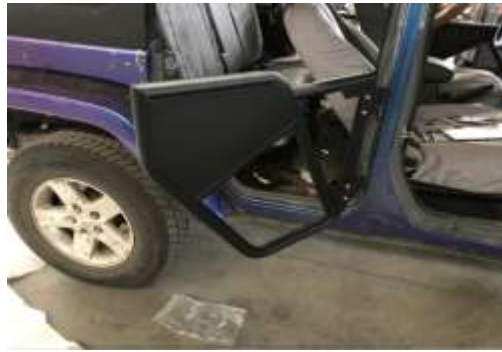
6. Installation completed

Step 6: Installation completed.
