Product Name: **BOV Kompact Hyundai i30N**  
Product Description: BOV Kompact Hyundai i30N  
Product Number: TS-0203-1036  
Document Version: V1.00 Rev A

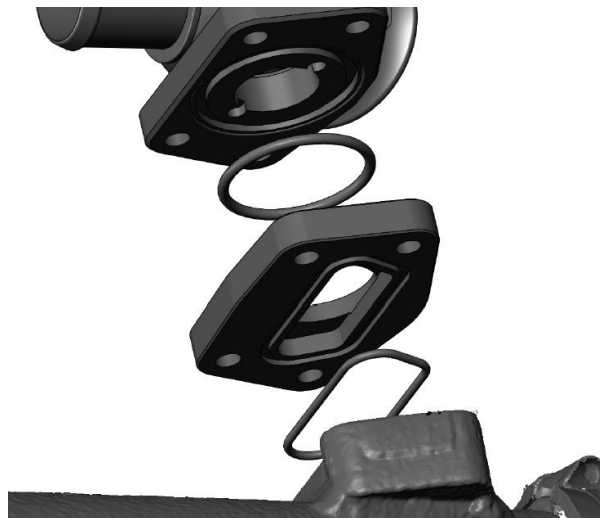
### 3 Align adapter plate with

Take note of the orientation of the adapter plate with the trapezoid passage to be placed against the matching port on the charge pipe and the circle port to be against the BOV. Ensure O-rings are in place and fit together with the four supplied bolts.

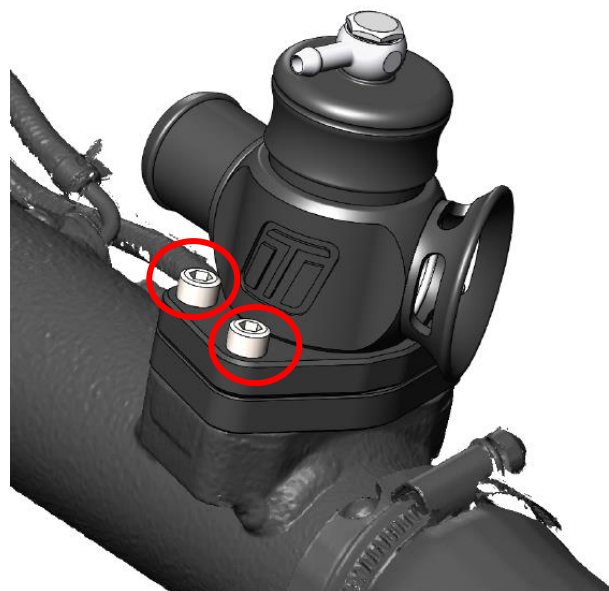
### 4 Mount your new Turbosmart Kompact BOV

Align your new Turbosmart Kompact BOV with the flange on the charge pipe, the bolt pattern will only allow the BOV to be fitted in one direction, ensure Both O-rings are correctly seated in their grooves and tighten down the bolts.

Re attached the recirculation hose onto the BOV and tighten the hose clamp. Align the swivel nipple on the cap of the BOV and attach the signal hose.
